The Greensand Country Landscape Partnership

SECRETS OF THE SANDS

SANDSTONE STRUCTURES AUDIT

November 2015

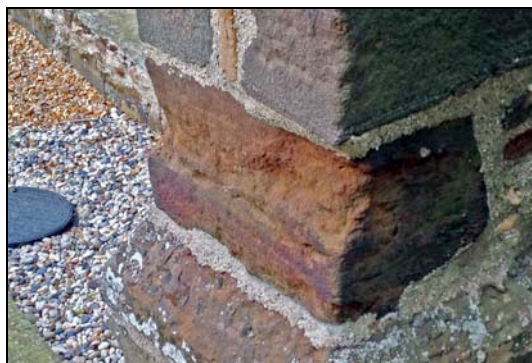
03.05: EROSION OF FRIABLE STONE

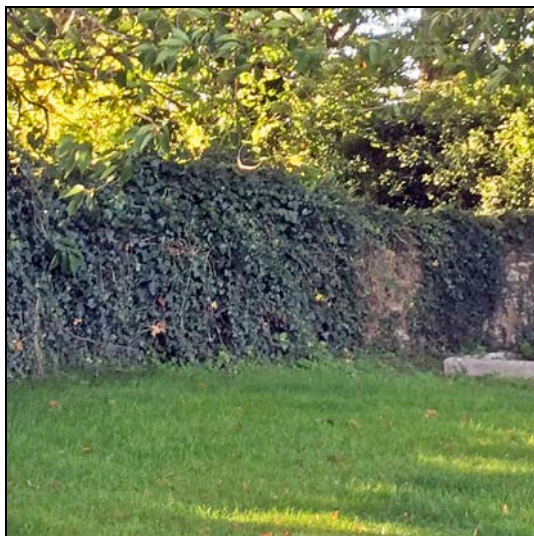
05.01: IVY-COVERED WALL

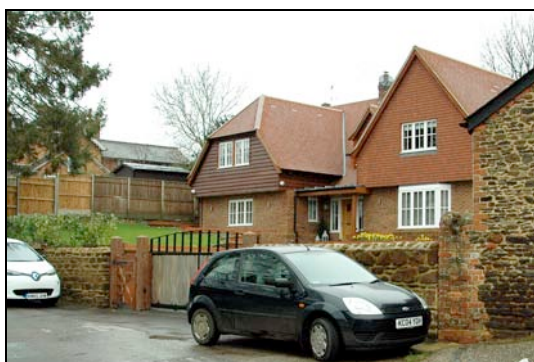
- 05.2.1 Comparing the records of the 2001 survey with what was observed on the ground in 2015 reveals a small but steady loss of sandstone walls due to changes in land usage or development. For example, on the north side of Watling Street in Little Brickhill where farm usage has ceased (Warren Farm) and agricultural buildings have cleared, and with that the loss of a number of walls.
- 05.2.2 There are also instances of where walls have been knocked-through or demolished to enable access, such as for the building or 5 Heath Road in Great Brickhill and 59 High Street in Clophill where an existing gateway has been widened to create vehicular access to two new houses (57a and 59a) which also illustrates how minor sandstone structures can be at risk due to accidental damage: over half the wall in front of 57a was toppled when carrying out works to form a parking space.

05.03: WALL PART DEMOLISHED TO CREATE ACCESS (GREAT BRICKHILL)

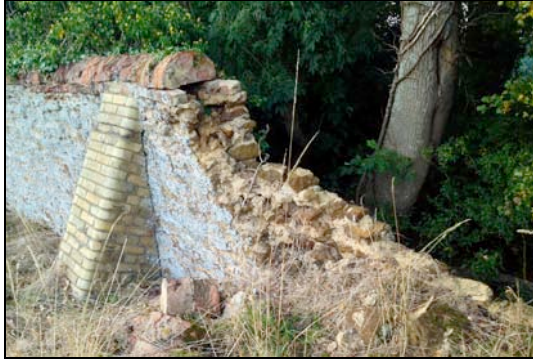
05.05: TOTAL COLLAPSE OF WALL

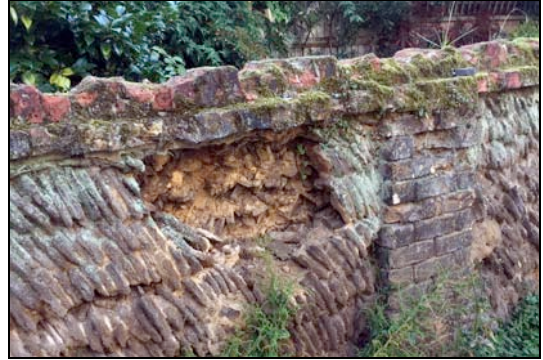
for stones to loosen and eventually become dislodged, leaving voids that make walls vulnerable to progressive collapse, as can be seen in the diagonally-laid wall alongside 6 Market Street in Potton and — an extreme example — much of the 2.8 km sandstone wall to the east, south and west of Sandy Warren (Lodge).

05.06: FALLEN STONES LEAVING VOID

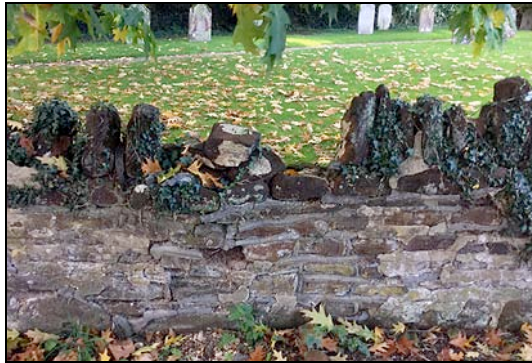
- 05.3.3 Copings are exposed to high levels of rain and hence often saturated with exposed beds of mortar highly vulnerable to frost damage and — again — the loosening and eventual loss of coping stones, e.g. Tingrith churchyard wall. And while the relatively high porosity of most sedimentary stones means that freeze-thaw is not generally a

05.08: LOSS OF COPING STONES

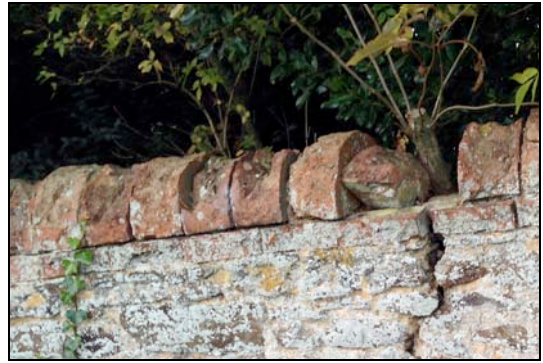
problem, brick copings are particularly susceptible to frost, as can be seen in the massive half-round capping to the wall to Great Brickhill Manor (which being south facing is also leaning towards the prevailing weather).

05.09: DETERIORATED BRICK COPING

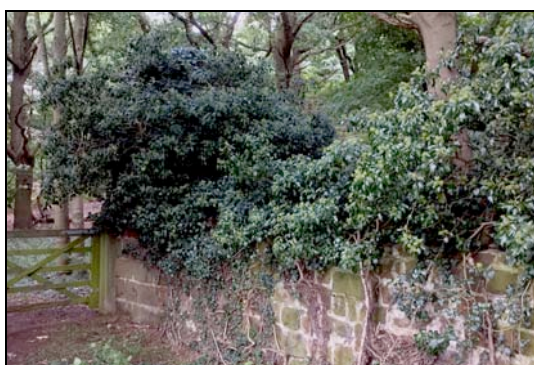
preventing the build-up of soil and damage caused by unmanaged vegetation, notably the penetration of the masonry by the woody secondary growths of ivy and displacement by the trunks and roots of self-sown trees close to walls. The impact of unmanaged vegetation is particularly notable on the wall of Sandy Warren (including to dressed stone gate piers which are now almost enveloped). However, it must also be appreciated that vegetation is often an essential part of the character of an old wall and that in many instances its presence is benign and therefore managed retention is preferable, e.g. the walls to Husborne Crawley churchyard.

05.11: HARMFUL VEGETATION

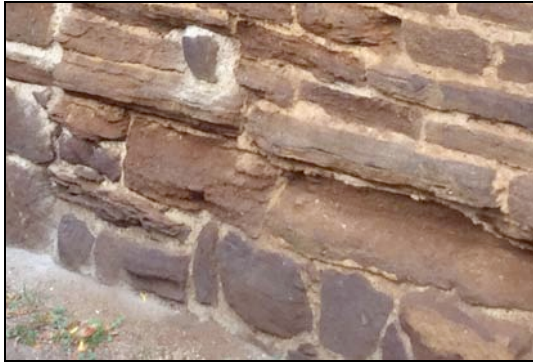
- 05.4.3 However, there is a significant problem with the accelerated decay of sandstone at low level alongside roads and pavements due to contamination by de-icing salts (sodium chloride), the impact of which is intensified by hard, impervious surfaces like asphalt adjacent. This is especially the case in Clophill where the bases of some walls on the High Street (57–59) are so deeply eroded as to risk eventual collapse. Similarly — though to a lesser extent — the long retaining wall running back from the High Street on the east side of Mill Lane (the boundary of Clophill House). It is instructive to compare these walls with the barn at Water End, where a grass verge controls contamination and splash-back, and the stone is in excellent condition.

05.13: SALT EROSION BESIDE ROAD

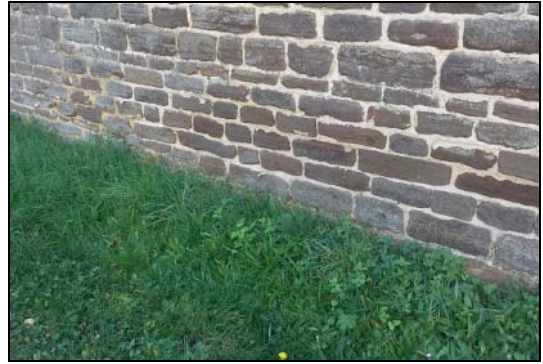
05.14: GRASS VERGE PROTECTS WALL

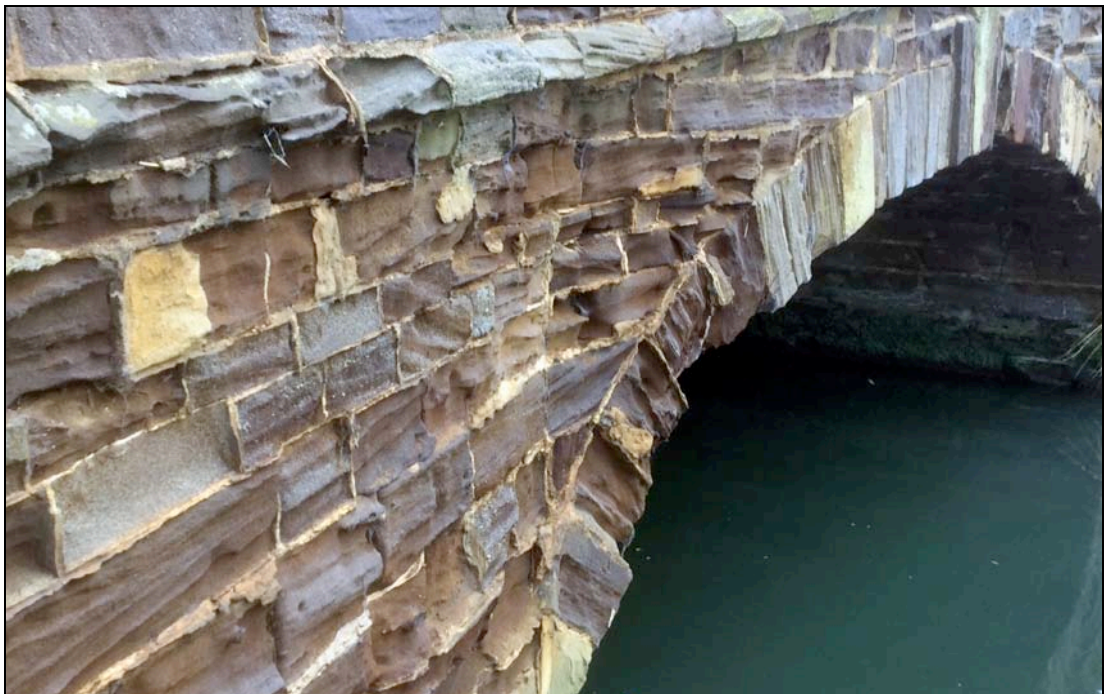
- 05.4.4 Groundwater can also carry salts, which can result in the premature decay to earth-bound (retaining) walls. This is especially the case around burial grounds due to the fact that approximately 5% of the mass of a decomposed corpse is made up of various mineral salts that are typically released as ground contaminants over a 10–12 year period, albeit over half within the first year (Environment Agency, 2004). It is therefore important that sandstone retaining walls are allowed to as far as possible ‘breathe’, i.e. promote the passage and thence evaporation of salt-contaminated water rather than allow a build-up of contaminants to become trapped behind, though efflorescence and some colouring of surfaces may have to be accepted, as can be seen to the low retaining wall along the east side of Haynes churchyard. Waterborne salts percolating through bridge decks — even if just along the edges — will also accelerate the decay of any stonework below, as evident in the deep erosion of the facing stone to the grade II listed Girtford Bridge.

05.15: DEEP EROSION DUE TO SALTS LEECHING FROM ROAD DECK OF 18TH CENTURY GIRTFORD BRIDGE, EXACERBATED BY CEMENT POINTING

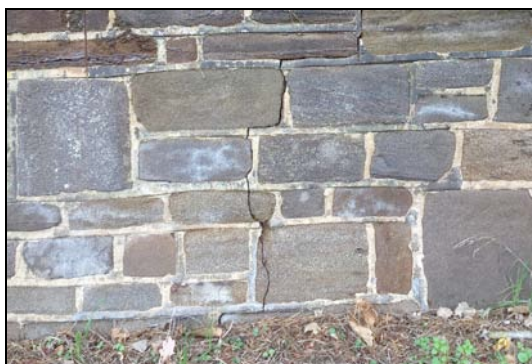
05.17: THERMAL CRACKING

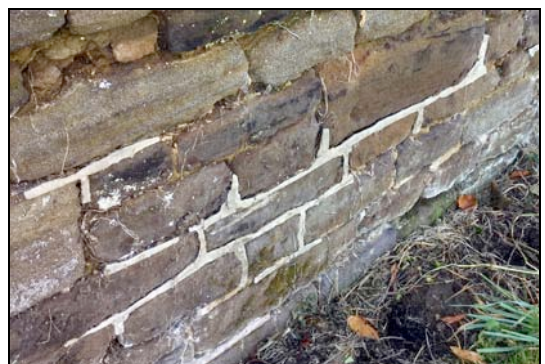
05.18: FAILED CEMENT MORTAR

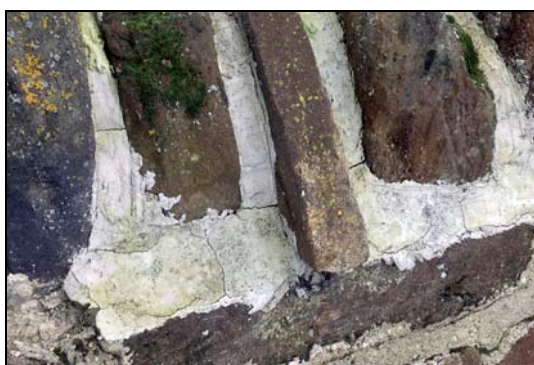
- 05.5.2 The use of cement mortar for bedding, jointing and pointing — often failing due to inadequate raking out, poor compaction or feathering — is a major issue in terms of the on-going survival and character of minor sandstone structures across the Greensand Country. It is the most extensive example of inappropriate repair, most evident where mud mortars and open joints that should never have been pointed have been filled. While there are good examples of lime-based pointing and instances where original joints have been ‘left alone’, these are few. Even where lime mortars have been used, poor execution (feathered edges, smearing, closed surfaces, etc.) and a probable lack of protection has resulted in failure. exacerbating which is a tendency to ‘stretch’ on-edge coping stones rather than placing them tight, leaving highly vulnerable mortared gaps to the heads of the walling between.

05.19: FAILURE OF LIME MORTAR DUE TO POOR WORKSMANSHIP

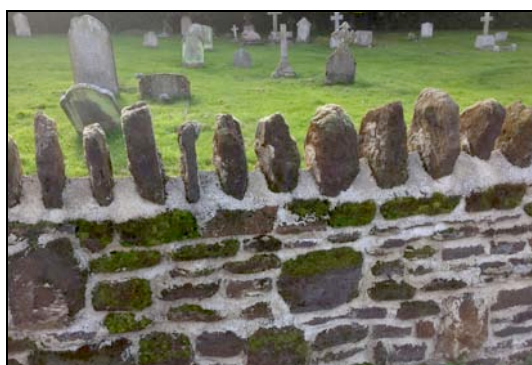
05.20: STRETCHED COPING STONES EXPOSING VULNERABLE MORTAR
