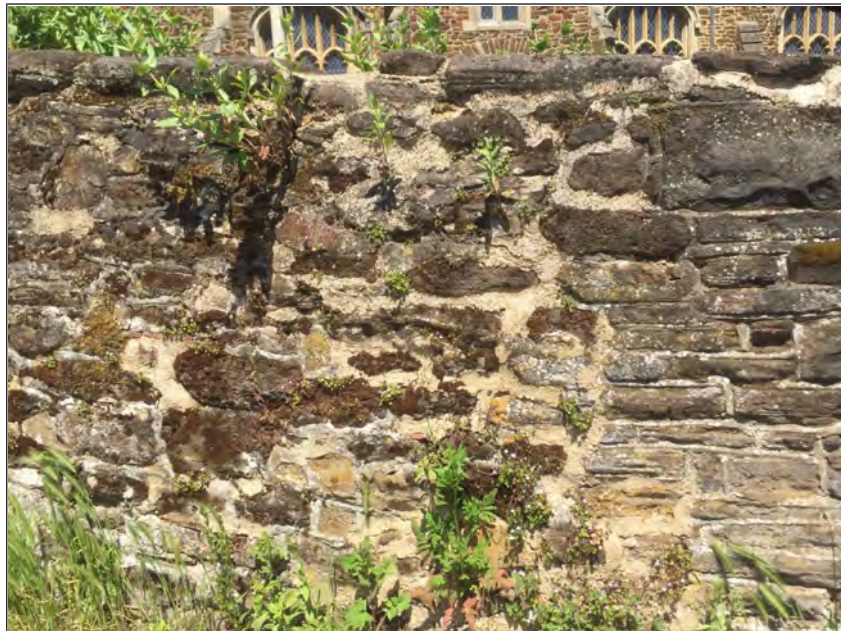
**Condition** ☐ Good ☒ Reasonable ☐ Poor ☐ At Risk ☐ Not seen close

**Notes** Unclear if all wall is snecked due to rough-racking (smearing) of render. Parts of wall are in poor condition.

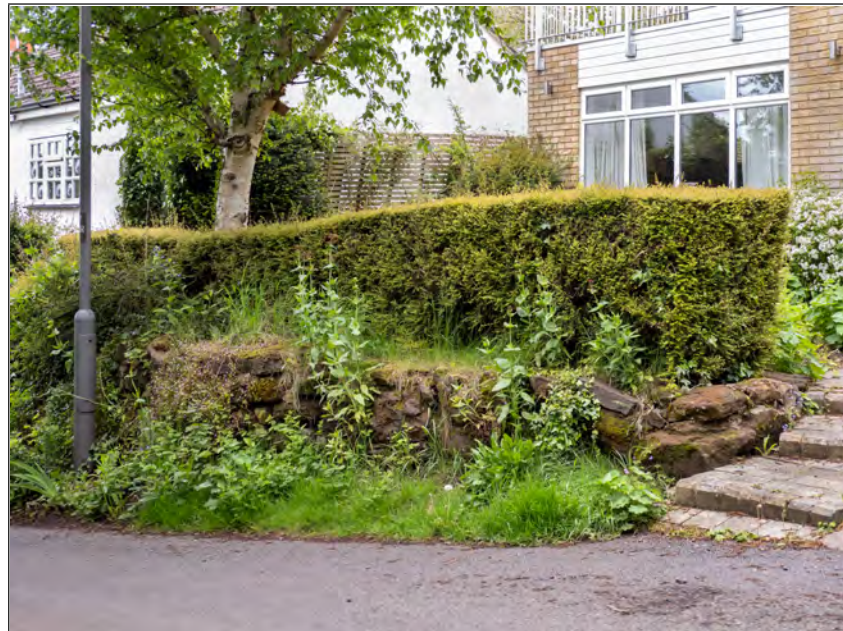
**Condition** ☐ Good ☐ Reasonable ☒ Poor ☐ At Risk ☐ Not seen close

**Notes** Open joints, loose stones, etc.

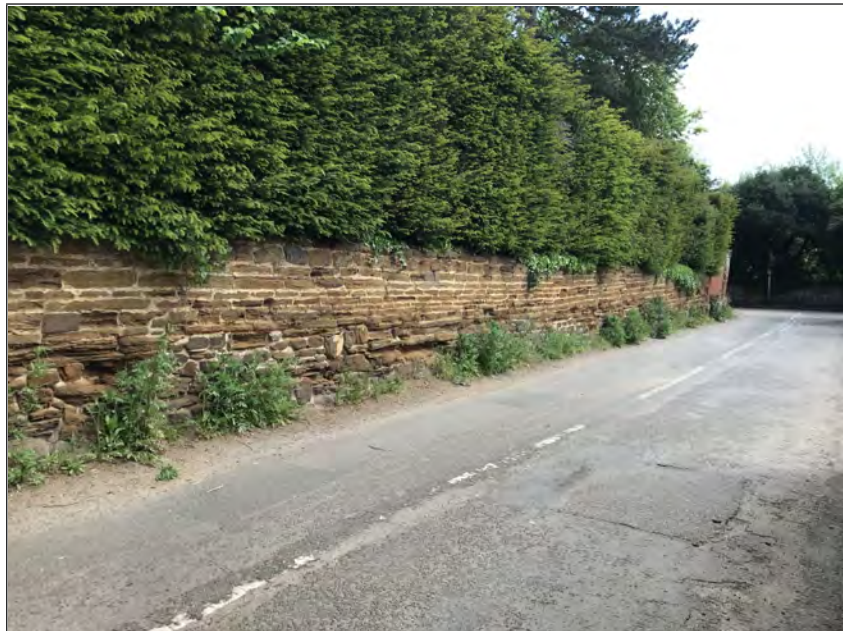
**Notes** Boundary wall on Mill Lane. Lower part of wall has been repaired in random rubble. Reported that upper part of wall (non-retaining) was taken down. Some parts of wall verging on poor condition due to salt erosion.

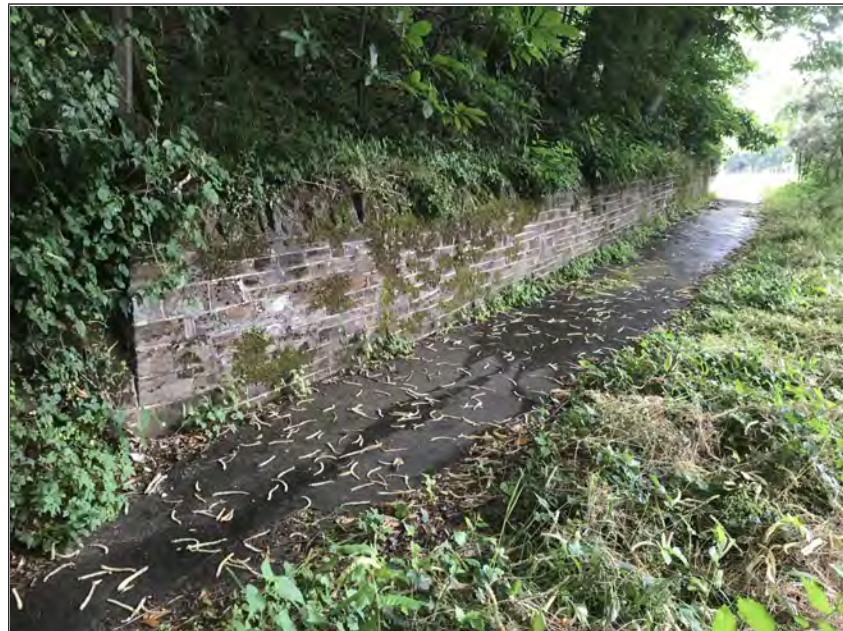
**Notes** Massive wall alongside A6. Some areas in poor condition though generally reasonable.

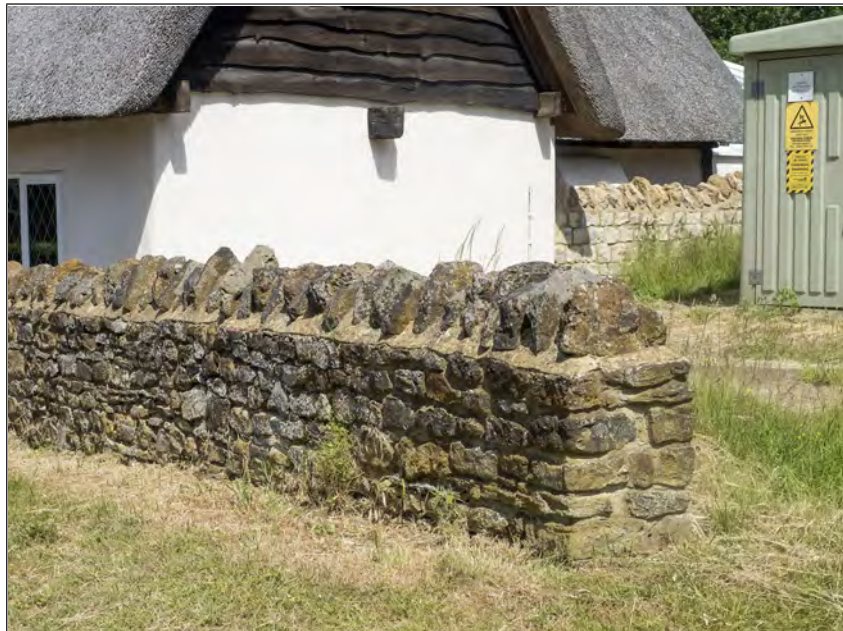
**Condition** ☐ Good ☐ Reasonable ☒ Poor ☐ At Risk ☐ Not seen close

**Notes** Part of western end missing.

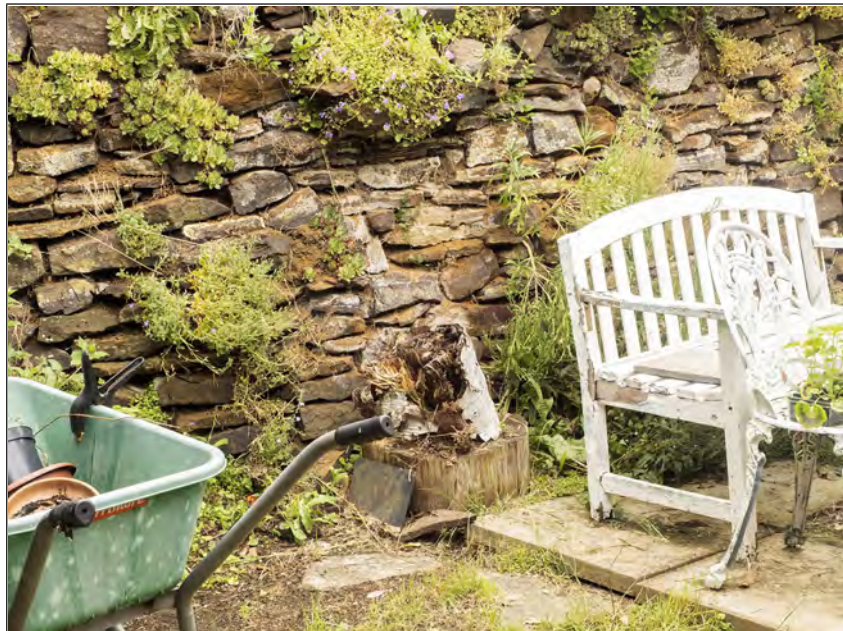
**Notes** Garden wall to the right (east). Wall is in places cracked full height and depth.

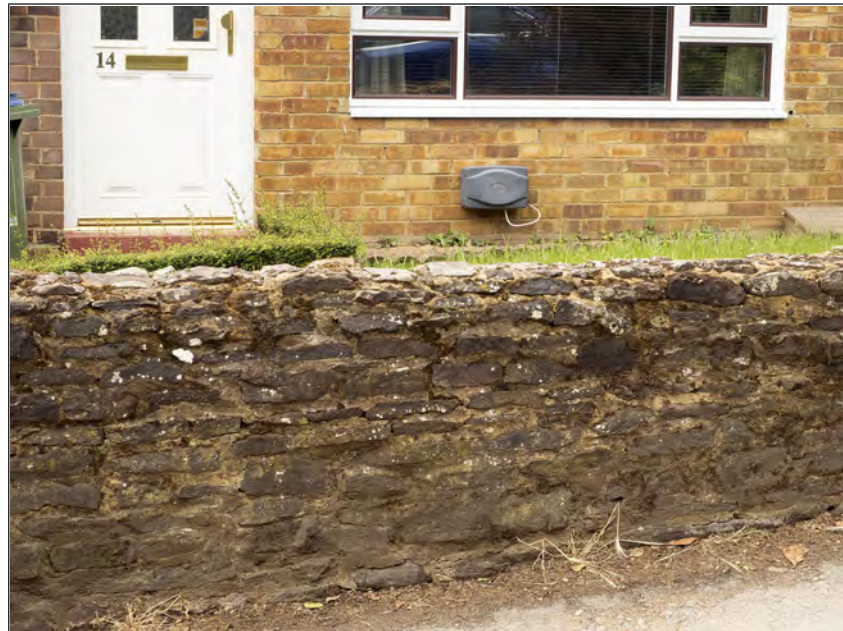
**Condition** ☐ Good ☐ Reasonable ☒ Poor ☐ At Risk ☐ Not seen close

**Notes** Coping deteriorating.

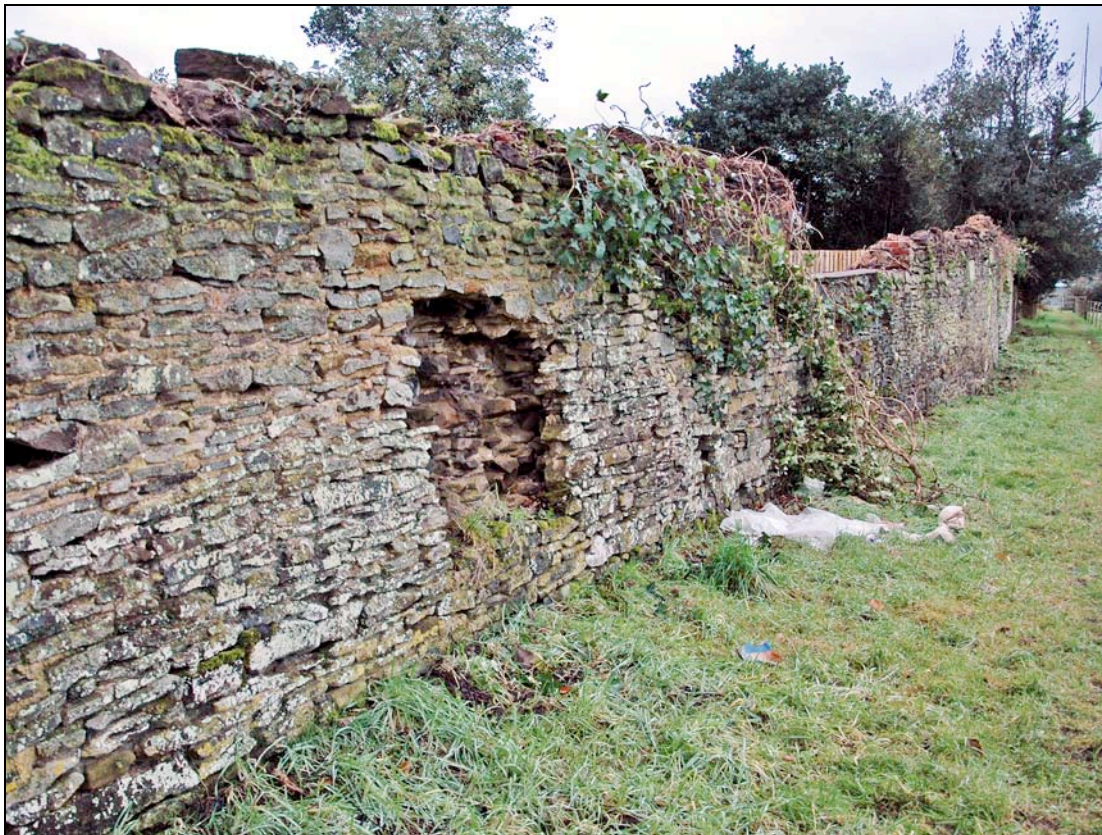
*5.07: FALLEN STONES, DETERIORATION OF COPING & INVASIVE VEGETATION LEAVING WALL IN POOR CONDITION + RISK OF EVENTUAL COLLAPSE*

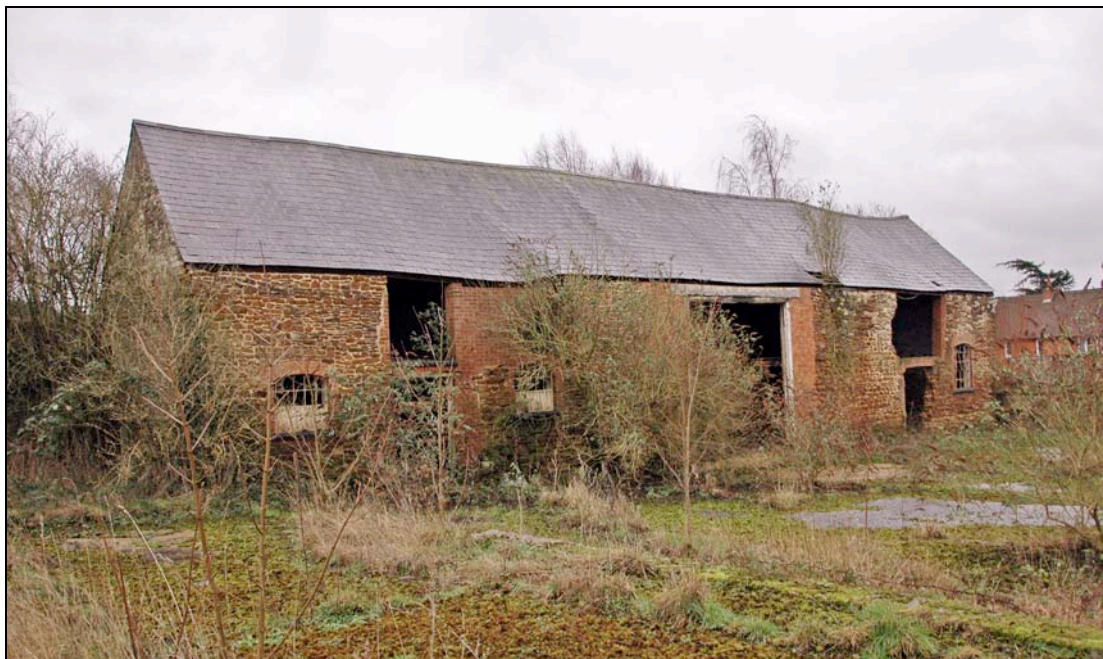
- 05.3.4 Unused buildings that are left to fall into dereliction can also become as vulnerable as freestanding walls, especially when roofs are lost and wall heads are exposed to the weather. The extent to which neglect can threaten the survival of sandstone buildings is illustrated by the parlous state of a farm buildings at Overend Green and Buttermilk Wood, and the 'stable' to the north of Maulden churchyard (refer 04.1.2). As noted in 03.4, wholly sandstone buildings are a rarity across the Greensand Country with unconverted barns and animal houses being particularly scarce (04.1.2, second bullet). The potential loss of three is a serious issue.

5.10: ABANDONED FARM BUILDING FALLING INTO DERELICTION (LITTLE BRICKHILL)

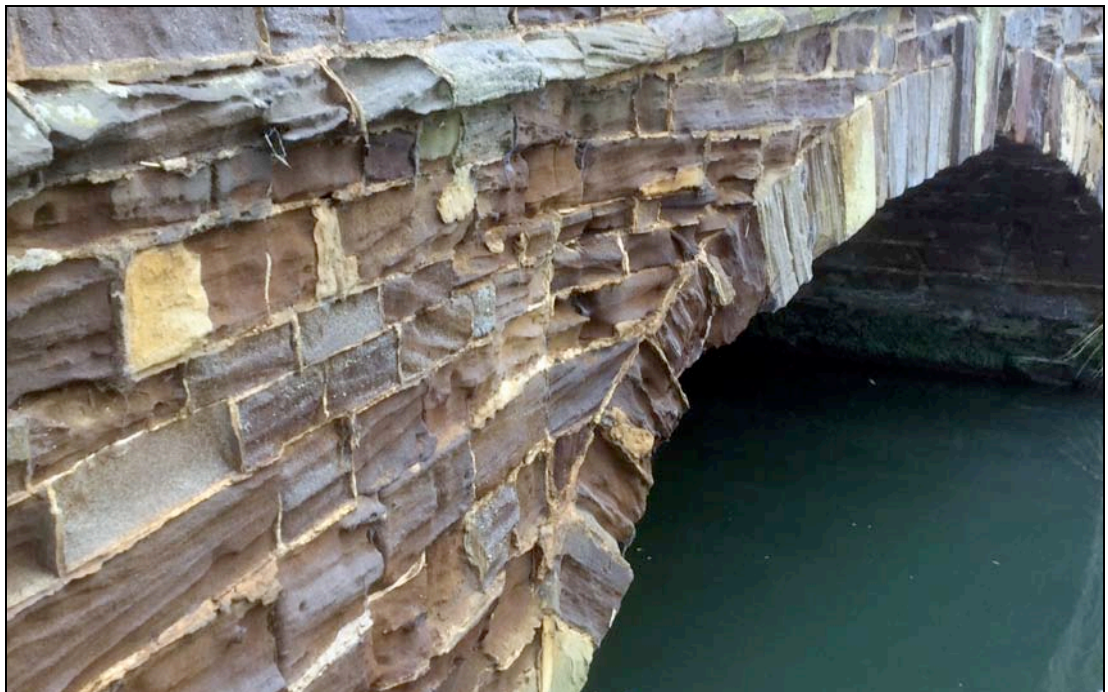
- 05.4.4 Groundwater can also carry salts, which can result in the premature decay to earth-bound (retaining) walls. This is especially the case around burial grounds due to the fact that approximately 5% of the mass of a decomposed corpse is made up of various mineral salts that are typically released as ground contaminants over a 10–12 year period, albeit over half within the first year (Environment Agency, 2004). It is therefore important that sandstone retaining walls are allowed to as far as possible ‘breathe’, i.e. promote the passage and thence evaporation of salt-contaminated water rather than allow a build-up of contaminants to become trapped behind, though efflorescence and some colouring of surfaces may have to be accepted, as can be seen to the low retaining wall along the east side of Haynes churchyard. Waterborne salts percolating through bridge decks — even if just along the edges — will also accelerate the decay of any stonework below, as evident in the deep erosion of the facing stone to the grade II listed Girtford Bridge.

05.15: DEEP EROSION DUE TO SALTS LEECHING FROM ROAD DECK OF 18TH CENTURY GIRTFORD BRIDGE, EXACERBATED BY CEMENT POINTING

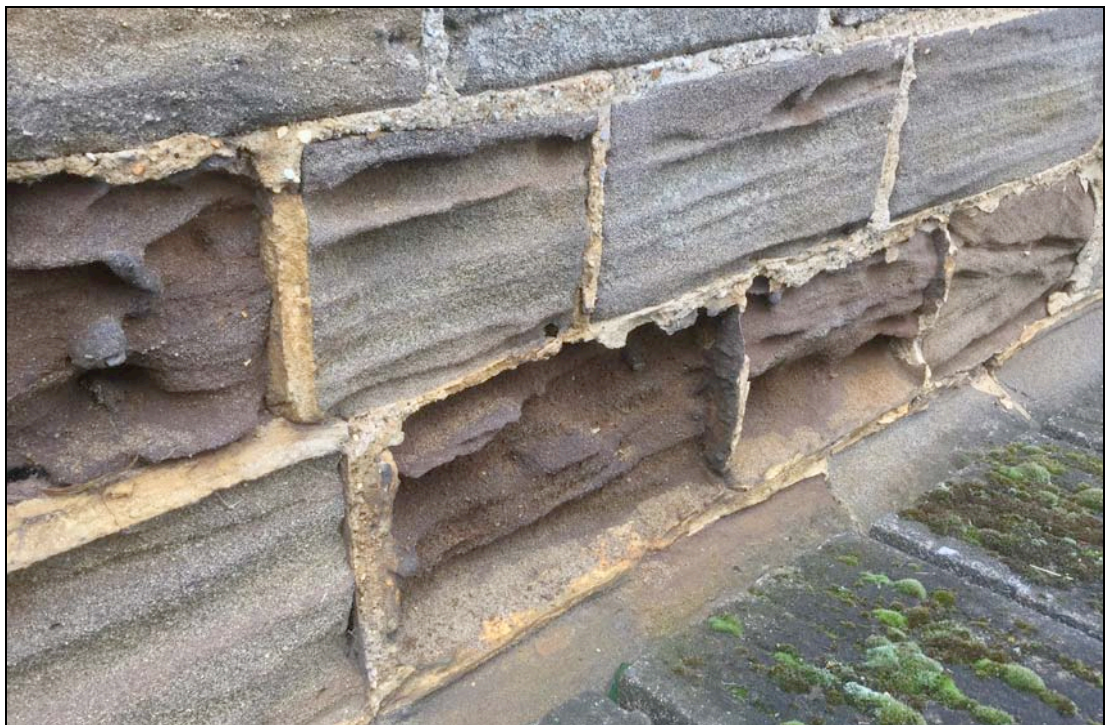
- 05.5.1 Another characteristic of salt damage to sandstone arises from repointing with modern Portland cement mortars, which are high in sulphates and other potentially damaging minerals. Furthermore, cement-based mortars are considerably less pervious than many sandstones, meaning that they inhibit the breathability of the masonry, forcing more water to evaporate through the stones and hence the accelerated deterioration of the facework, an extreme case being the flanks of Girtford Bridge where the mortar — which now sits proud of the stones — adds another agent of decay to the salts and groundwater noted in 05.4. The rigid, impervious nature of cement-based mortars also means that walls are less able to accommodate thermal movement (expansion and contraction, a feature of all building materials and not just masonry) and hence are more prone to cracking.

05.16: DETRIMENTAL IMPACT OF HARD CEMENT POINTING ON GIRTFORD BRIDGE

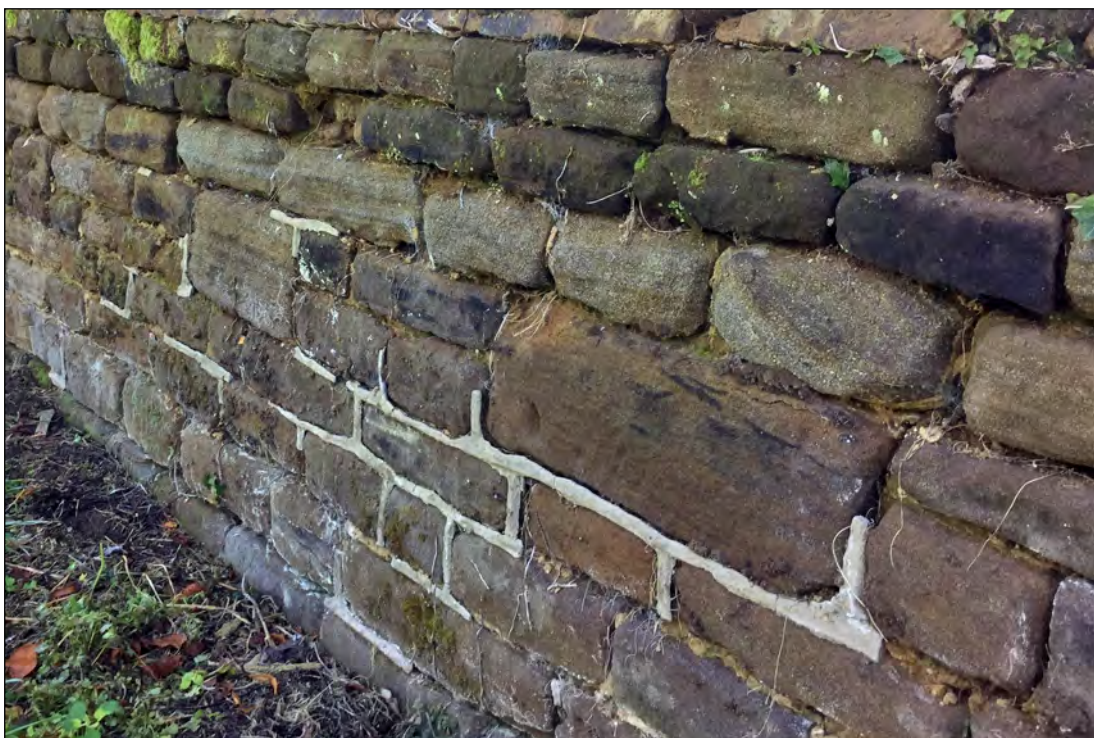
C.05: OPEN JOINTS & FAILING CEMENT MORTAR IN NEED OF RENEWAL

The purpose of repointing selected joints and areas of the walling is to ensure that open bed joints or perpends which compromise the weathering function of the walls are filled with mortar which is more permeable than the adjacent masonry, and that — where practical and appropriate — damaging cement-rich pointing is replaced.

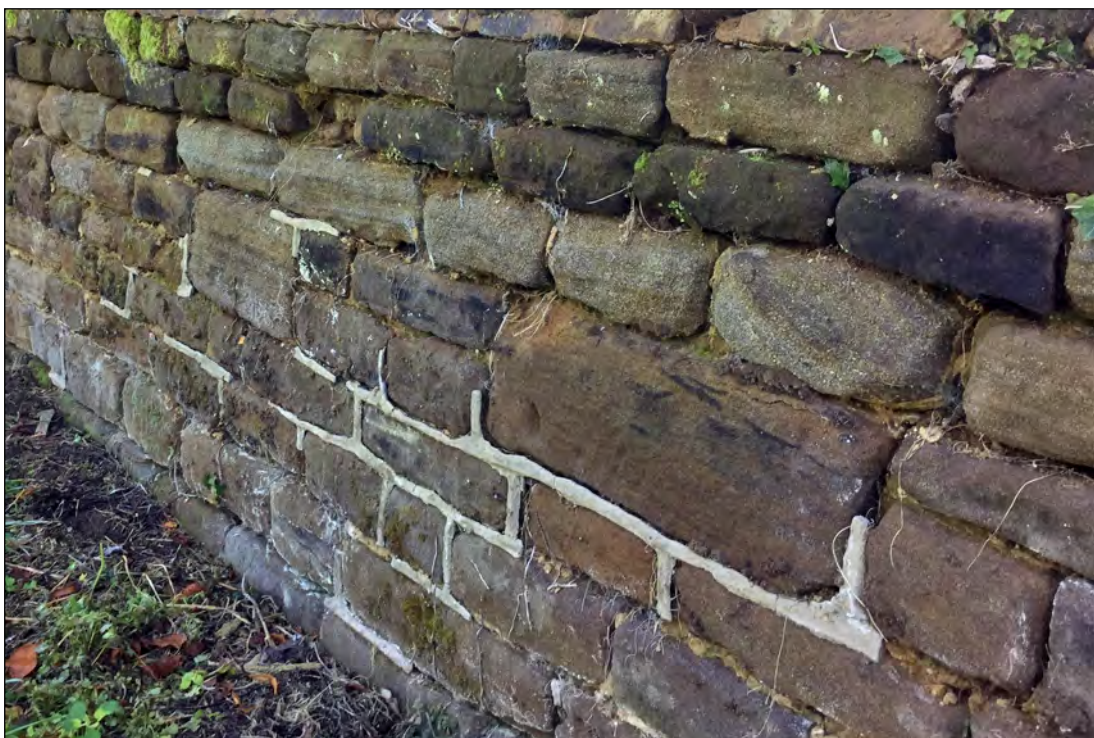
C.05: OPEN JOINTS & FAILING CEMENT MORTAR IN NEED OF RENEWAL

The purpose of repointing selected joints and areas of the walling is to ensure that open bed joints or perpends which compromise the weathering function of the walls are filled with mortar which is more permeable than the adjacent masonry, and that — where practical and appropriate — damaging cement-rich pointing is replaced.
