Hydrant Pit Coupler Incidents and EI 1584 Third Edition

EI 1584 Third Edition - Hydrant Pit Valves and Couplers

HYDRANT COUPLER KNOCK-OFF INCIDENT SUMMARY SHARING LESSONS

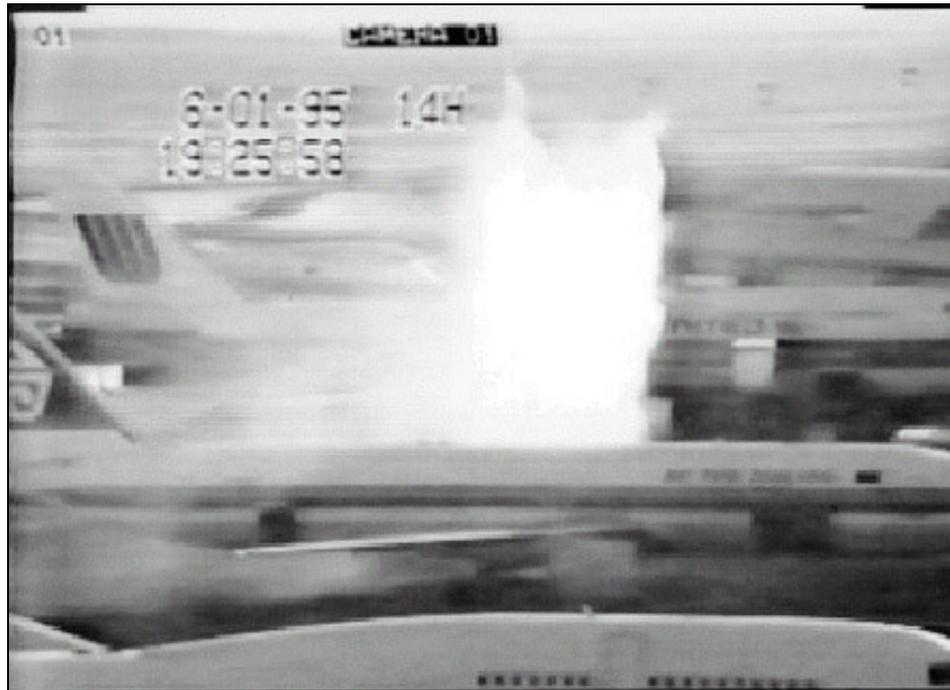
Most of us have seen the graphic images of the Auckland incident in 1995 when a pit coupler became detached from a hydrant pit valve during fuelling, resulting in a release of fuel under full hydrant pressure. Had this spray come into contact with a source of ignition such as a hot aircraft engine or the exhaust system of a nearby vehicle, the outcome could have been an ignition of explosive force with the possibility of multiple fatalities. The event was captured on a CCTV security camera and the image below clearly shows the spray which engulfed several neighbouring aircraft.

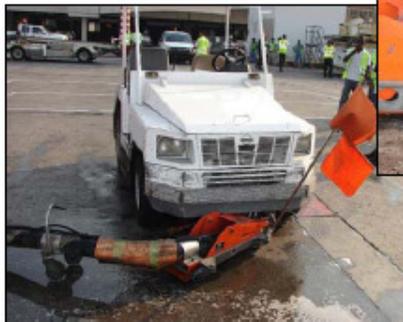
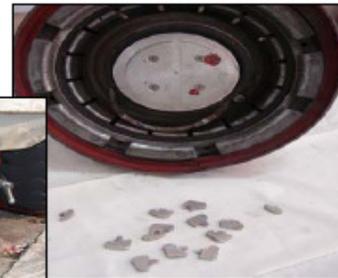
The Airport Fire Department attended, sprayed foam over the area and cleared the spill then continued to stand-by. The tug was towing one dolly loaded with baggage. The tug had stopped directly over the hydrant pit and pit valve, with the hydrant intake coupler and 4" intake hose (fitted with a "Crocodile" unit) lodged under the front of the tug.

The intake coupler and 'Crocodile' unit were damaged. The air-line was severed and the fuel sense line had a small cut. No damage was found on the intake hose. The hydrant intake coupler poppet o-ring was found on the ground, but the pit valve showed no external signs of damage.

All pit valves and couplers had been upgraded to API/IP 1584 Third Edition⁽¹⁾ in 2006. The pit valve was fitted with an air-operated pilot. The coupler performed in accordance with the designed "break-away" characteristics and allowed the pit valve to close; 13 of the 16 coupler lugs sheared as a result of the impact.

The tug was lifted from the hydrant pit using a forklift. The hydrant was isolated, depressurised and the hydrant pit valve removed and quarantined. The riser, base flange and pit box (an "environmental" type) were examined and no movement or damage was evident. A tested hydrant pit

valve was fitted and the hydrant system slowly repressurised, vented and inspected to bring the hydrant back into full service.
