Potential Hazard of Split Tip Winglets

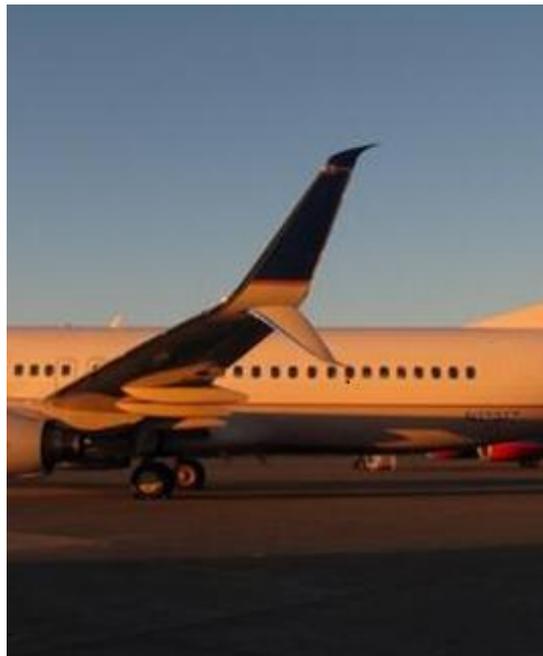
The *split scimitar* winglet

These new *split tip winglets* have both an upward projection and a more significant downward projection. The type being fitted to the Boeing 737 aircraft is known as the *split scimitar* winglet.

The purpose of this Bulletin is to warn airport managers and operations staff of the existence of the new winglets. We do not have any details of the dimensions of the downward blade of the winglet, and this may be subject to change as designs evolve. However, it is clear that the winglets reduce the clearance under the wing tip. They are therefore vulnerable to damage from fuelling vehicles and additional care should be taken when approaching and departing from aircraft fitted with these winglets.

Managers should ensure that all fuelling operators are made aware of this new design and of the need for caution when approaching and departing from aircraft fitted with them. Toolbox talks to consider potential hazards presented by the split tip winglets are recommended.
