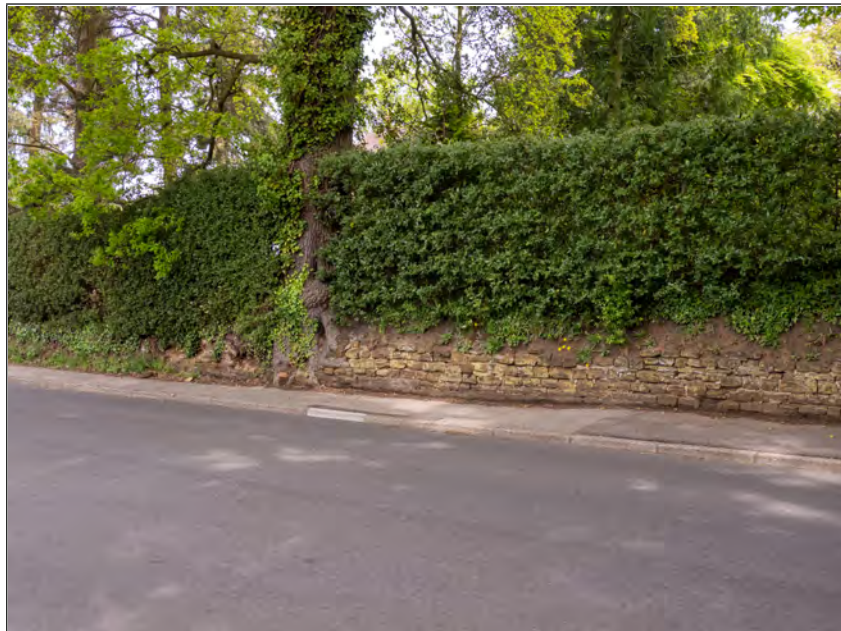
**Condition** ☐ Good ☒ Reasonable ☐ Poor ☐ At Risk ☐ Not seen close

**Notes** 7,9,11, 13, 13A and 15 Weathercock Lane form a group with wall on opposite side of road.

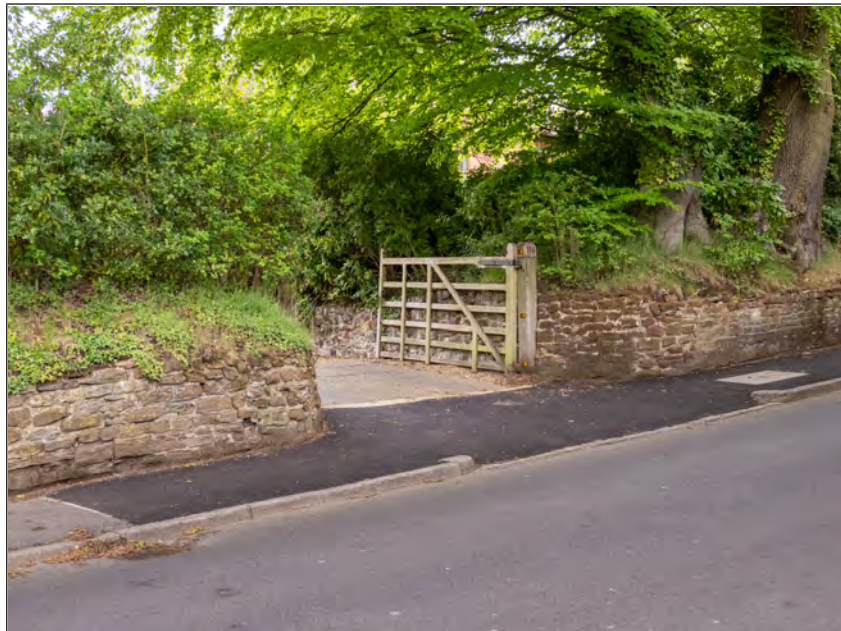
**Condition** ☐ Good ☒ Reasonable ☐ Poor ☐ At Risk ☐ Not seen close

**Notes** 7,9,11, 13, 13A and 15 Weathercock Lane form a group with wall on opposite side of road.

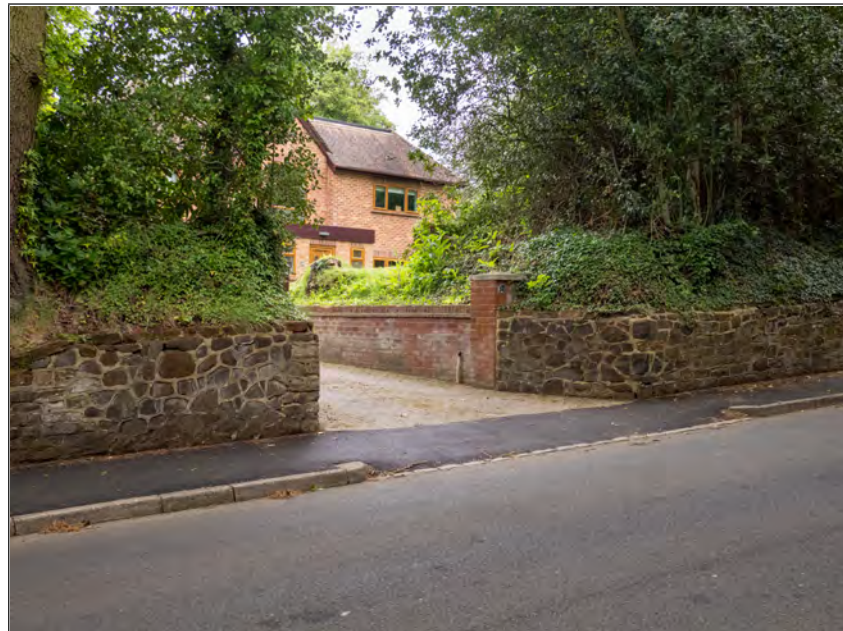
**Condition** ☐ Good ☒ Reasonable ☐ Poor ☐ At Risk ☐ Not seen close

**Notes** 7, 9, 11, 13, 13A and 15 Weathercock Lane form a group with wall on opposite side of road.

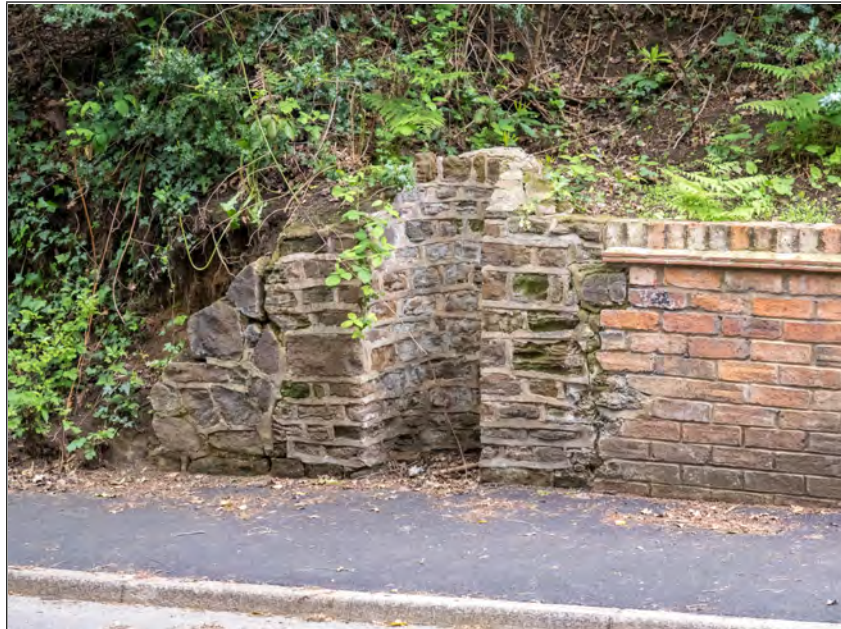
**Condition** ☐ Good ☒ Reasonable ☐ Poor ☐ At Risk ☐ Not seen close

**Notes** 7,9,11, 13, 13A and 15 Weathercock Lane form a group with wall on opposite side of road.

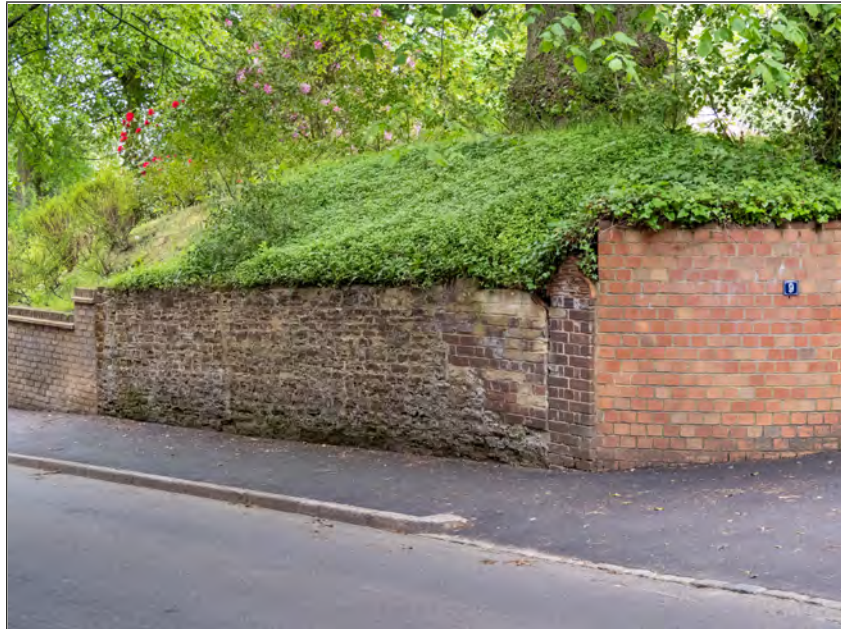
**Condition** ☐ Good ☒ Reasonable ☐ Poor ☐ At Risk ☐ Not seen close

**Notes** 7,9,11, 13, 13A and 15 Weathercock Lane form a group with wall on opposite side of road.

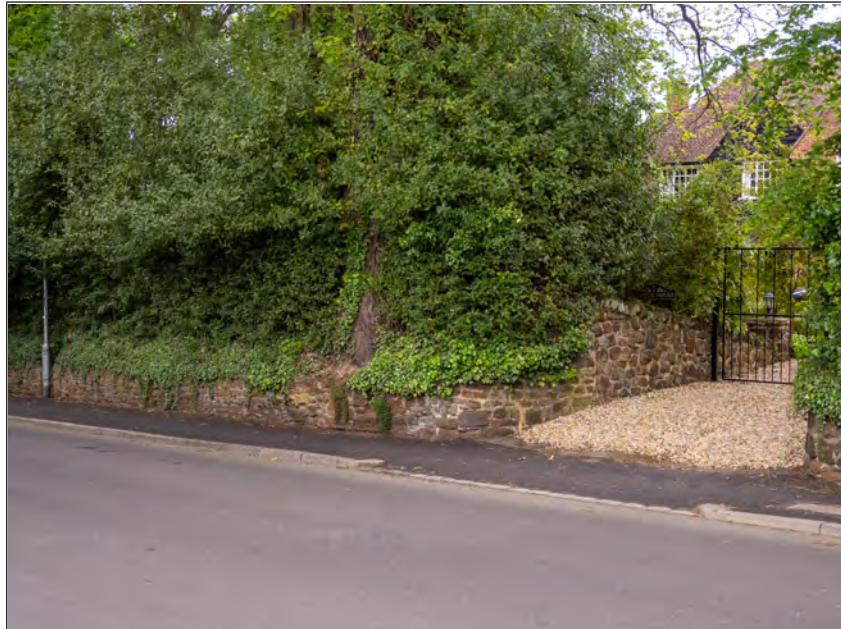
**Condition** ☐ Good ☒ Reasonable ☐ Poor ☐ At Risk ☐ Not seen close

**Notes** 7, 9, 11, 13, 13A and 15 Weathercock Lane form a group with wall on opposite side of road.

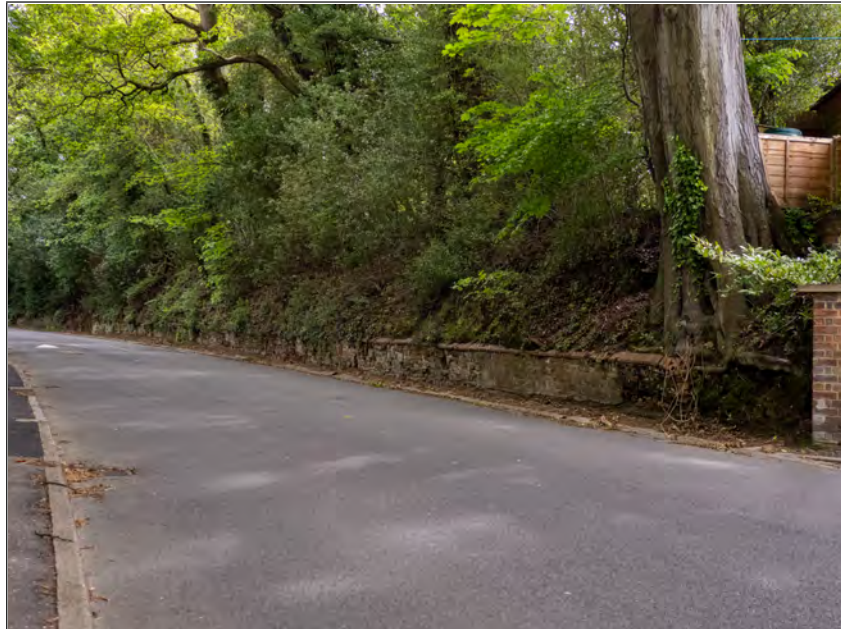
**Condition** ☐ Good ☐ Reasonable ☒ Poor ☐ At Risk ☐ Not seen close

**Notes** Runs along the backs of houses on Concha Park + St. Vincent's as far as 1 St. Vincent's. Mix of stone and brick. Very poor condition and fragmentary. Part of grouping with walls on north side of Weathercock Lane (7, 9, 11, 13, 13A and 15).

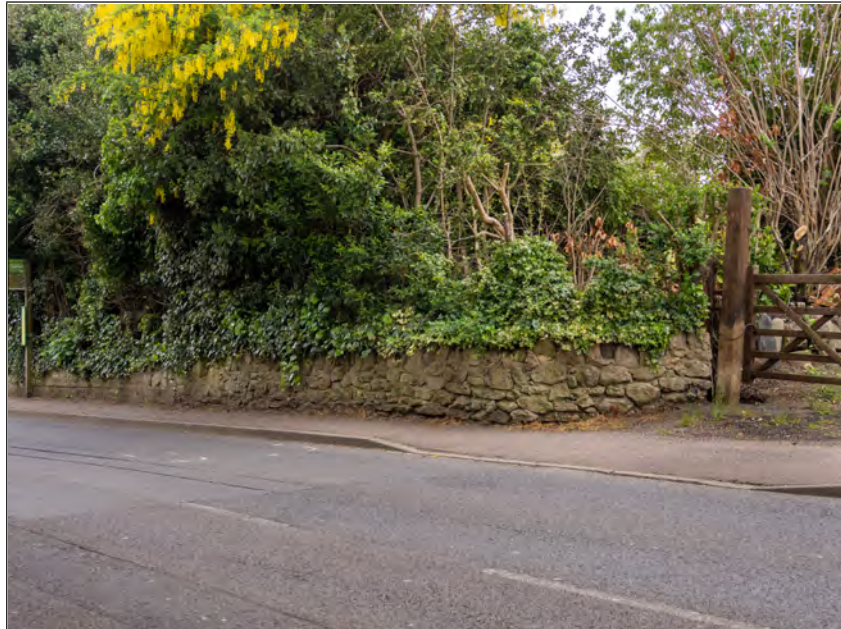
**Condition** ☐ Good ☒ Reasonable ☐ Poor ☐ At Risk ☐ Not seen close

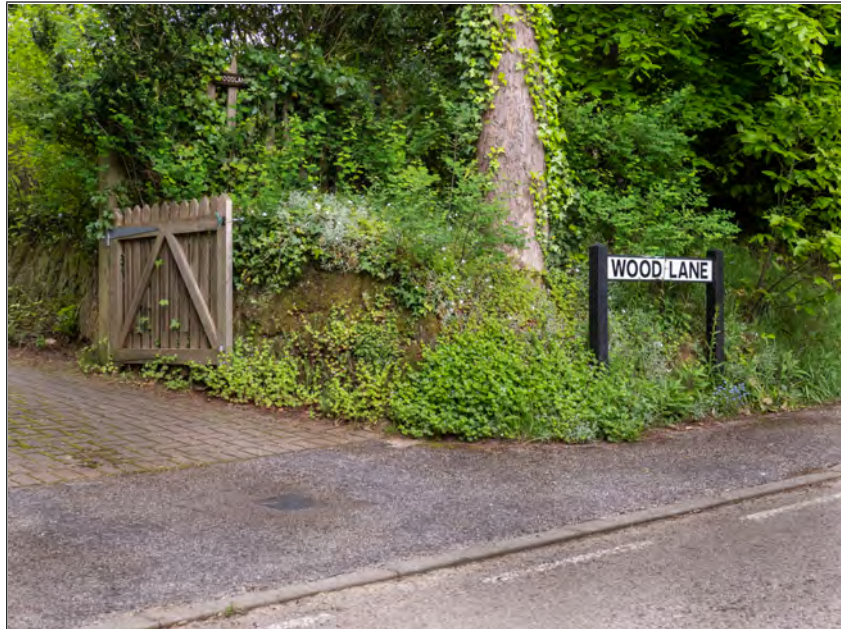
**Condition** ☐ Good ☒ Reasonable ☐ Poor ☐ At Risk ☐ Not seen close

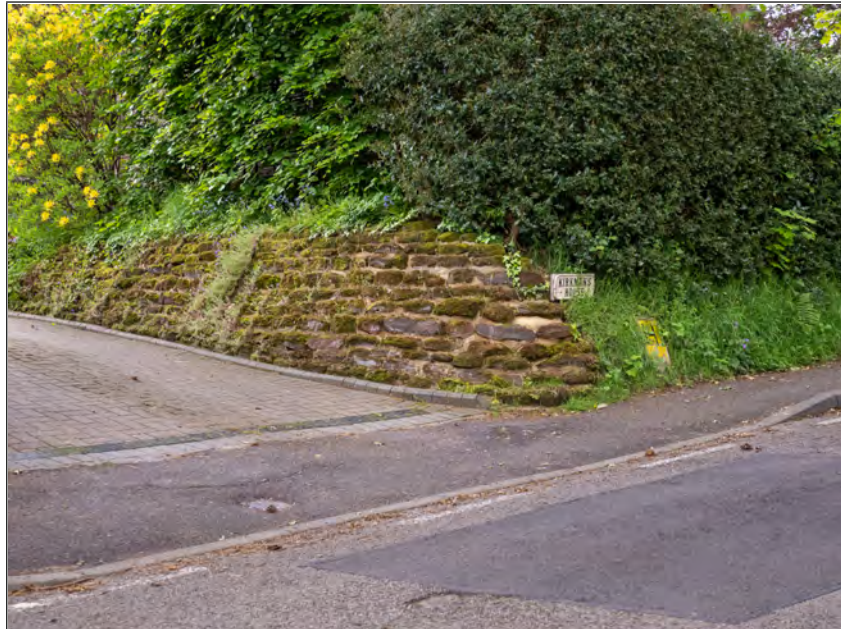
**Condition** ☐ Good ☒ Reasonable ☐ Poor ☐ At Risk ☐ Not seen close

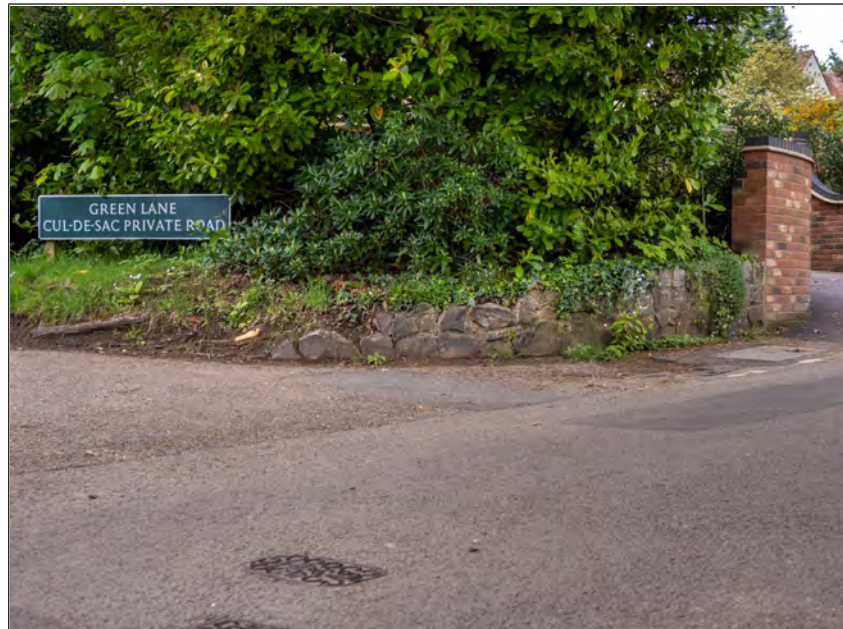
**Condition** ☐ Good ☒ Reasonable ☐ Poor ☐ At Risk ☐ Not seen close

**Notes** On corner of entry to Green Lane.

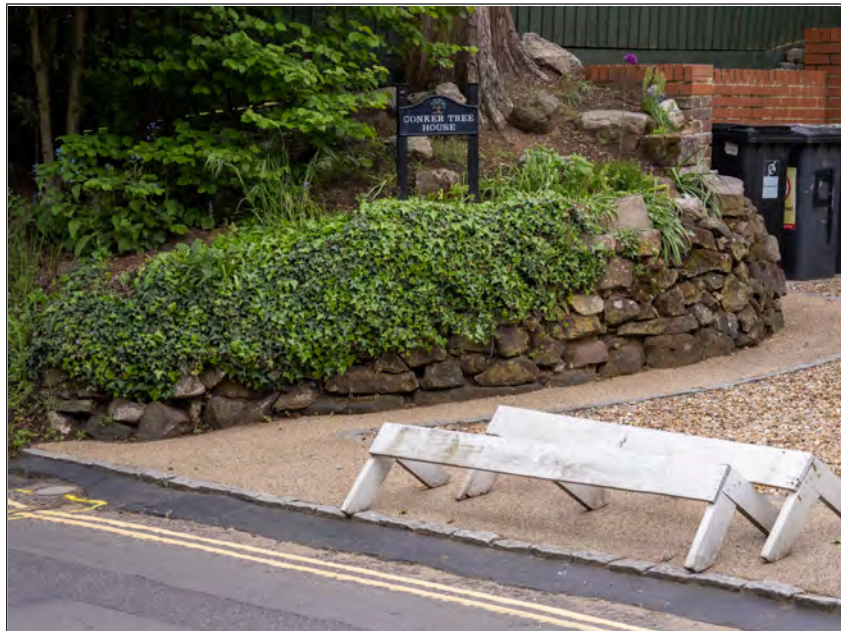
**Condition** ☐ Good ☒ Reasonable ☐ Poor ☐ At Risk ☐ Not seen close

**Notes** Roughly built out of large stones.

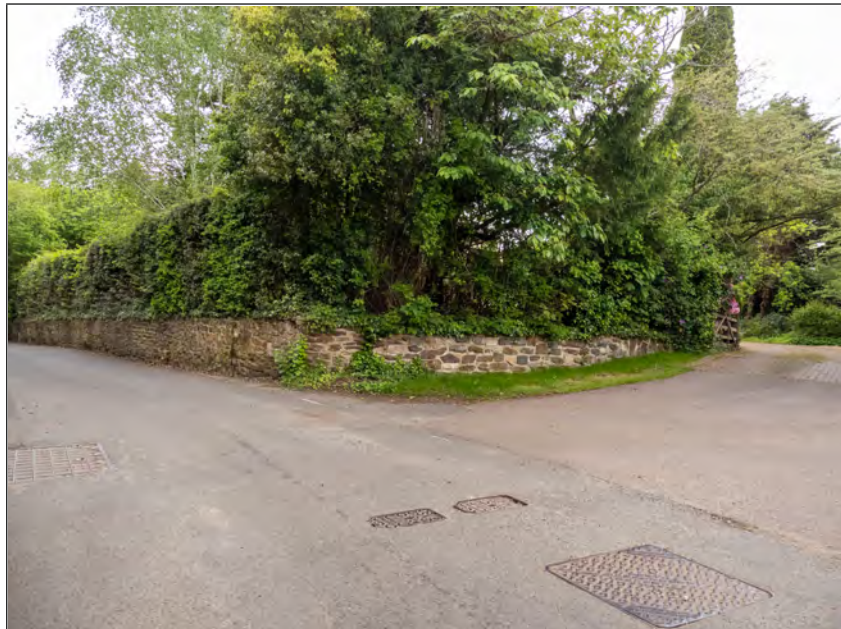
**Condition** ☐ Good ☒ Reasonable ☐ Poor ☐ At Risk ☐ Not seen close

**Notes** Contiguous with brick wall to the north.

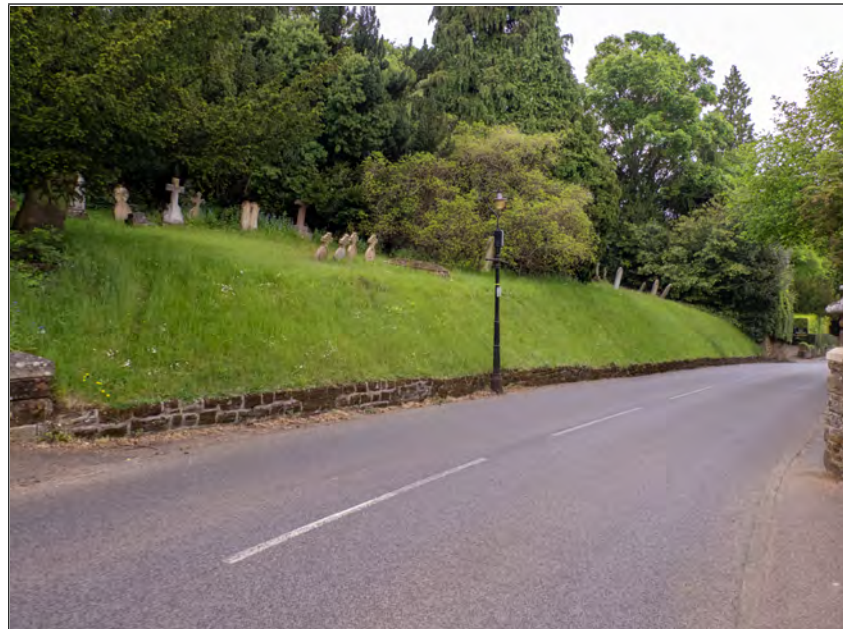
**Condition** ☐ Good ☒ Reasonable ☐ Poor ☐ At Risk ☐ Not seen close

**Notes** Extends to become wall to entrance The Rookery (house to south).

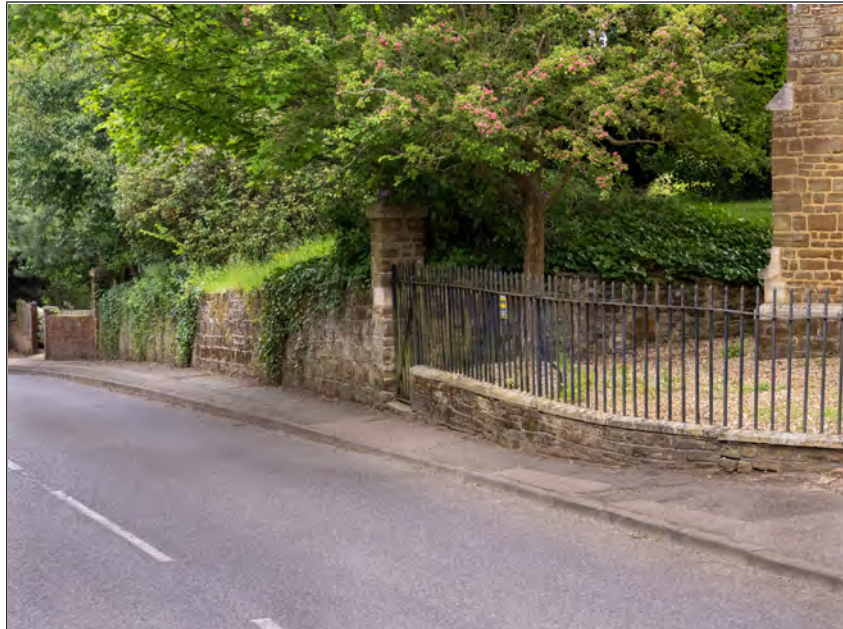
**Condition** ☐ Good ☒ Reasonable ☐ Poor ☐ At Risk ☐ Not seen close

**Notes** Part of the wall is low (3-4 courses), remainder is retaining (churchyard to south of church).

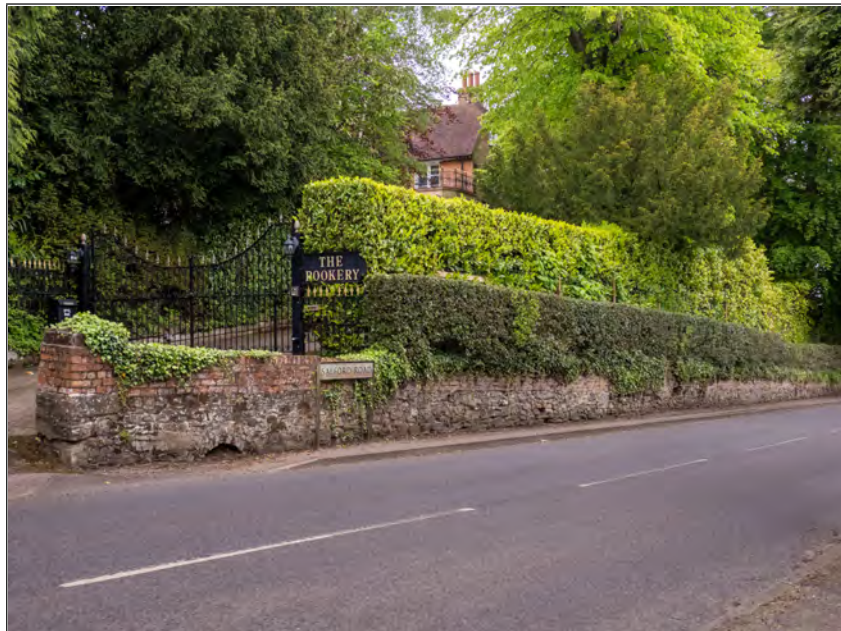
**Condition** ☐ Good ☒ Reasonable ☐ Poor ☐ At Risk ☐ Not seen close

**Notes** Mix of stone and brick (top courses) with the latter becoming more dominant towards the southern end of the wall. See cemetery for wall alongside entrance.

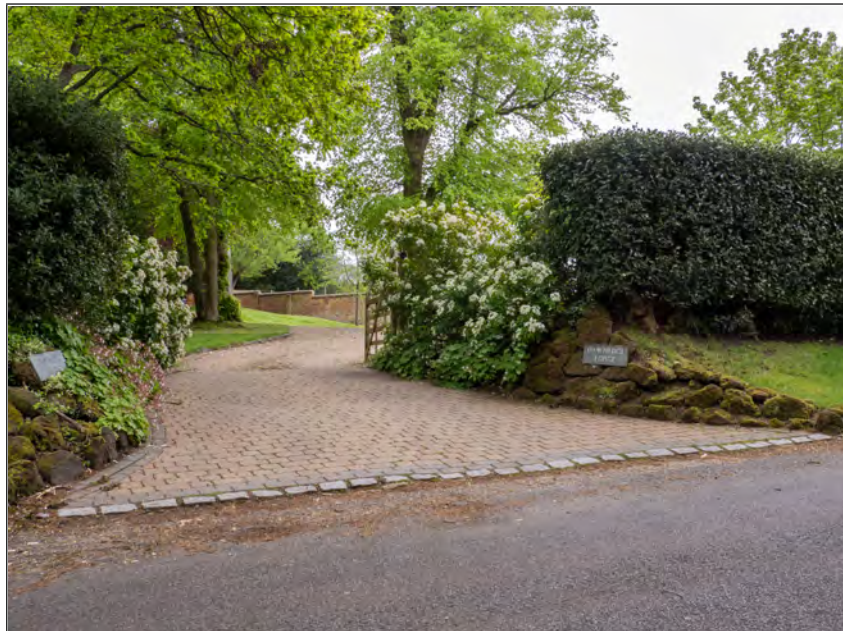
**Condition** ☐ Good ☒ Reasonable ☐ Poor ☐ At Risk ☐ Not seen close

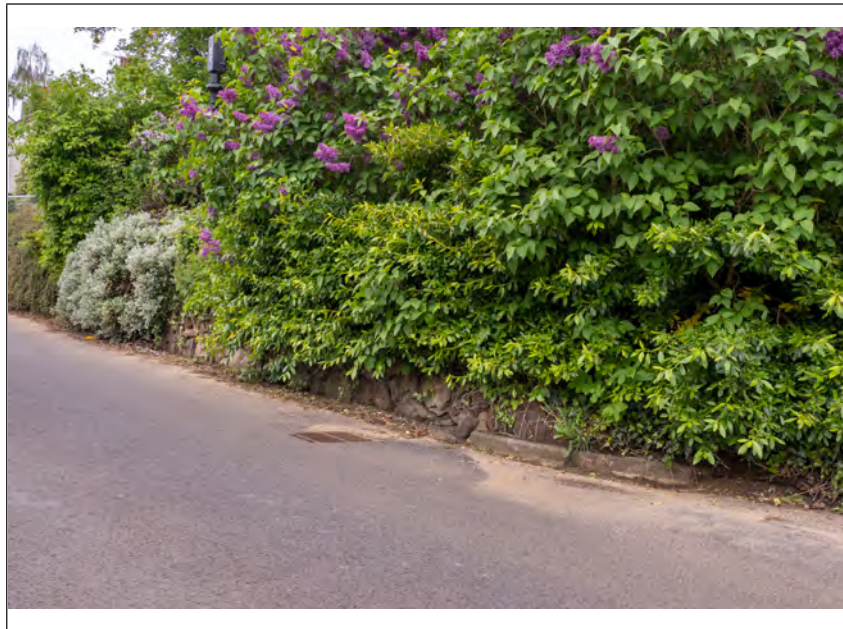
**Condition** ☐ Good ☒ Reasonable ☐ Poor ☐ At Risk ☐ Not seen close

**Notes** Contiguous with wall to 8.  
.....  
.....

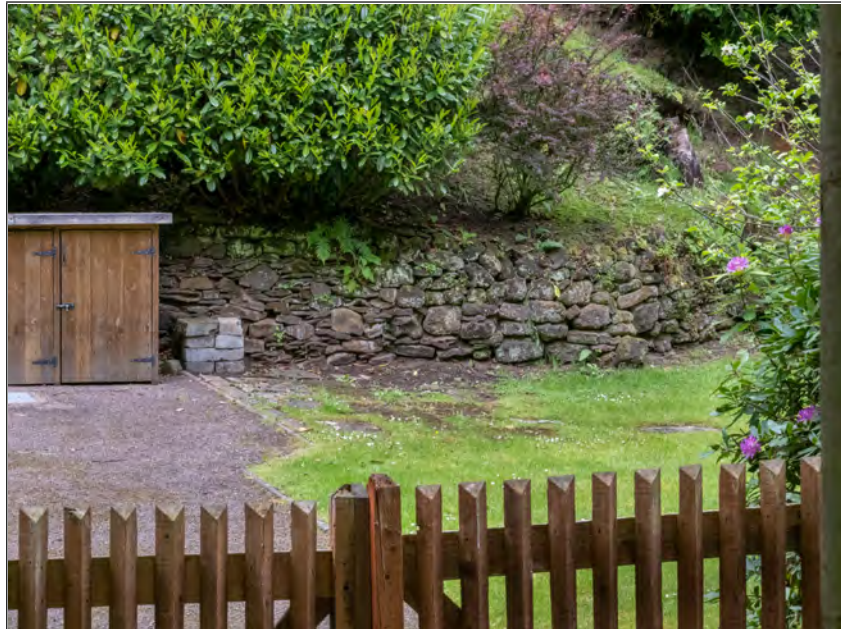
**Condition** ☒ Good ☐ Reasonable ☐ Poor ☐ At Risk ☐ Not seen close

**Notes** Massive retaining walls forming terraces to rear garden.

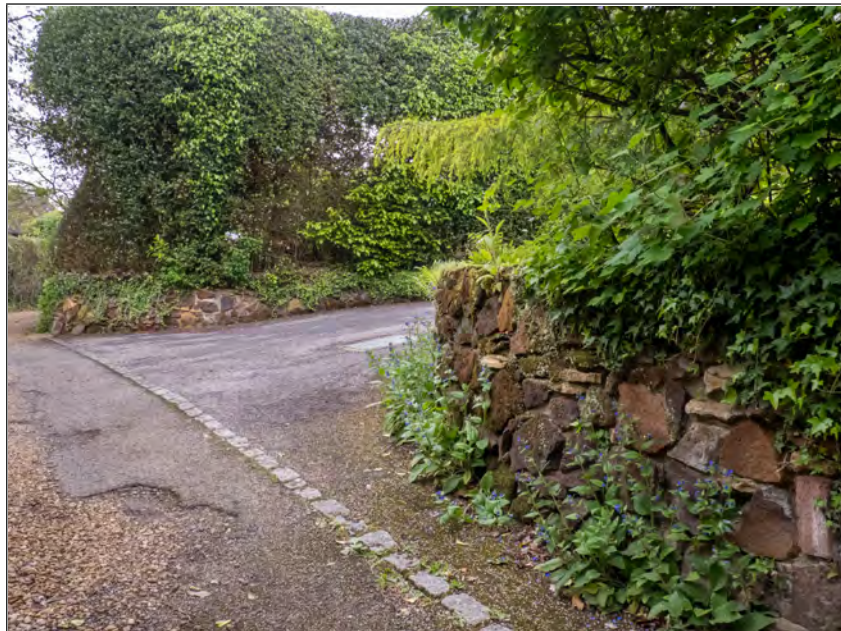
**Condition** ☐ Good ☒ Reasonable ☐ Poor ☐ At Risk ☐ Not seen close

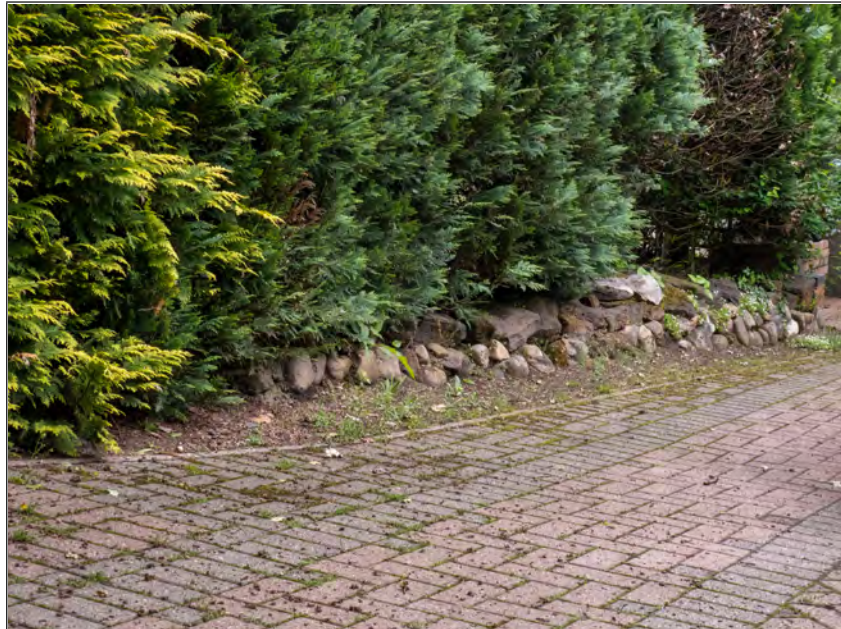
**Condition** ☐ Good ☒ Reasonable ☐ Poor ☐ At Risk ☐ Not seen close

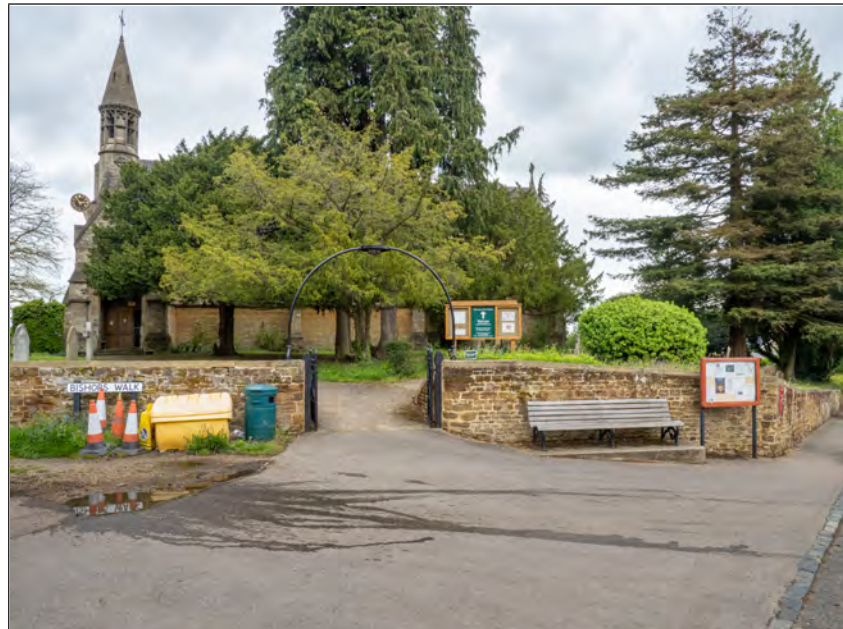
**Condition** ☐ Good ☒ Reasonable ☐ Poor ☐ At Risk ☐ Not seen close

**Notes** Most of wall alongside Church Road is retaining. Becomes free standing as it turns into Bishops Walk

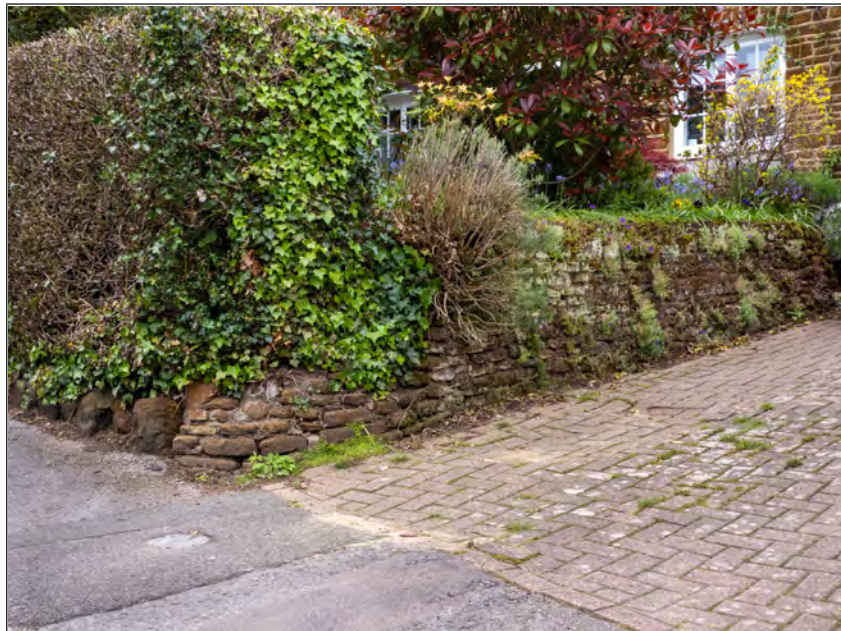
**Condition** ☐ Good ☒ Reasonable ☐ Poor ☐ At Risk ☐ Not seen close

**Notes** Front garden retaining walls.

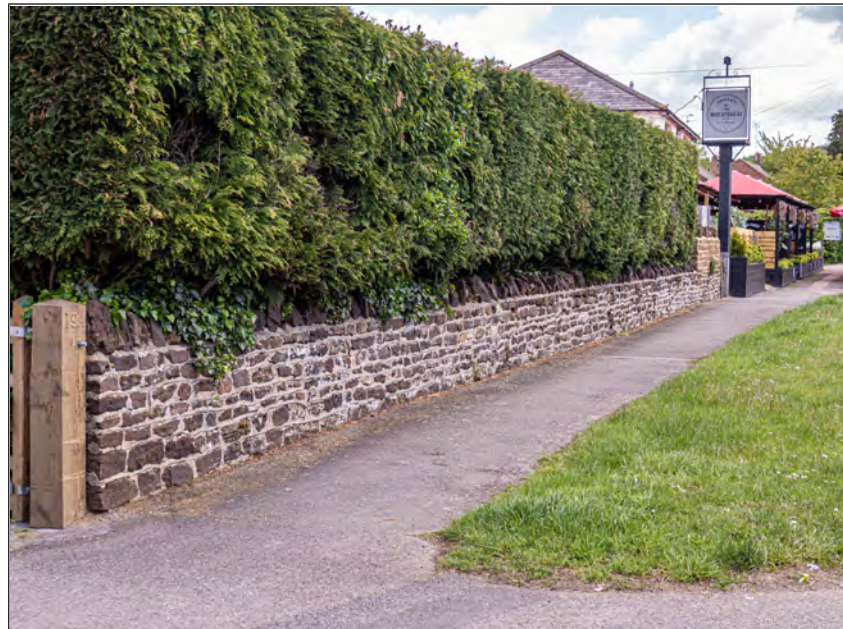
**Condition** ☒ Good ☐ Reasonable ☐ Poor ☐ At Risk ☐ Not seen close

**Notes** 19A to 31 form a group.

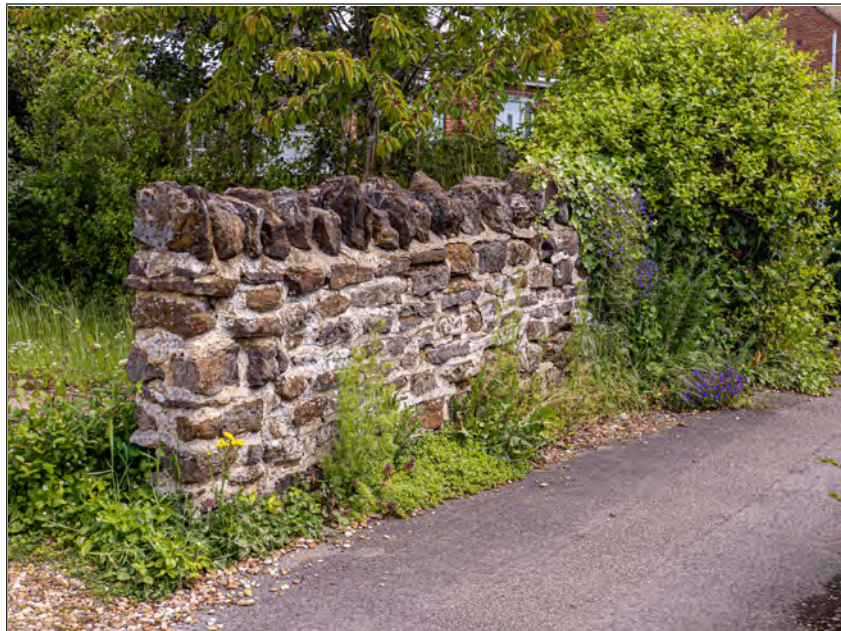
**Condition** ☒ Good ☐ Reasonable ☐ Poor ☐ At Risk ☐ Not seen close

**Notes** 19A to 31 form a group.  
.....  
.....

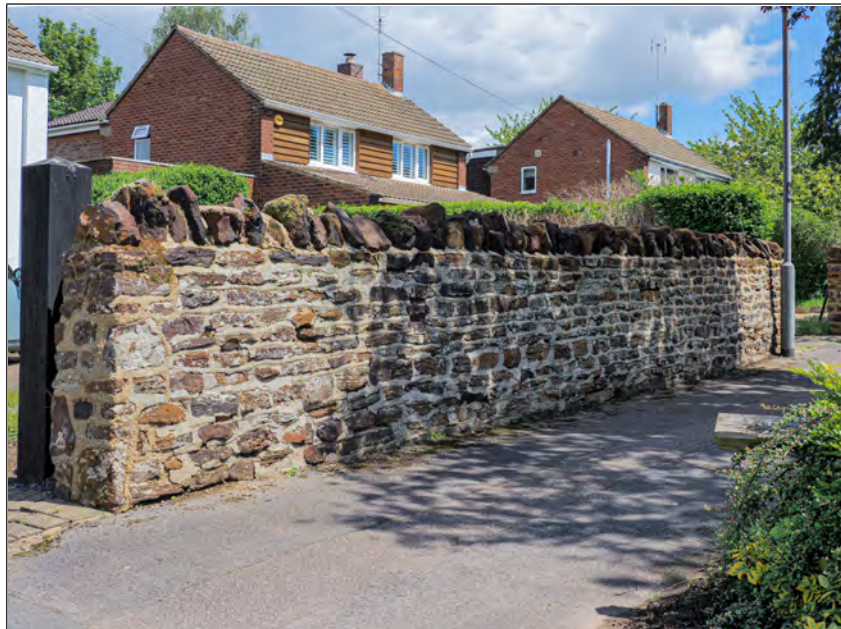
**Condition** ☒ Good ☐ Reasonable ☐ Poor ☐ At Risk ☐ Not seen close

**Notes** 19A to 31 form a group.

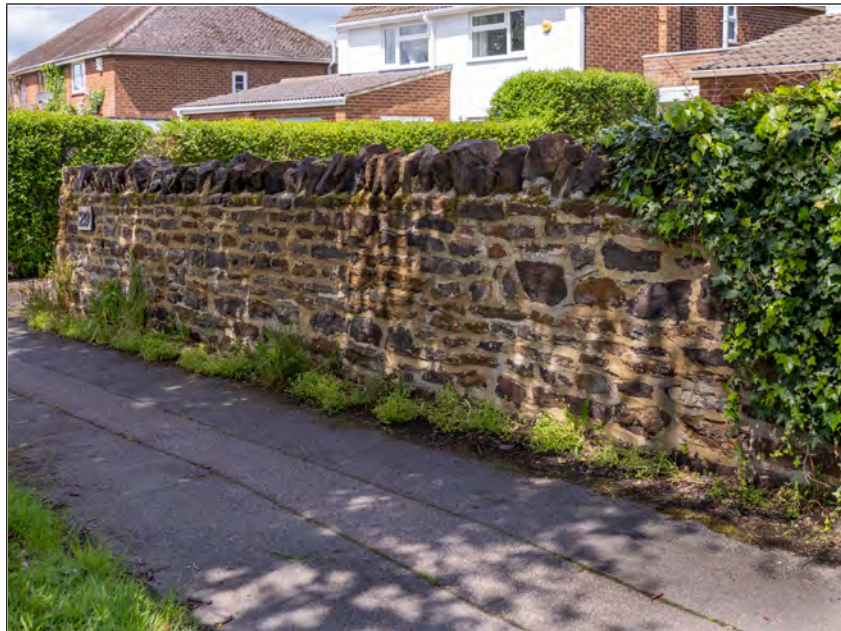
**Condition** ☒ Good ☐ Reasonable ☐ Poor ☐ At Risk ☐ Not seen close

**Notes** 19A to 31 form a group.

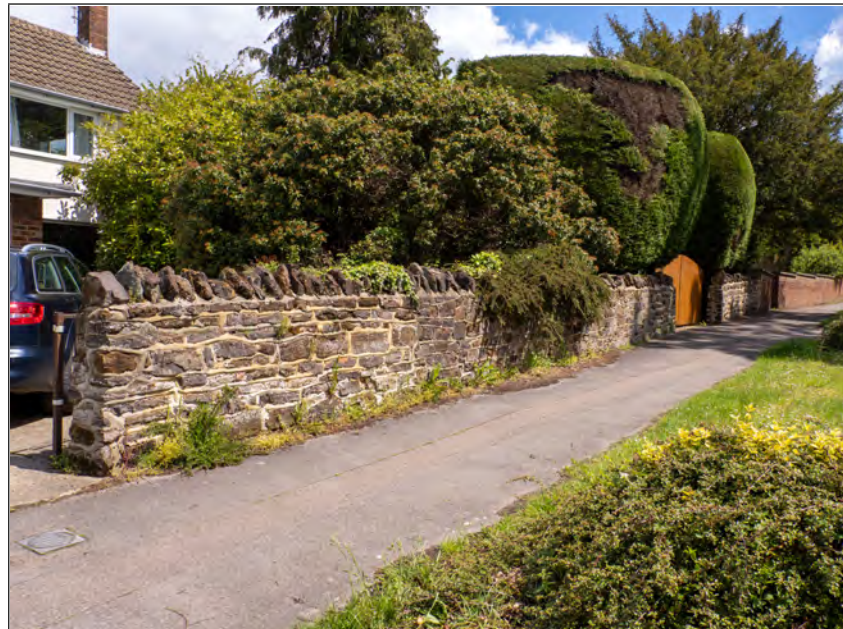
**Condition** ☒ Good ☐ Reasonable ☐ Poor ☐ At Risk ☐ Not seen close

**Notes** 19A to 31 form a group.

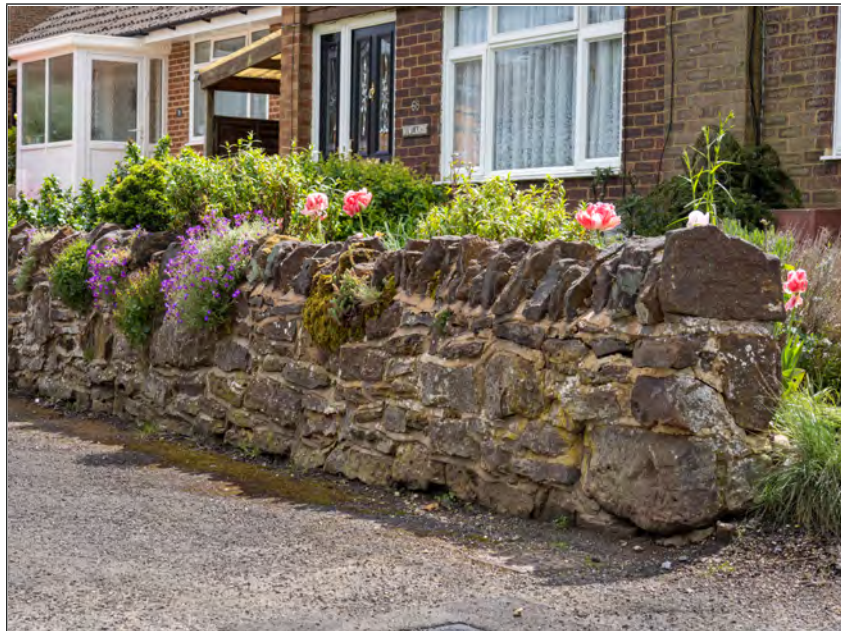
**Condition** ☒ Good ☐ Reasonable ☐ Poor ☐ At Risk ☐ Not seen close

**Notes** Contiguous with 68.

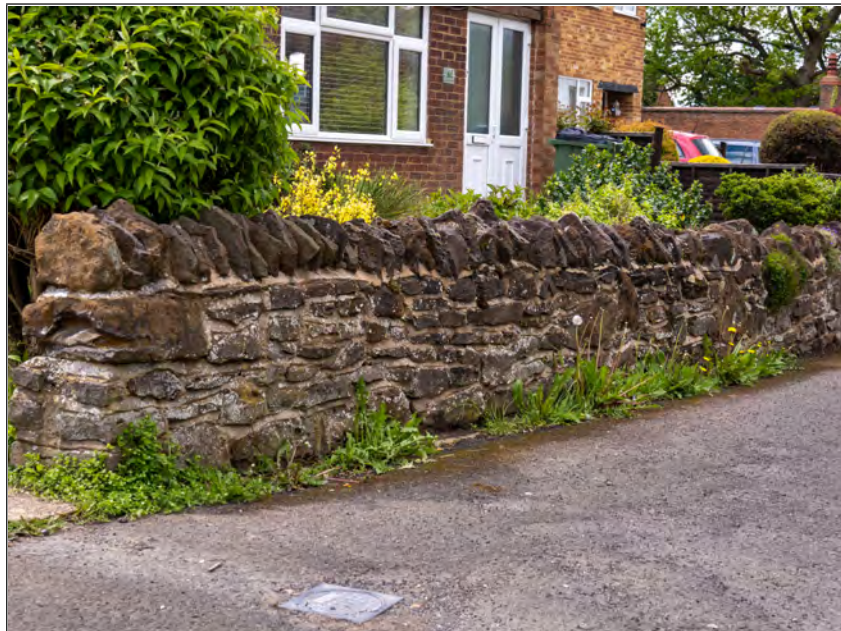
**Condition** ☒ Good ☐ Reasonable ☐ Poor ☐ At Risk ☐ Not seen close

**Notes** Contiguous with 66.

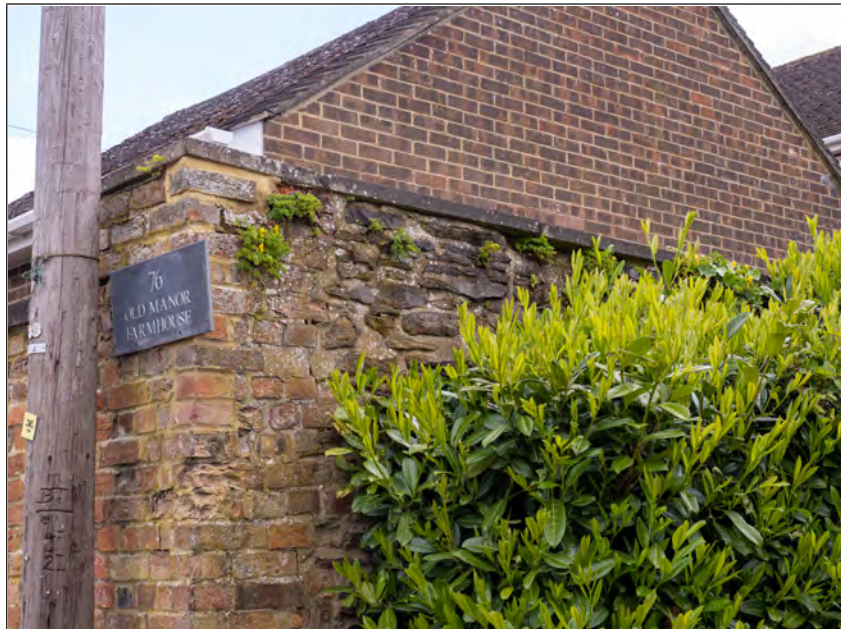
**Condition** ☒ Good ☐ Reasonable ☐ Poor ☐ At Risk ☐ Not seen close

**Notes** Small panel of stonework either side of entry to Old Manor Farm (also serves Driveside).

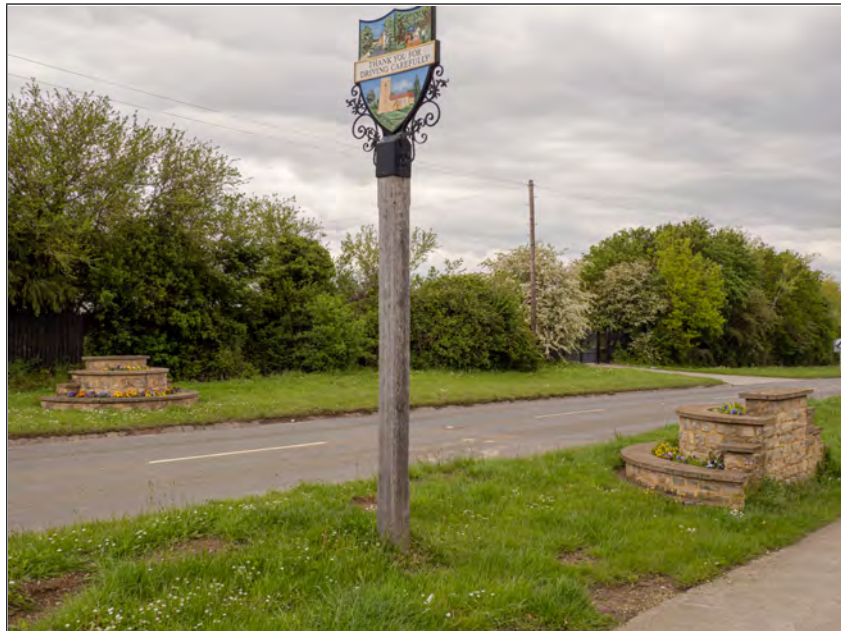
**Condition** ☒ Good ☐ Reasonable ☐ Poor ☐ At Risk ☐ Not seen close

**Notes** Either side of road between Bellow Hill Farm (west) and Blind Pond Industrial Estate (east).

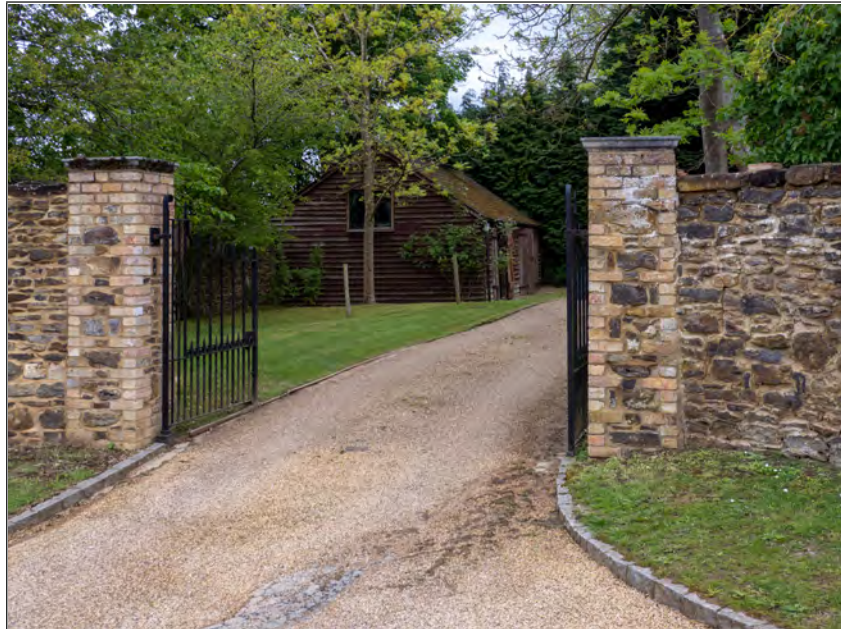
**Condition** ☒ Good ☐ Reasonable ☐ Poor ☐ At Risk ☐ Not seen close

**Notes** Brick piers with sandstone panels.

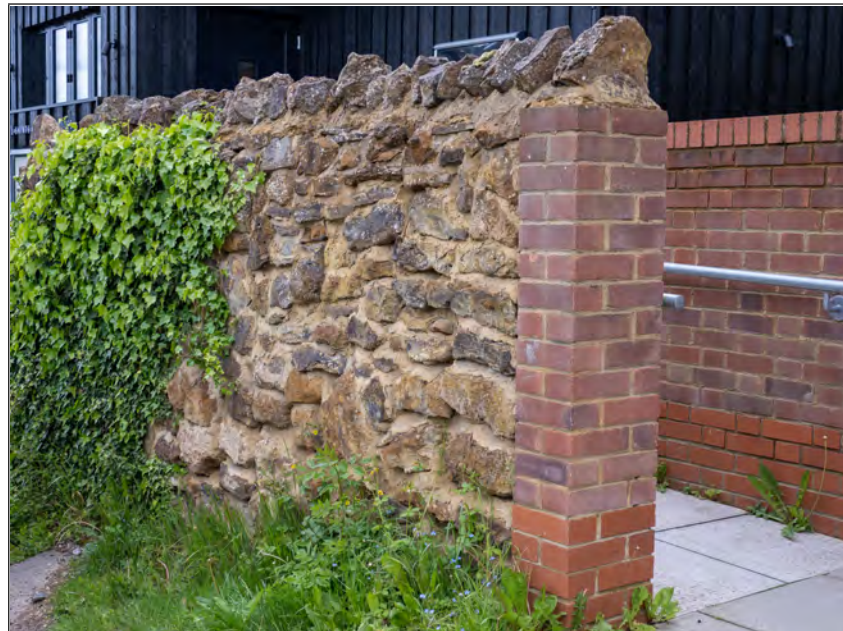
**Condition** ☒ Good ☐ Reasonable ☐ Poor ☐ At Risk ☐ Not seen close

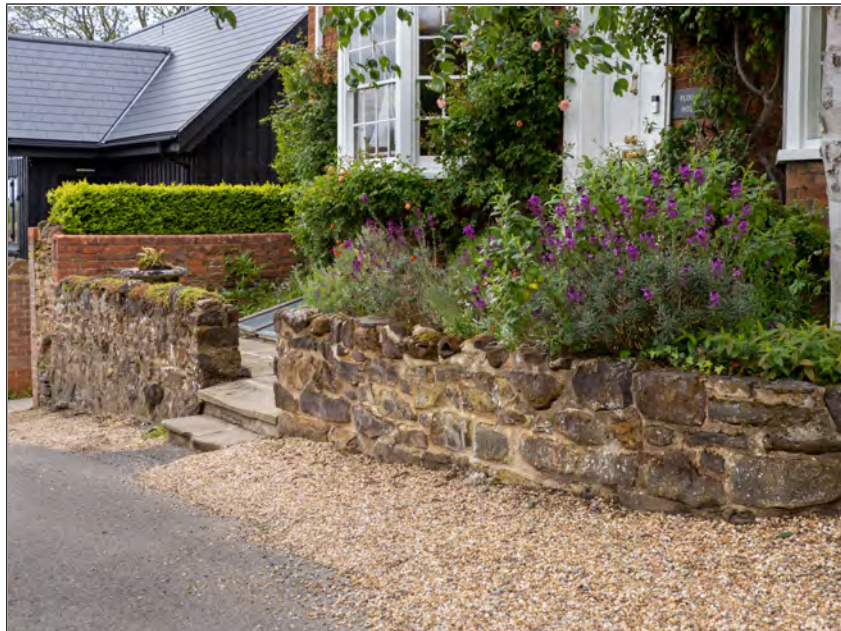
**Condition** ☐ Good ☒ Reasonable ☐ Poor ☐ At Risk ☐ Not seen close

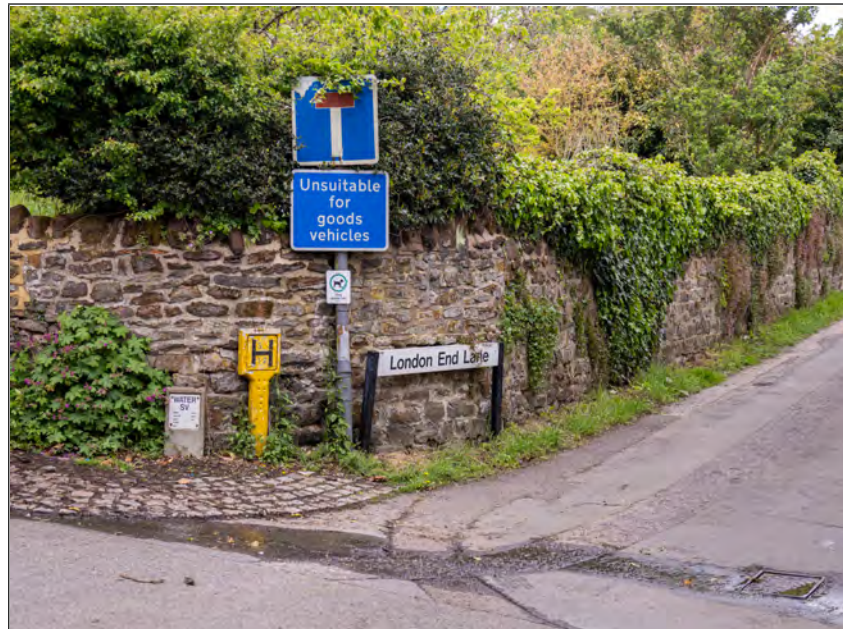
**Condition** ☐ Good ☒ Reasonable ☐ Poor ☐ At Risk ☐ Not seen close

**Notes** Returns onto London End (corner plot).

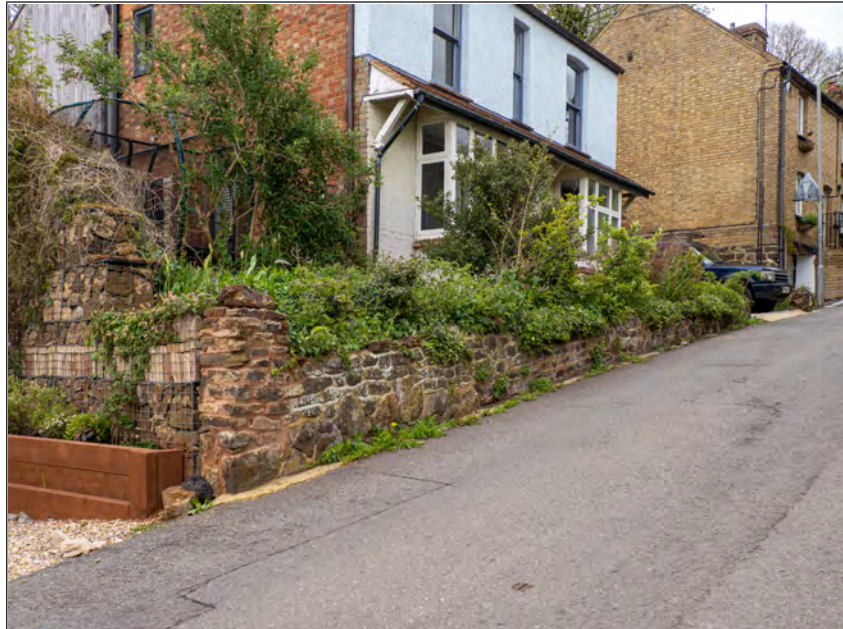
**Condition** ☐ Good ☒ Reasonable ☐ Poor ☐ At Risk ☐ Not seen close

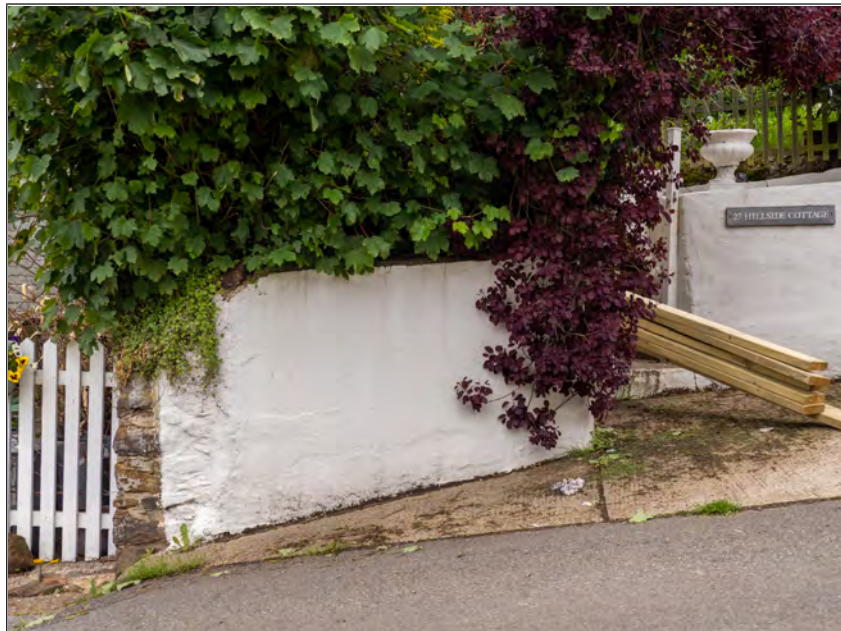
**Condition** ☐ Good ☒ Reasonable ☐ Poor ☐ At Risk ☐ Not seen close

**Notes** Wall has been almost totally rendered over and painted white, though appears structurally sound. Stone visible at number 25 end.

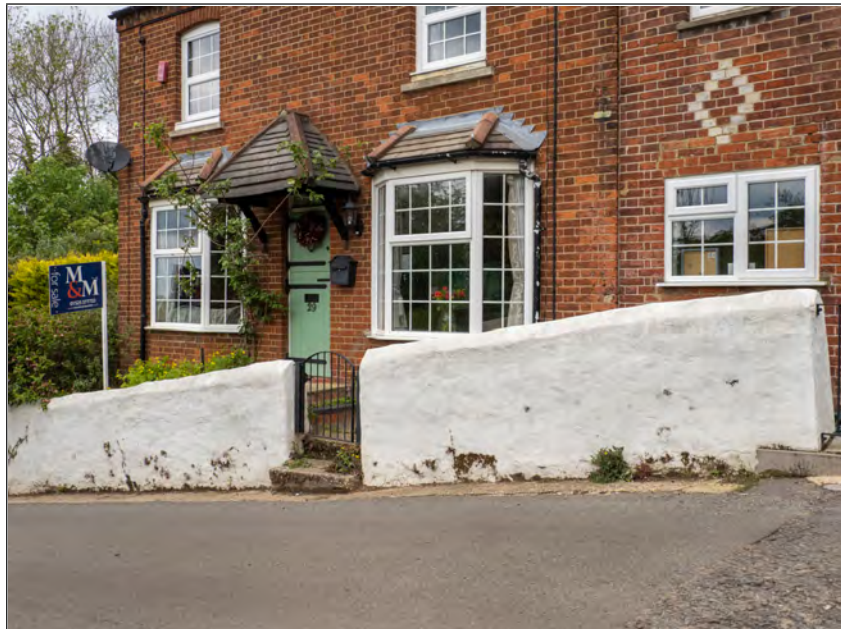
**Condition** ☐ Good ☐ Reasonable ☒ Poor ☐ At Risk ☐ Not seen close

**Notes** Wall has been painted white. Generally poor condition.

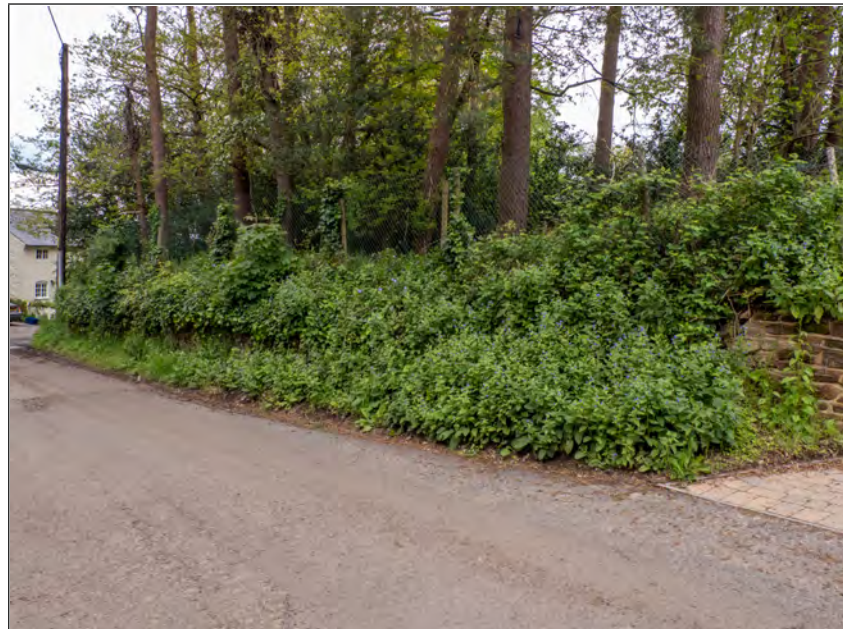
**Condition** ☐ Good ☒ Reasonable ☐ Poor ☐ At Risk ☐ Not seen close

**Notes** Generally in good condition, other than a stretch near the top. Returns to number 41.

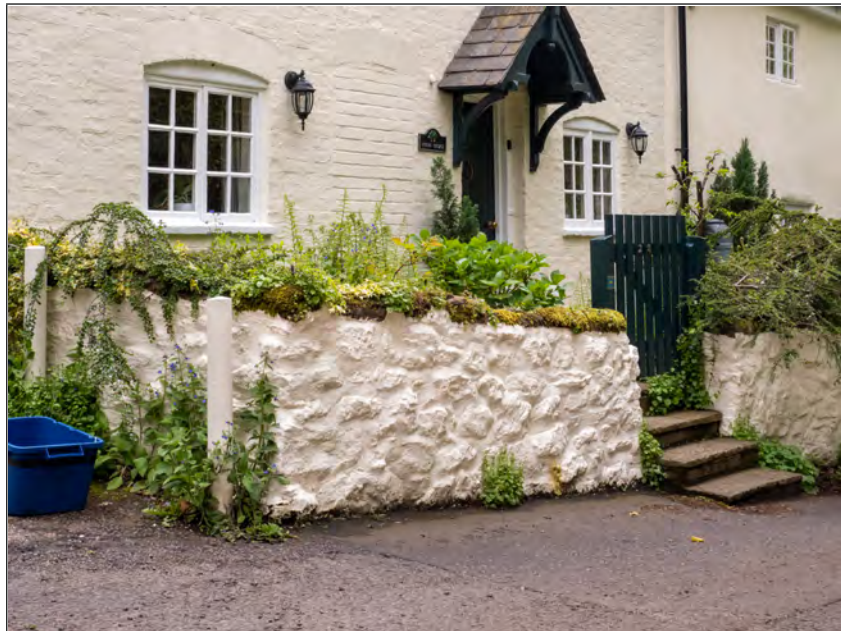
**Notes** Part painted white.
