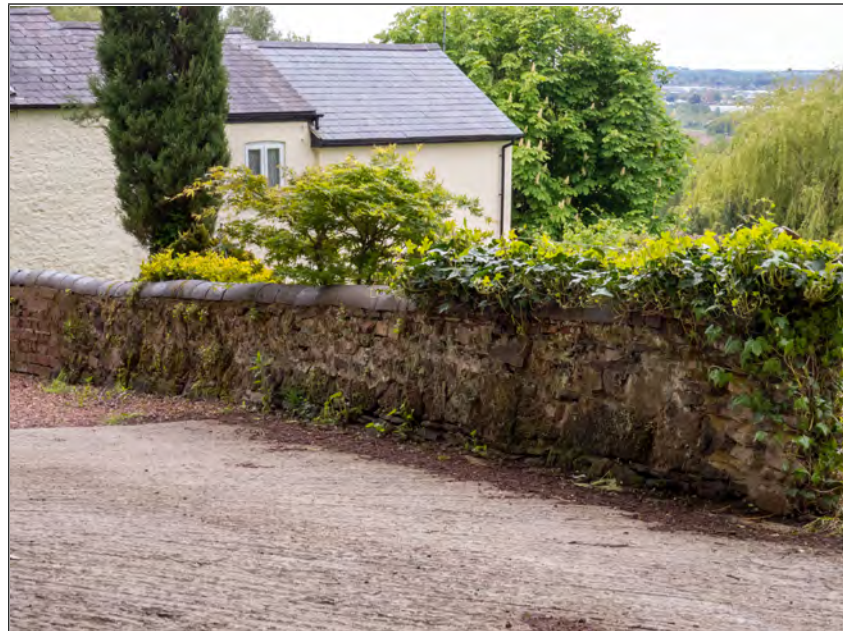
**Notes** Wall in part brick with brick coping.

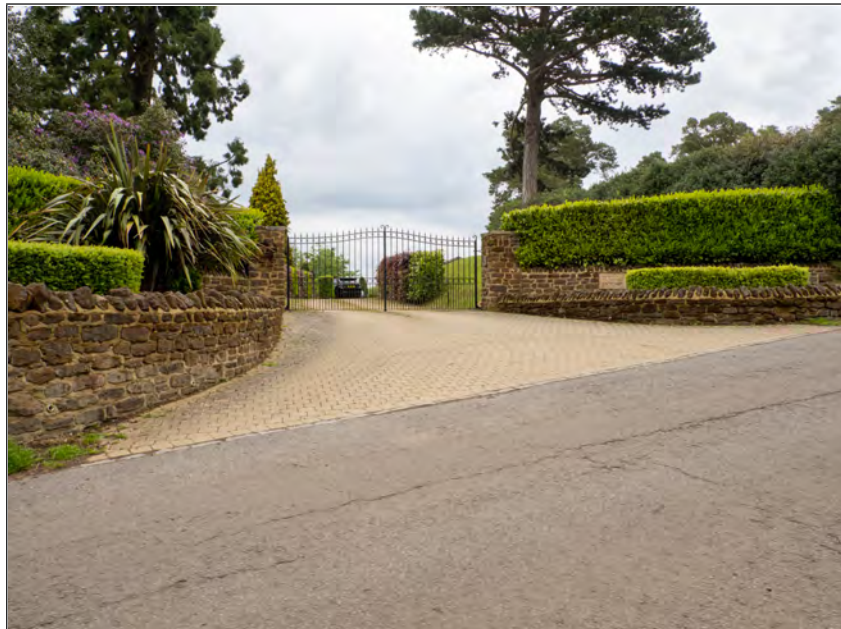
**Notes** Recent built incorporating piers, gates and railings. Small part of return is old.

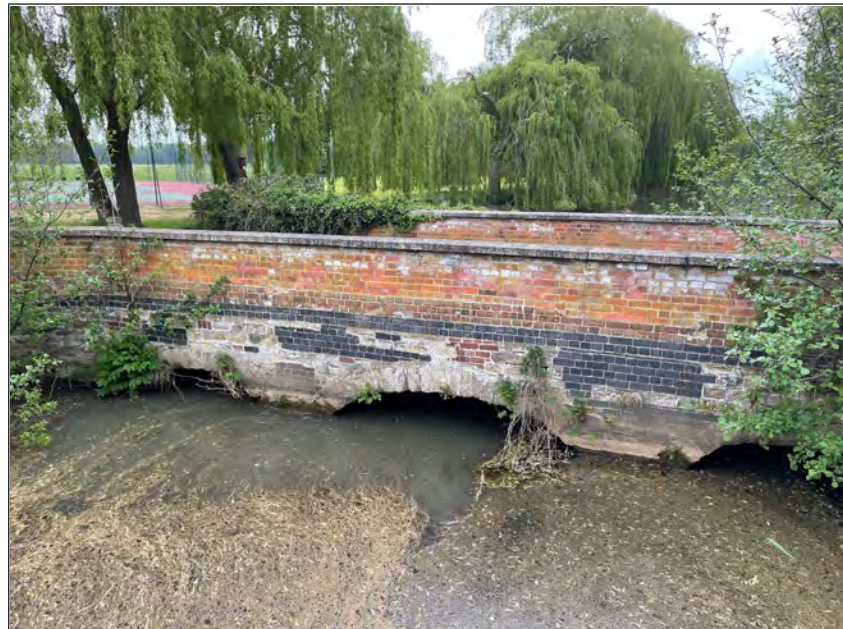
**Notes** Information taken from Bridges of Bedfordshire book published in 1997. Current situation unknown as within Chicksands military area. Part of Chicksands Priory registered landscape.

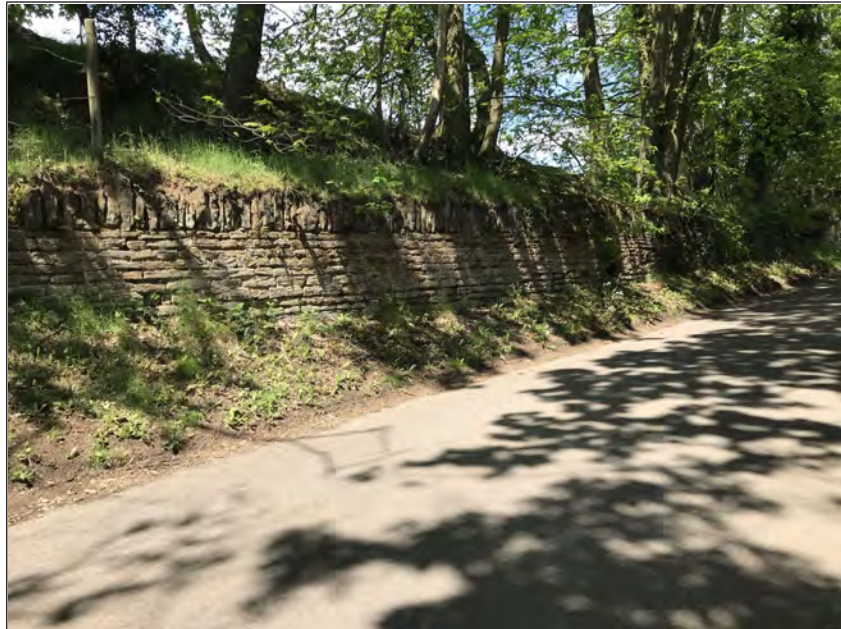
**Condition** ☐ Good ☐ Reasonable ☒ Poor ☐ At Risk ☐ Not seen close

**Notes** Sections have fallen and wall is under heavy pressure from tree roots.

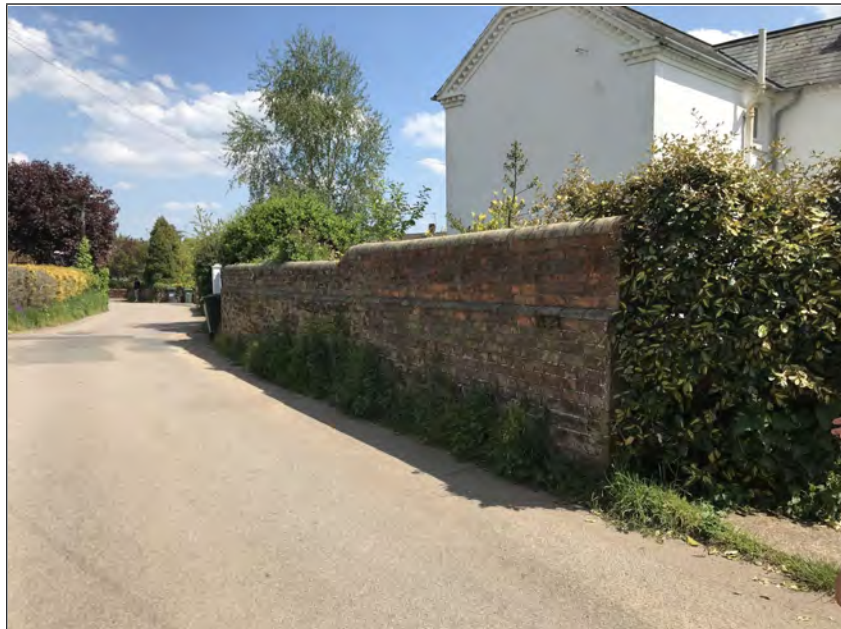
**Notes** Top courses are of brick.

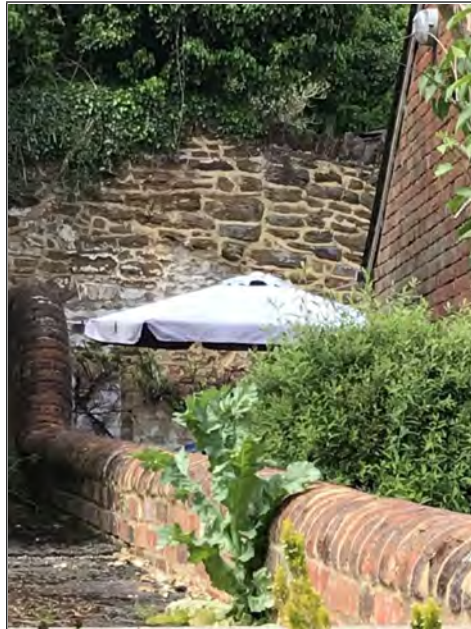
**Notes** Massive retaining wall behind house (information from 2001 survey + glimpsed).

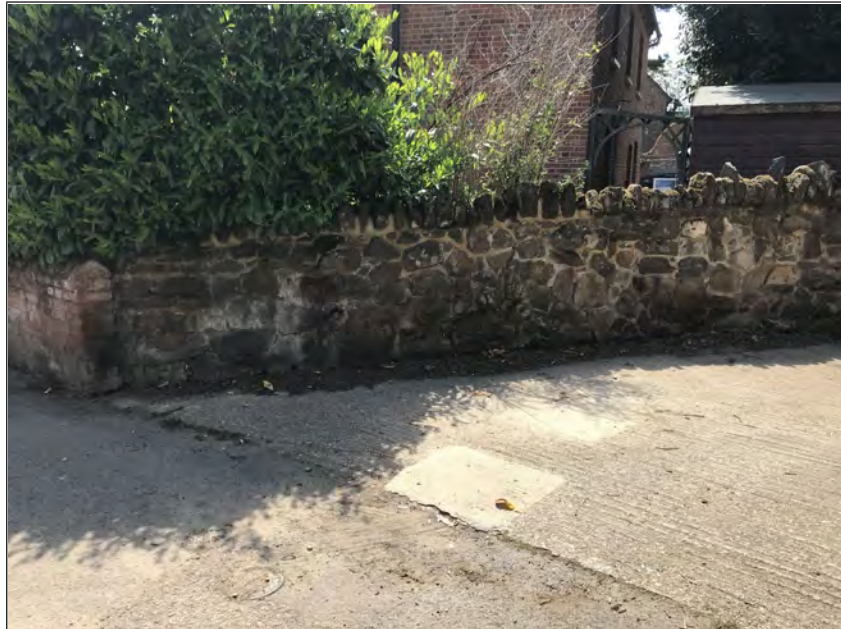
**Notes** Massive retaining wall behind house (information from 2001 survey + glimpsed).

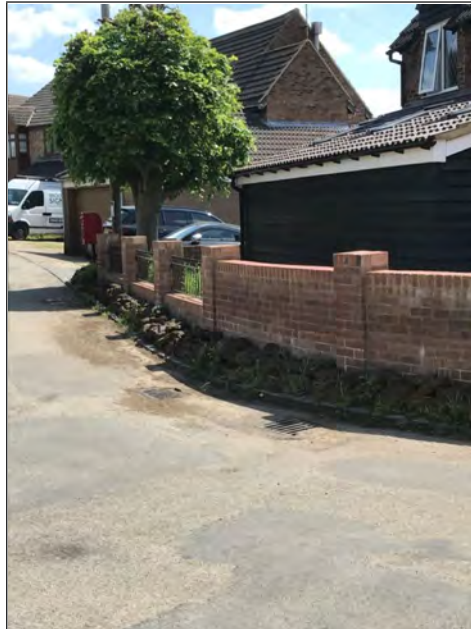
**Condition** ☐ Good ☐ Reasonable ☒ Poor ☐ At Risk ☐ Not seen close

**Notes** Little more than 203 courses of stone. Appears as if part of the wall has gone.

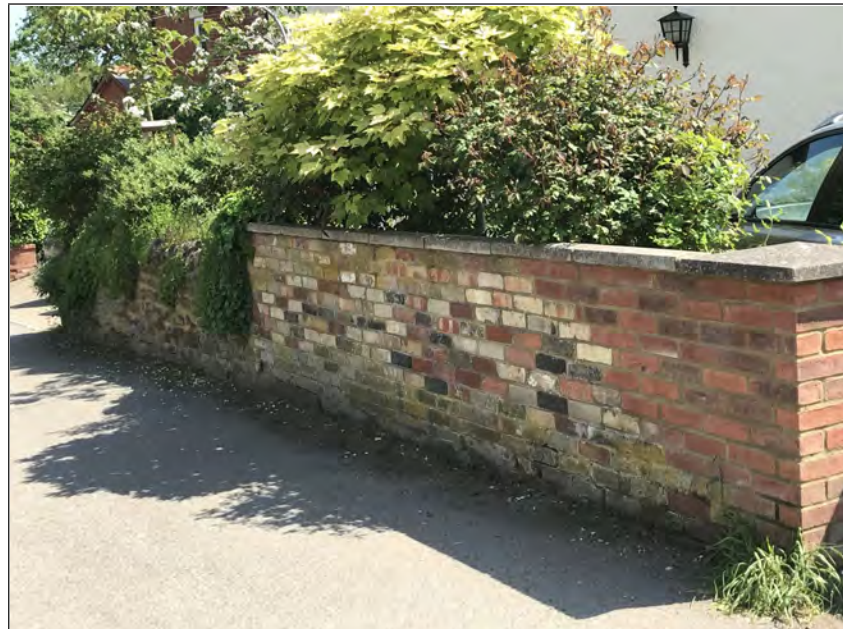
**Notes** Stonework is continuation of brick wall.

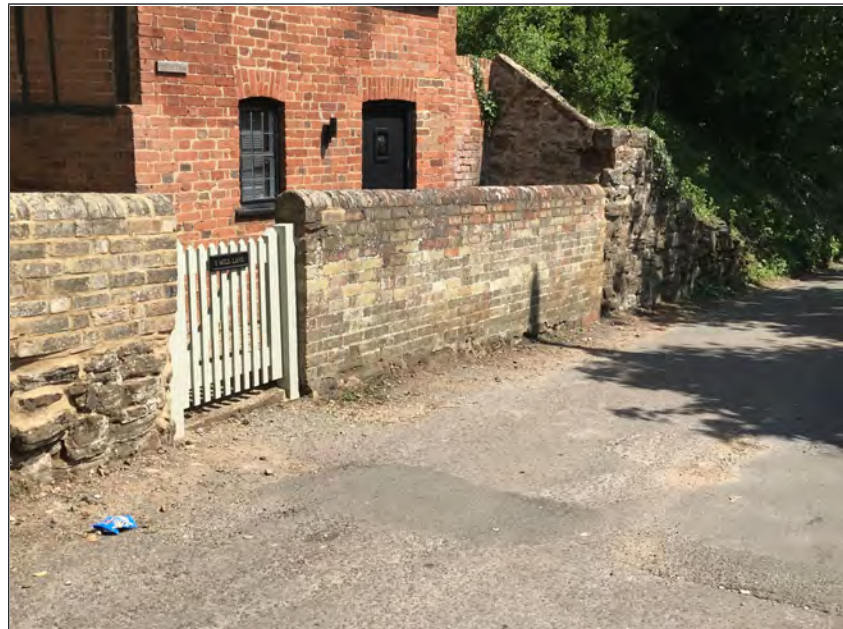
**Notes** Wall deteriorates as it heads south away from the house.

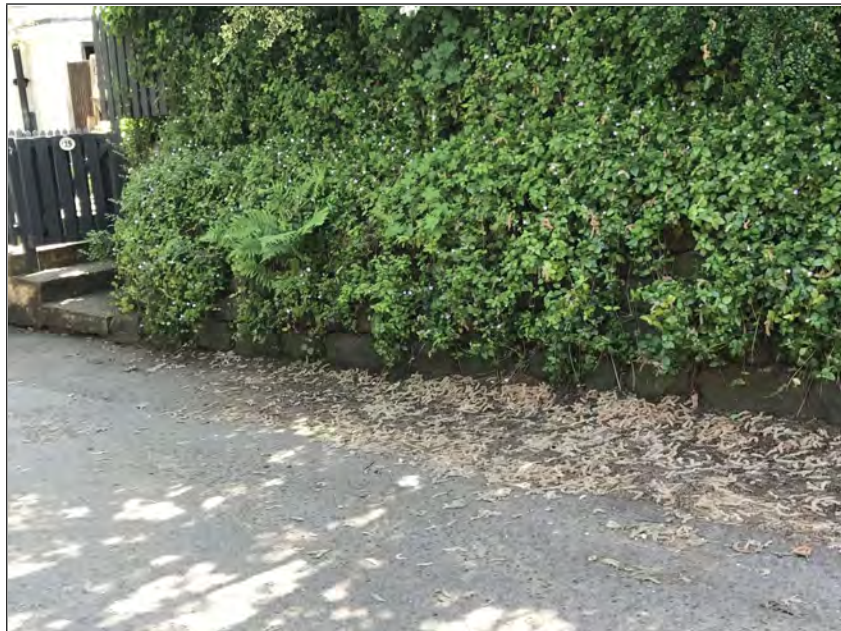
**Condition** ☐ Good ☐ Reasonable ☒ Poor ☐ At Risk ☐ Not seen close

**Notes** Northern part of eastern boundary on Mill Lane. More of a bank than a wall per se.

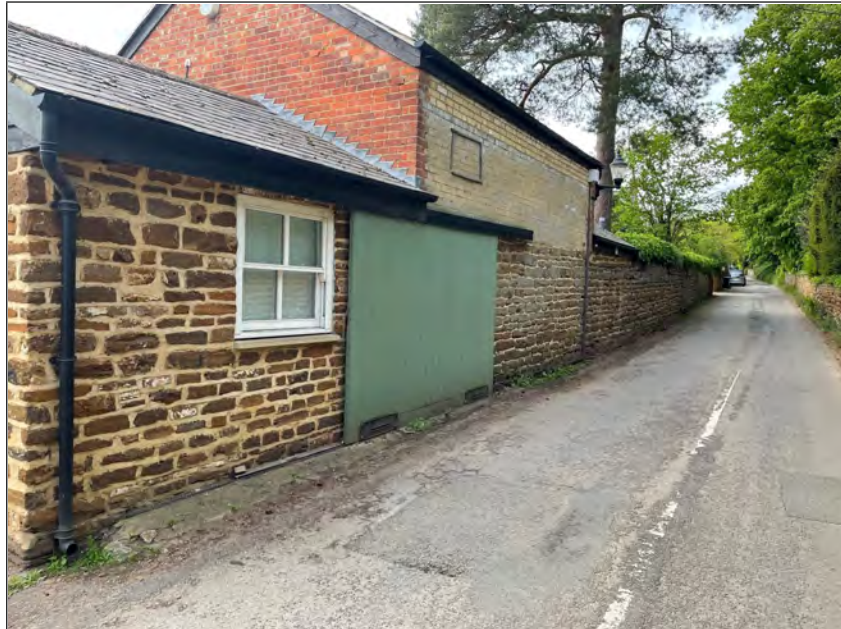
**Notes** Boundary wall on Mill Lane.

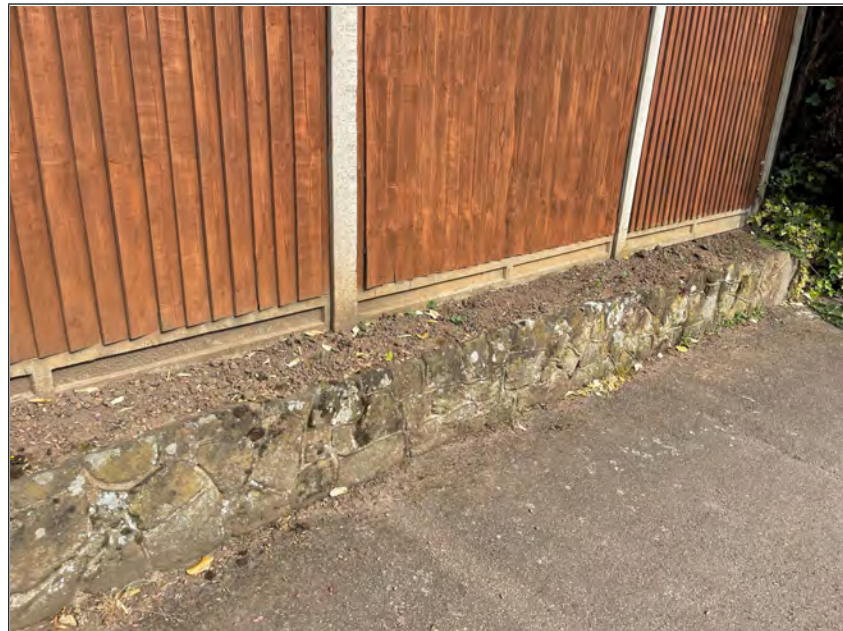
**Notes** Low rear wall of property with timber fence on Bedford Road (A6)

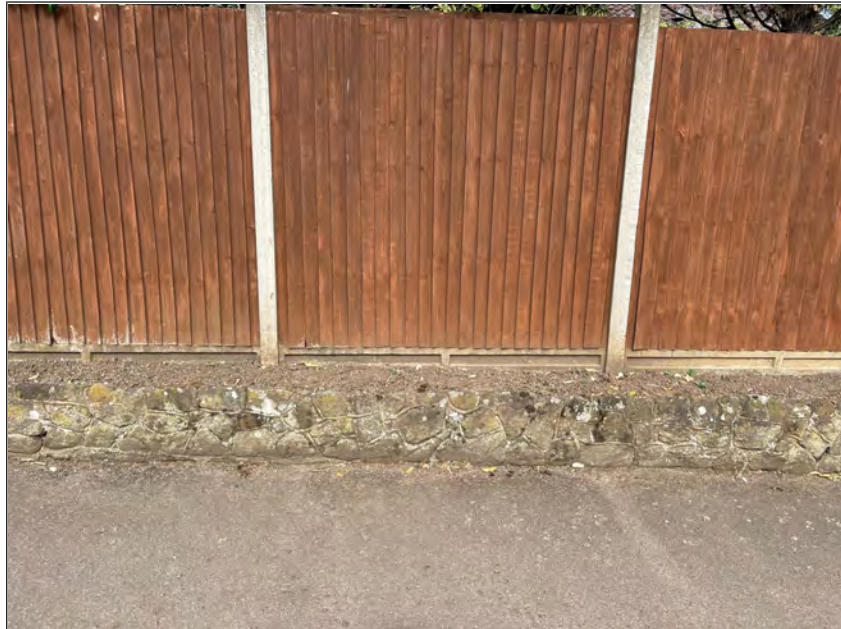
**Notes** Low rear wall of property with timber fence on Bedford Road (A6)

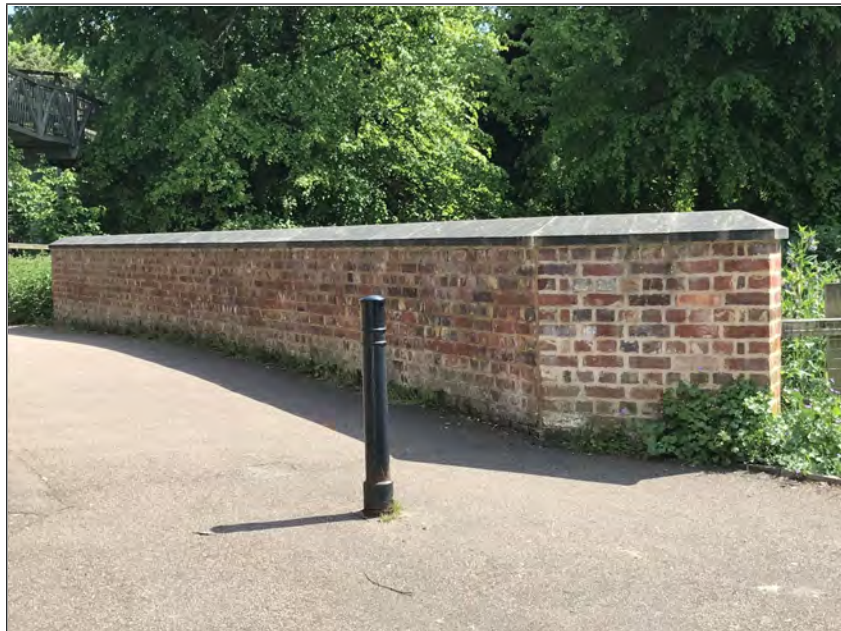
**Notes** Eastern parapet to culvert carrying River Flit under A507 and A6.

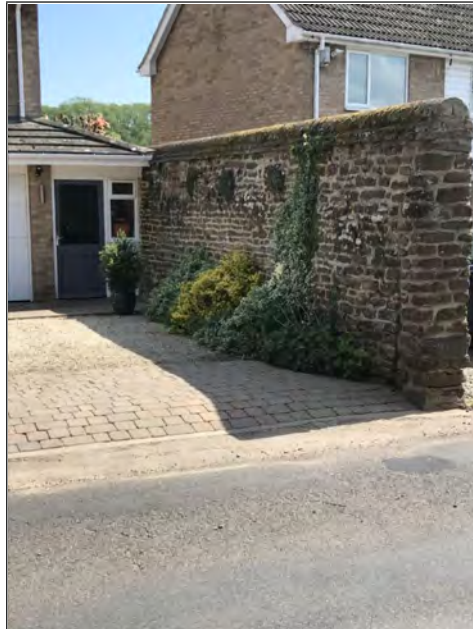
**Notes** Flank wall to number 32.

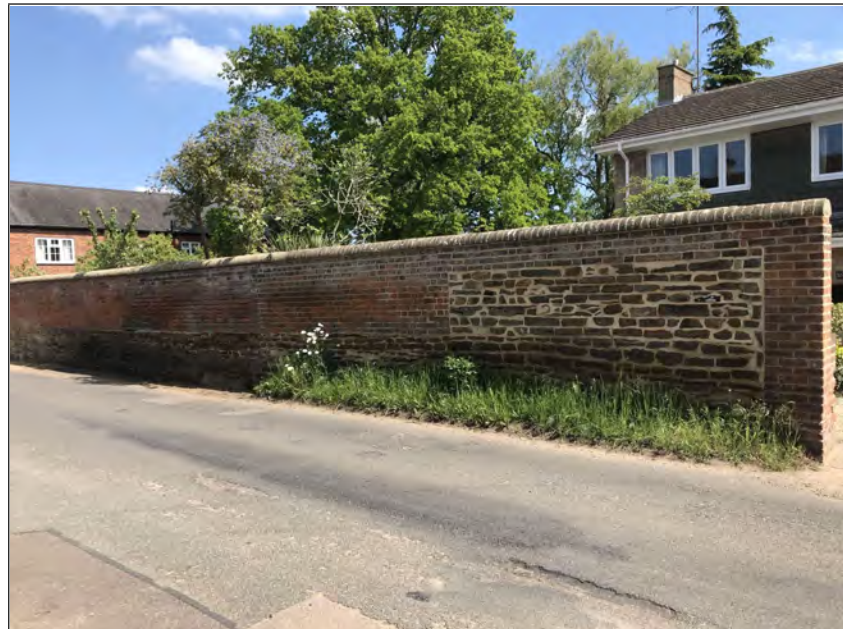
**Notes** Much of the wall is brick. Continues part way across frontage of 32A.

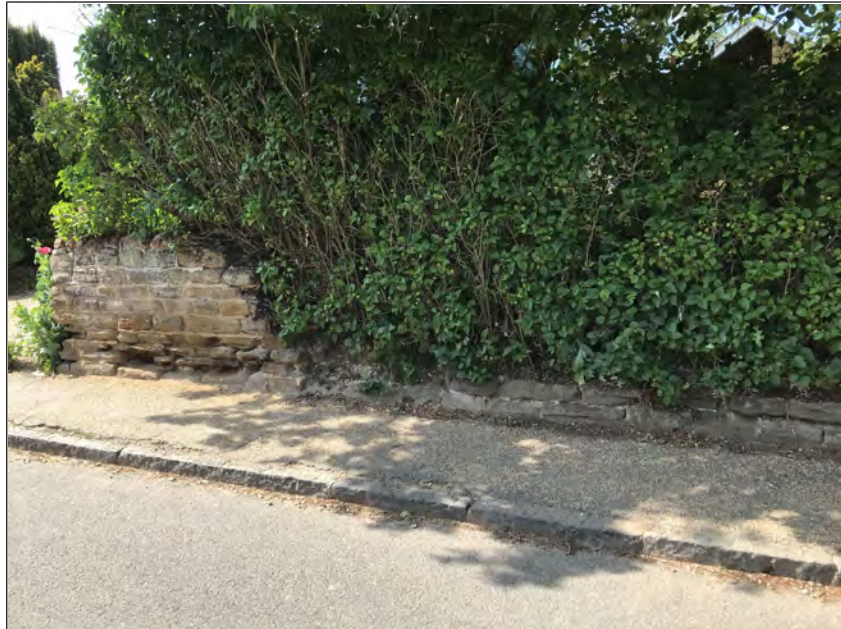
**Condition** ☐ Good ☐ Reasonable ☒ Poor ☐ At Risk ☐ Not seen close

**Notes** Part of wall demolished. Potential project.

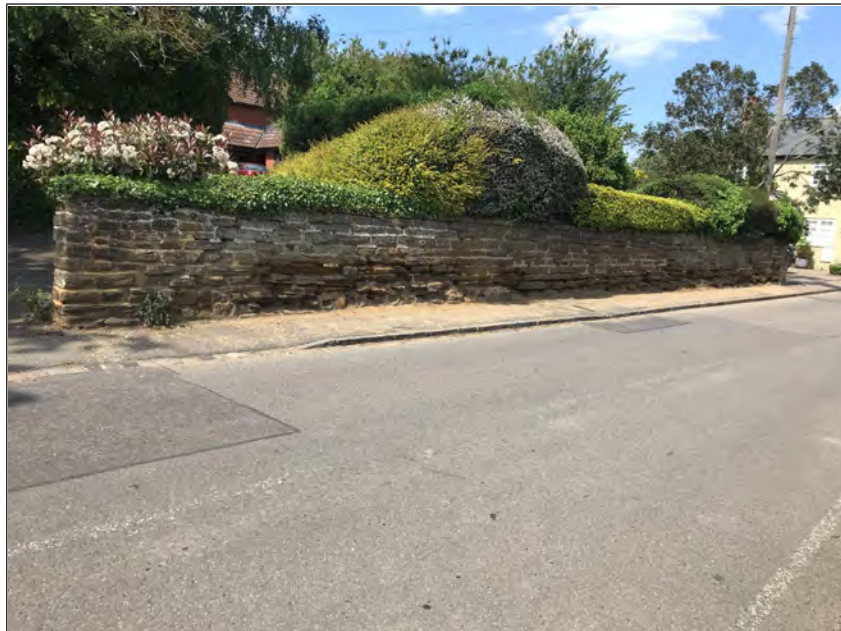
**Condition** ☐ Good ☐ Reasonable ☒ Poor ☐ At Risk ☐ Not seen close

**Notes** Deep salt erosion, failing pointing, etc. Potential project. Extends alongside and behind 61 to the east.

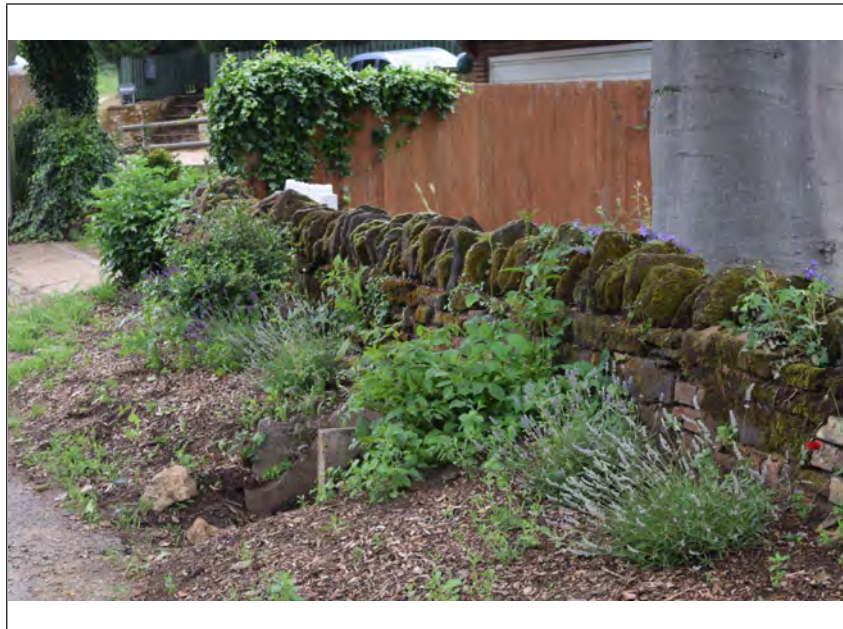
**Notes** Extends across part of flank of 3 Great Lane.

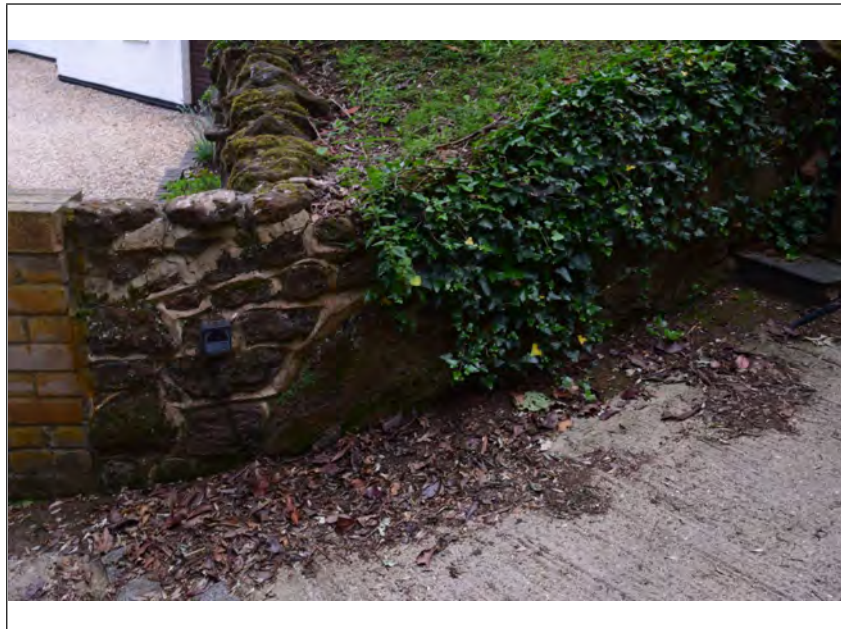
**Condition** ☐ Good ☒ Reasonable ☐ Poor ☐ At Risk ☐ Not seen close

**Notes** Part of wall missing next to gate. Lower (of two) retaining walls on boundary with cottage (Glen) to south.

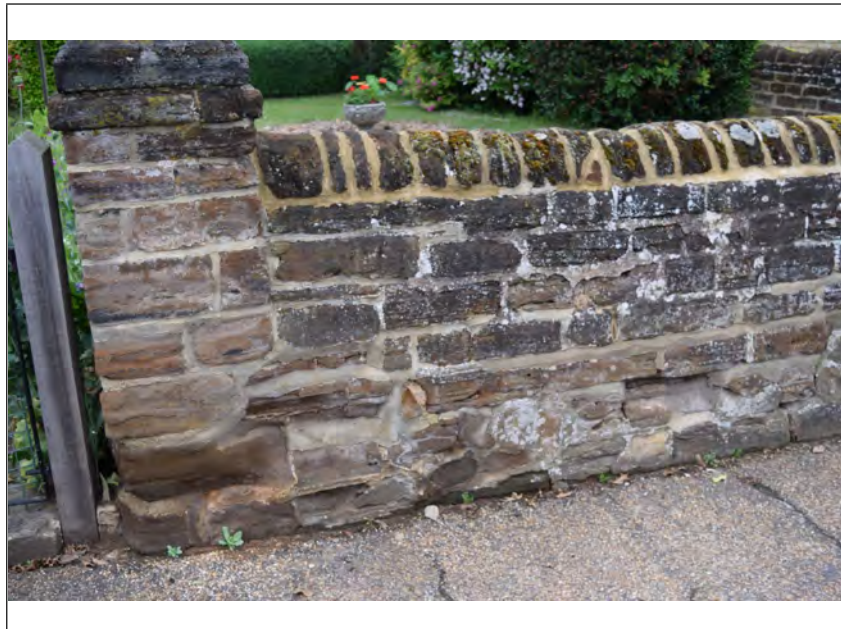
**Condition** ☐ Good ☒ Reasonable ☐ Poor ☐ At Risk ☐ Not seen close

**Notes** Some salt erosion at base.

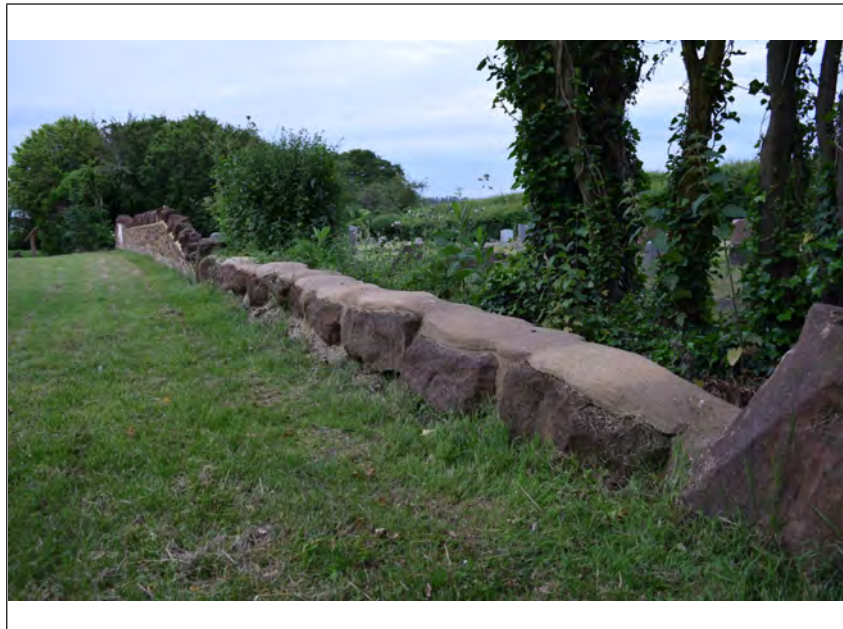
**Condition** ☐ Good ☐ Reasonable ☒ Poor ☐ At Risk ☐ Not seen close

**Notes** Length of wall to south of church. Heavily invaded by vegetation and almost hidden with much loss.

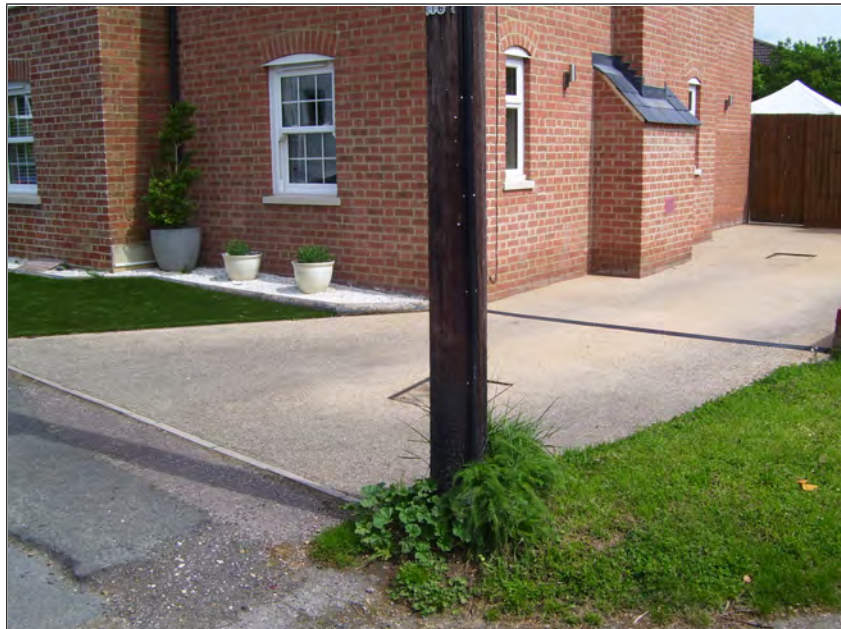
**Condition** ☐ Good ☐ Reasonable ☐ Poor ☐ At Risk ☒ Not seen close

**Notes** Low retaining wall heavily obscured by ivy, etc. Not 100% sure of nature or condition.  
2021 - Discovered wall demolished

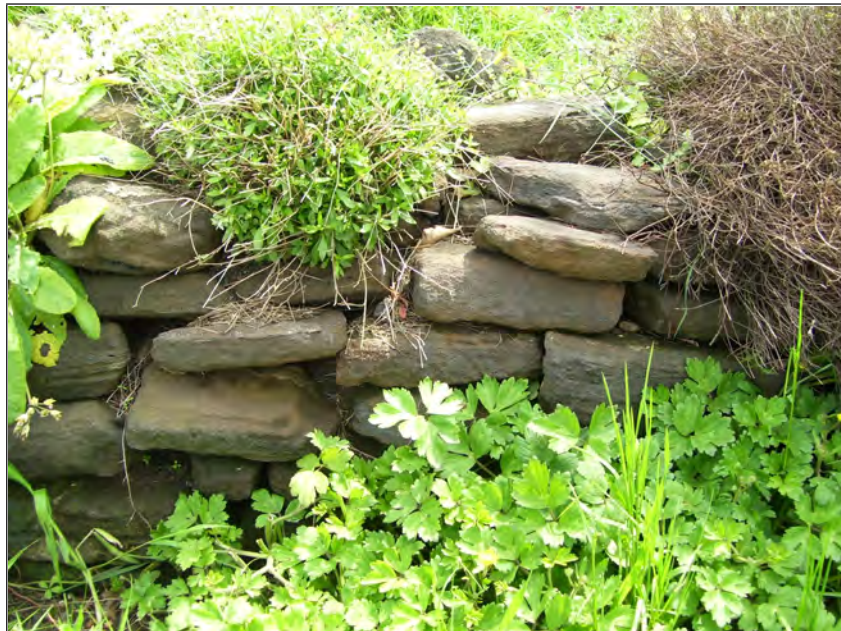
**Condition** ☐ Good ☒ Reasonable ☐ Poor ☐ At Risk ☐ Not seen close

**Notes** Notably worse condition than 2001 survey.

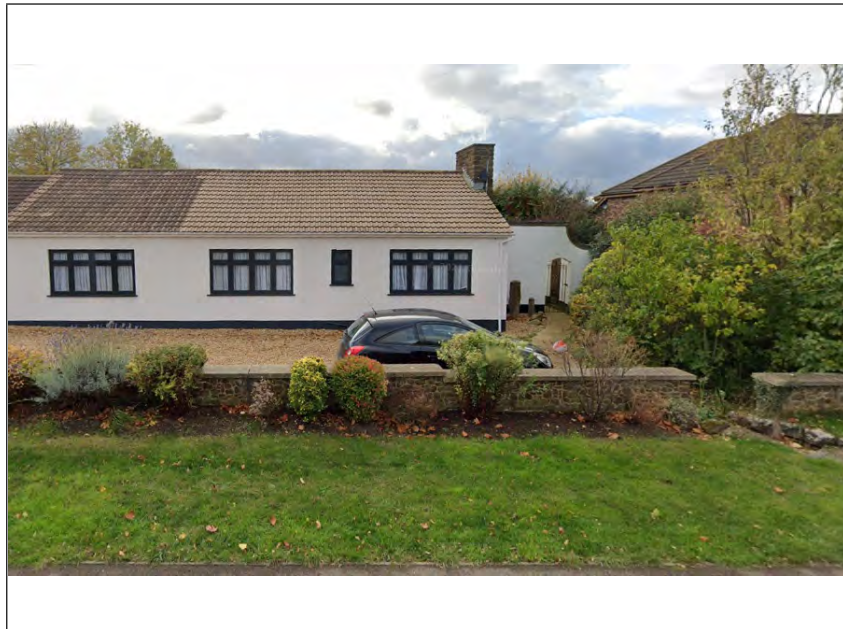
**Condition** ☒ Good ☐ Reasonable ☐ Poor ☐ At Risk ☐ Not seen close

**Notes** 2021 - Rebuilt and repointed

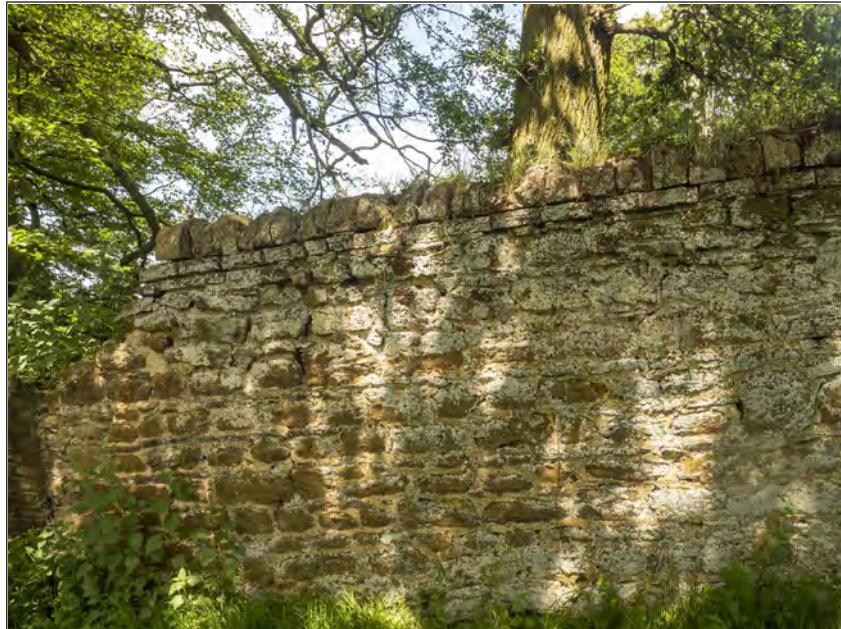
**Condition** ☐ Good ☐ Reasonable ☐ Poor ☒ At Risk ☐ Not seen close

**Notes** Stretch of parkland wall approx. 500m west of the Manor (continuation of wholly brick wall). Parious state with large areas of collapse. Potential project.

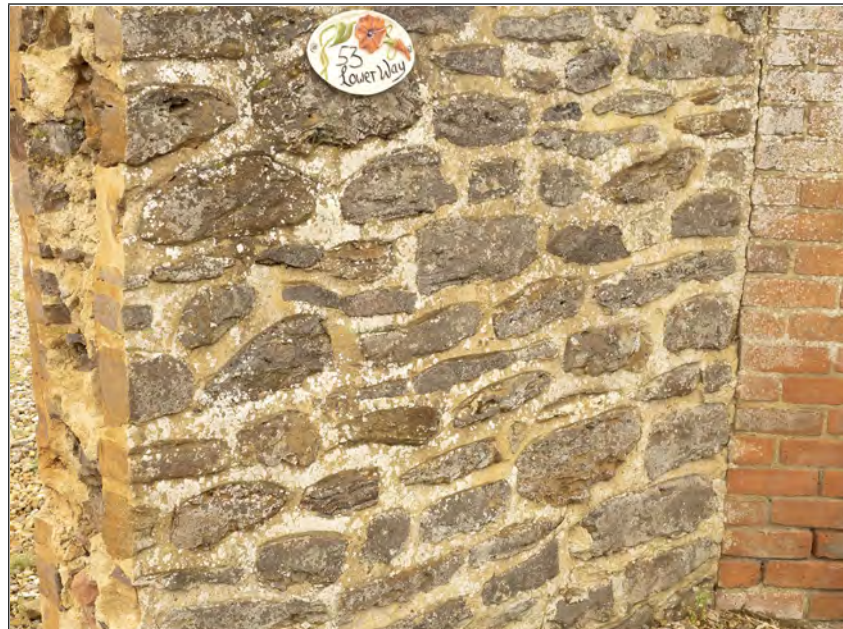
**Condition** ☒ Good ☐ Reasonable ☐ Poor ☐ At Risk ☐ Not seen close

**Notes** Wall flanking north side of driveway.

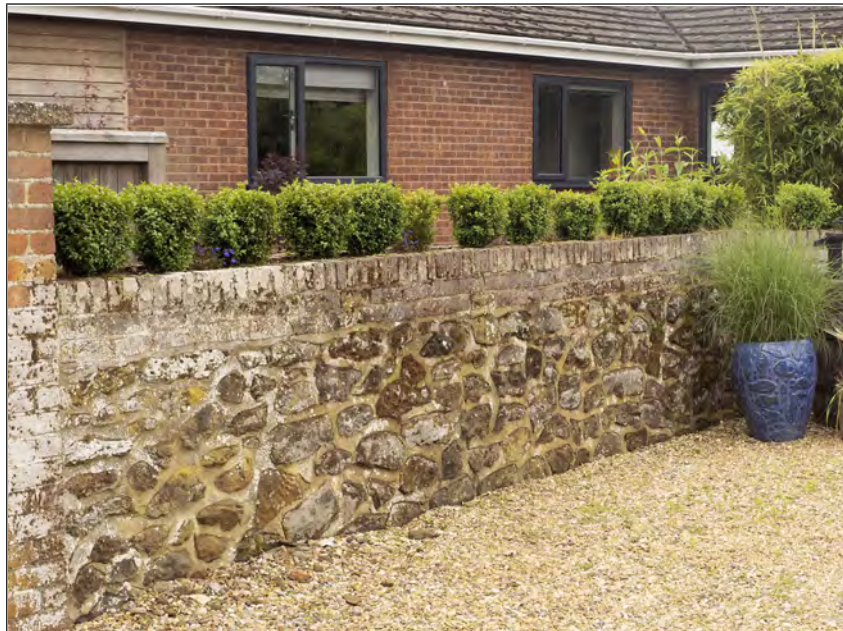
**Condition** ☒ Good ☐ Reasonable ☐ Poor ☐ At Risk ☐ Not seen close

**Notes** Separating (fence) wall.

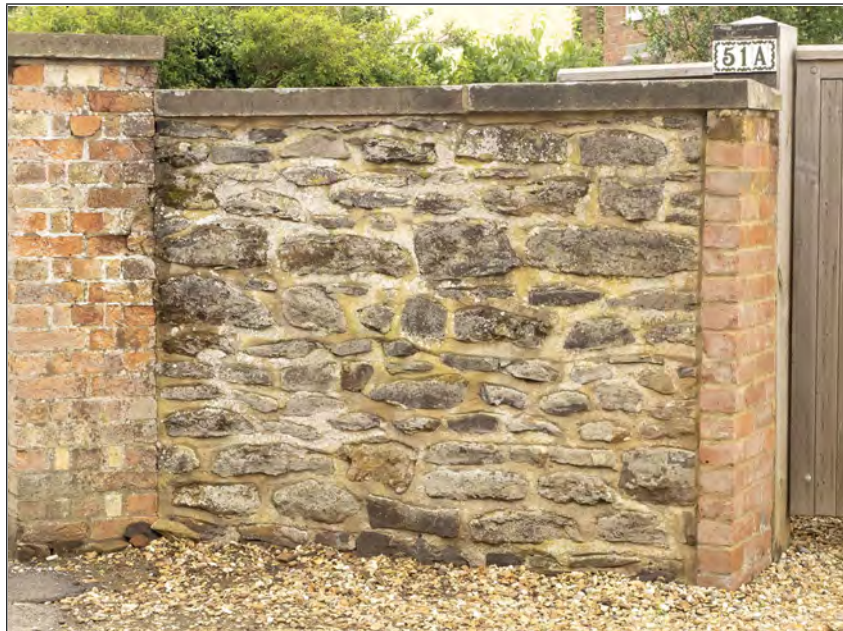
**Condition** ☒ Good ☐ Reasonable ☐ Poor ☐ At Risk ☐ Not seen close

**Notes** Extends across frontage of 53.

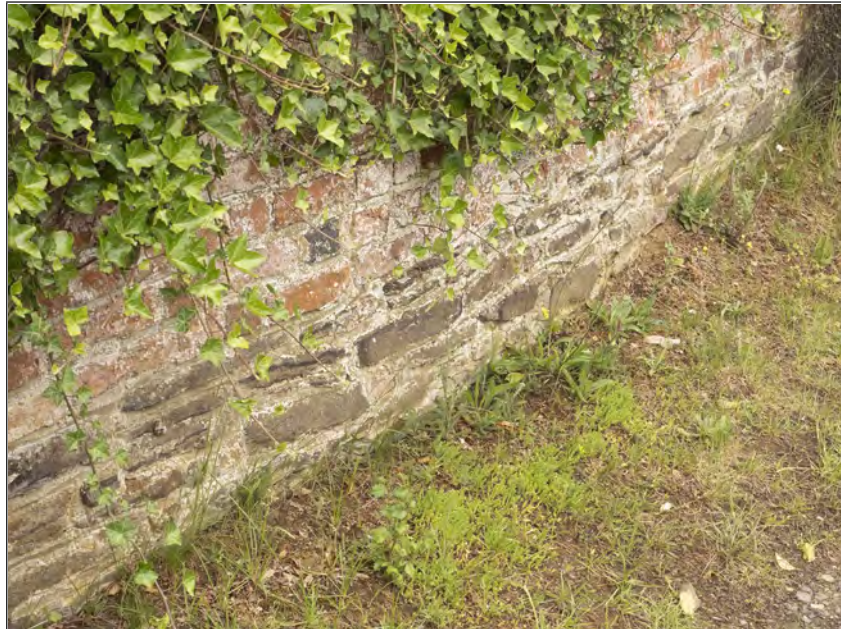
**Condition** ☐ Good ☒ Reasonable ☐ Poor ☐ At Risk ☐ Not seen close

**Notes** Lower courses of wall only. Most of wall is brick.

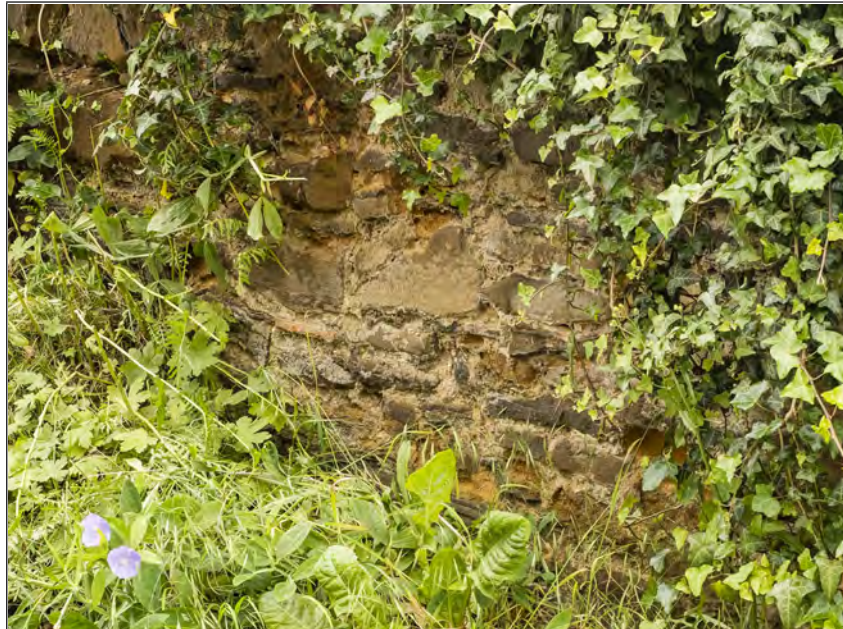
**Condition** ☐ Good ☒ Reasonable ☐ Poor ☐ At Risk ☐ Not seen close

**Notes** Boundary wall with 48 to the south.

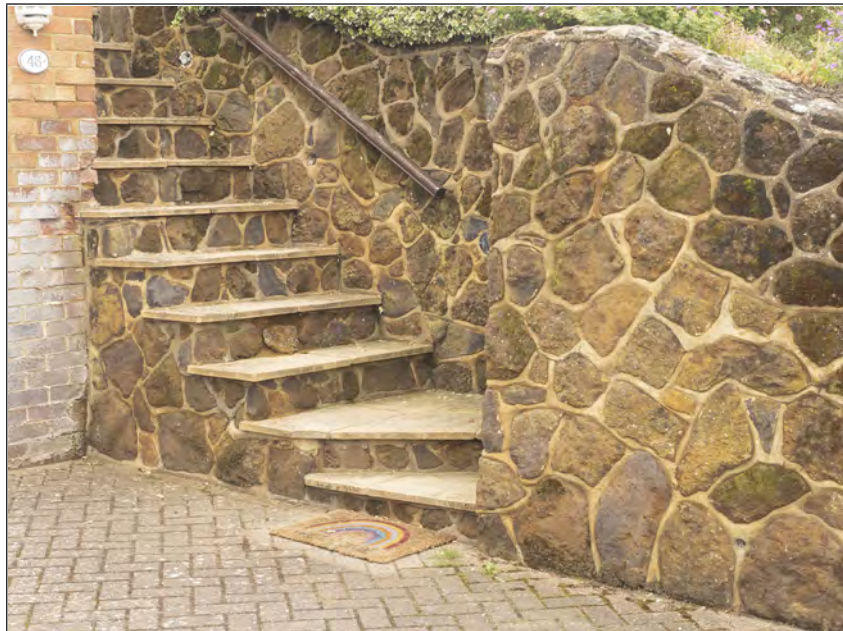
**Condition** ☒ Good ☐ Reasonable ☐ Poor ☐ At Risk ☐ Not seen close

**Notes** Includes steps up to house and integrates garage.

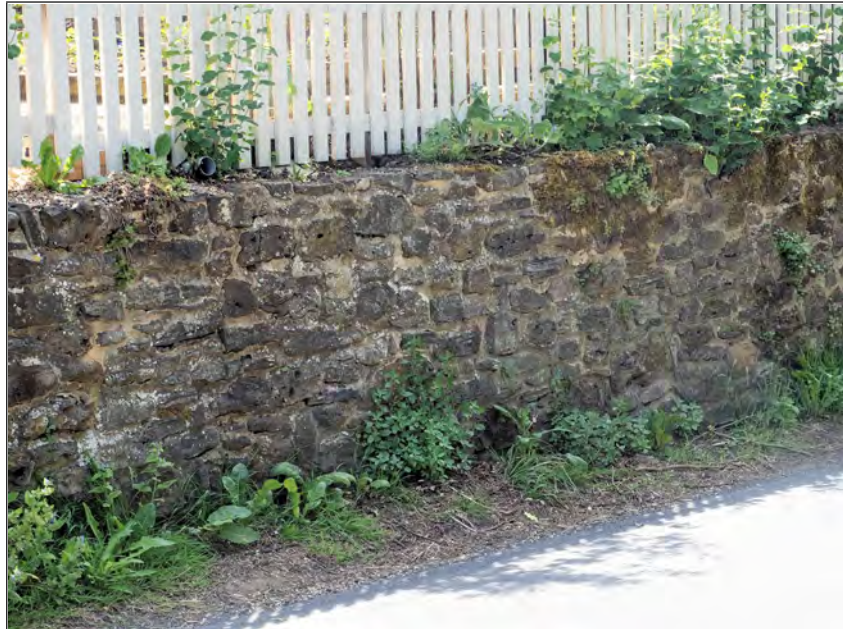
**Condition** ☐ Good ☒ Reasonable ☐ Poor ☐ At Risk ☐ Not seen close

**Notes** Between buildings on Lower Way.....

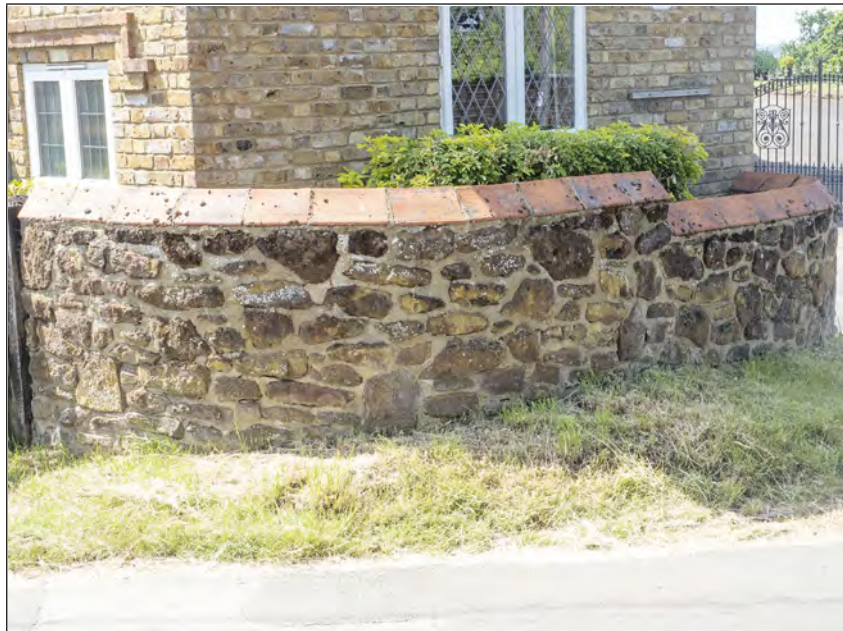
**Condition** ☐ Good ☒ Reasonable ☐ Poor ☐ At Risk ☐ Not seen close

**Notes** On Rotten Row.

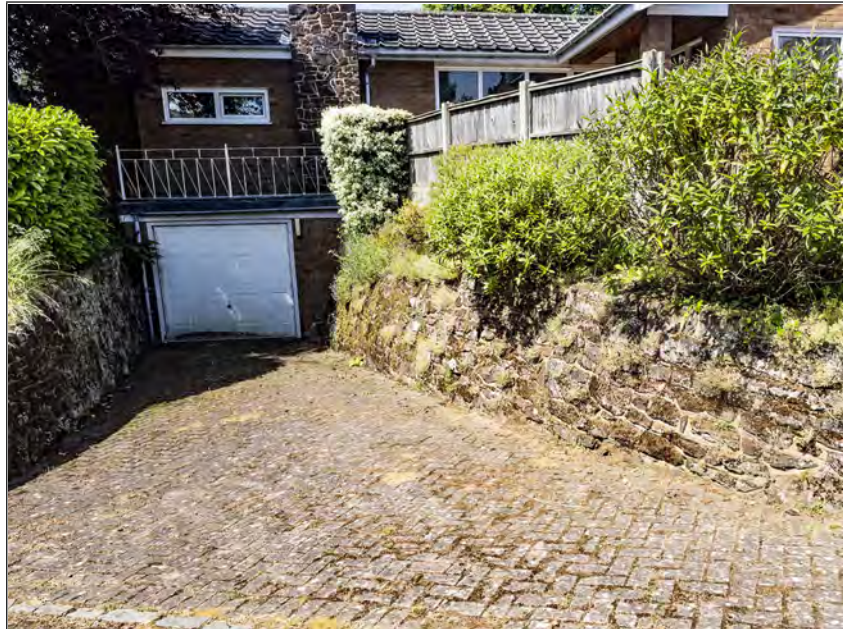
**Condition** ☐ Good ☒ Reasonable ☐ Poor ☐ At Risk ☐ Not seen close

**Notes** Garage entrance on lane dropping down from Rotten Row to Lower Way.

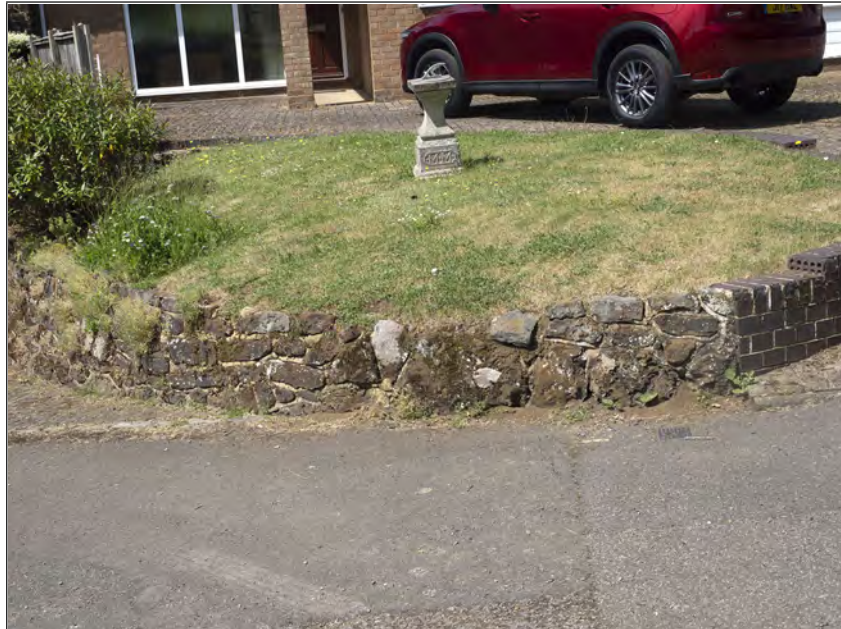
**Condition** ☐ Good ☒ Reasonable ☐ Poor ☐ At Risk ☐ Not seen close

**Notes** Low retaining wall to corner of site adjacent Lower Way.

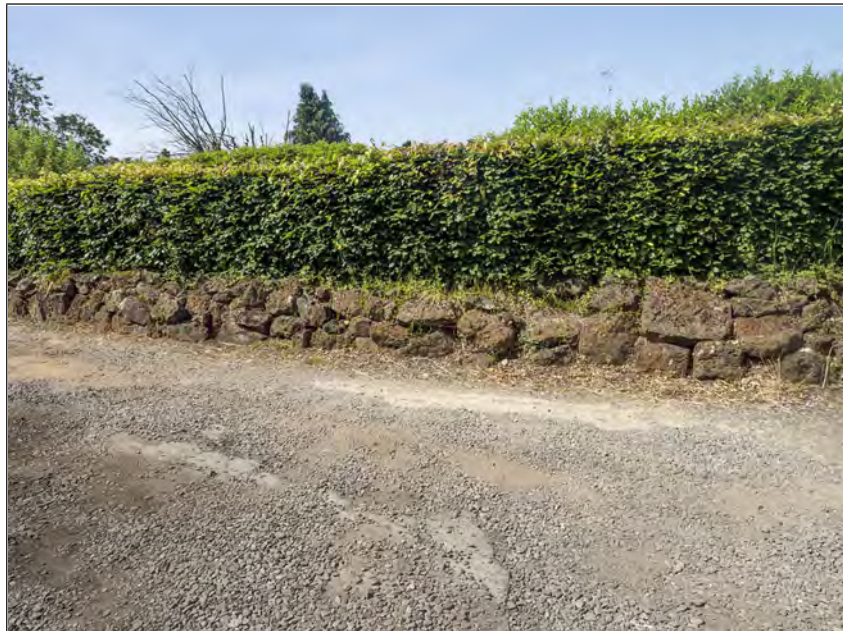
**Condition** ☐ Good ☒ Reasonable ☐ Poor ☐ At Risk ☐ Not seen close

**Notes** Possibly limestone and not sandstone.

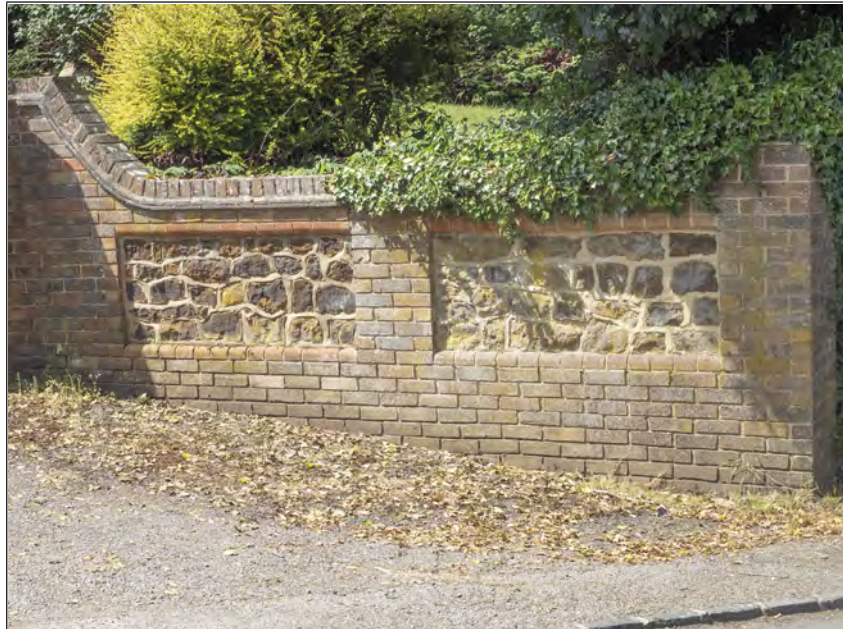
**Condition** ☒ Good ☐ Reasonable ☐ Poor ☐ At Risk ☐ Not seen close

**Notes** Stone panels in brick surrounds - wall is predominantly brick.

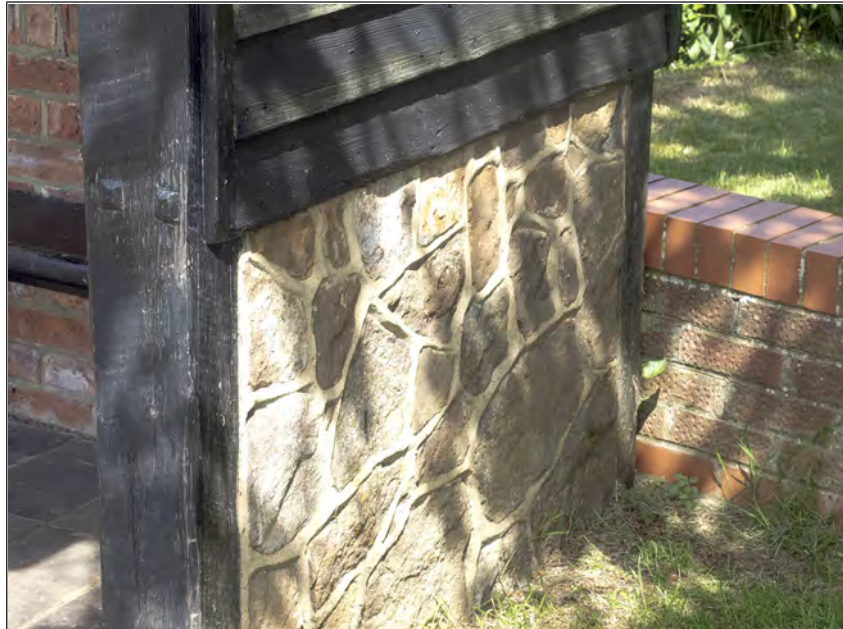
**Condition** ☒ Good ☐ Reasonable ☐ Poor ☐ At Risk ☐ Not seen close

**Notes** Stone panels on brick backing supporting timber + tile canopy.

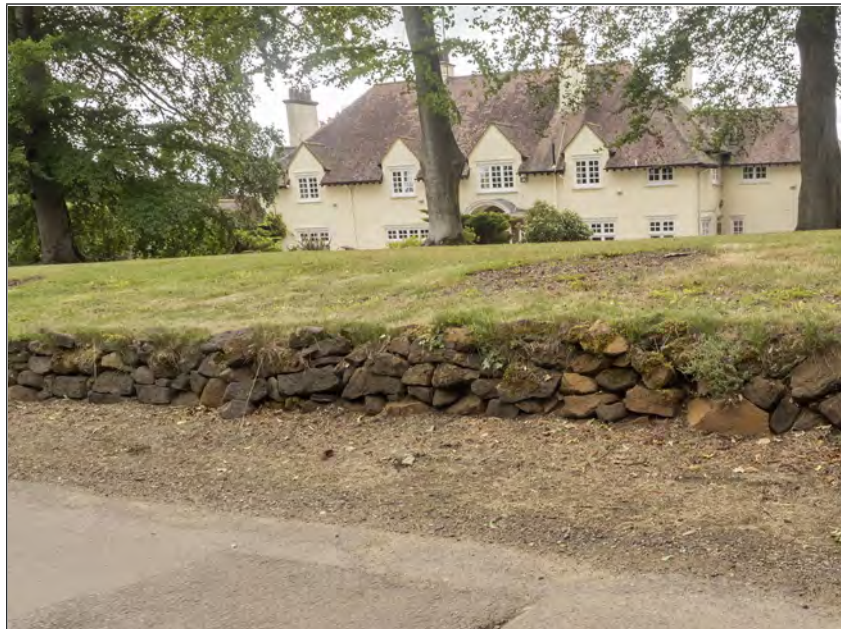
**Condition** ☐ Good ☒ Reasonable ☐ Poor ☐ At Risk ☐ Not seen close

**Notes** Low wall retaining front garden (lawn).

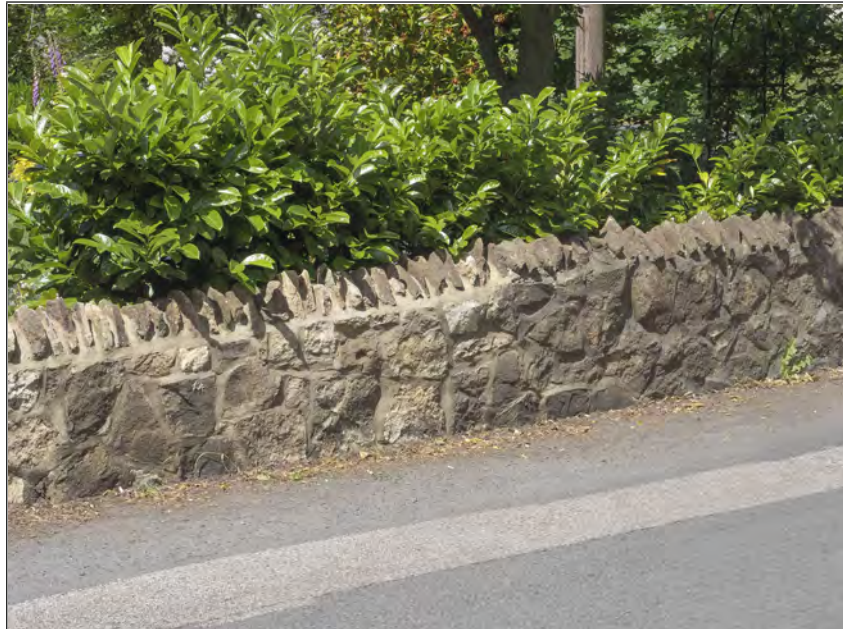
**Condition** ☐ Good ☒ Reasonable ☐ Poor ☐ At Risk ☐ Not seen close

**Notes** Might not be sandstone.
