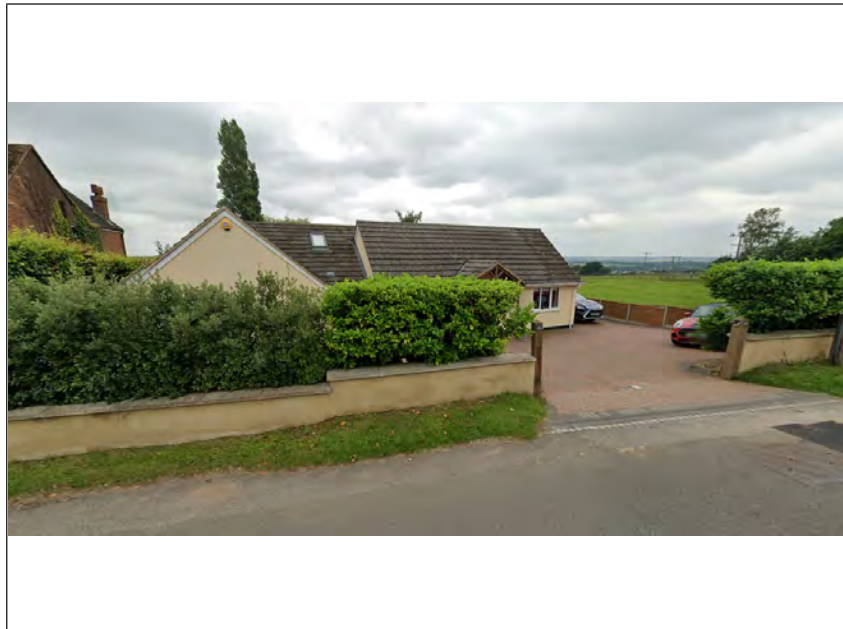
**Condition** ☐ Good ☒ Reasonable ☐ Poor ☐ At Risk ☐ Not seen close

**Notes** 2021 - wall is rendered and painted

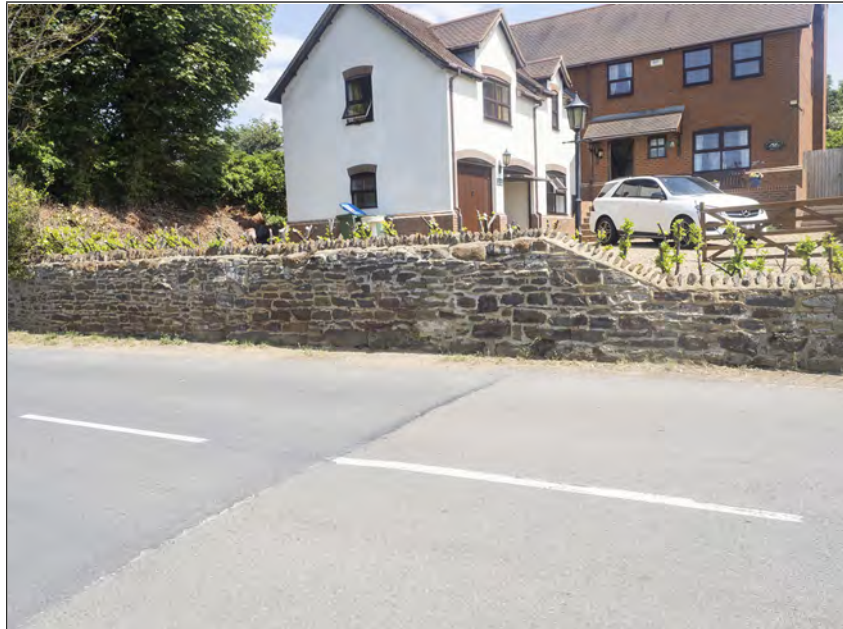
**Condition** ☒ Good ☐ Reasonable ☐ Poor ☐ At Risk ☐ Not seen close

**Notes** Wall fronts two properties within own gated enclosure.

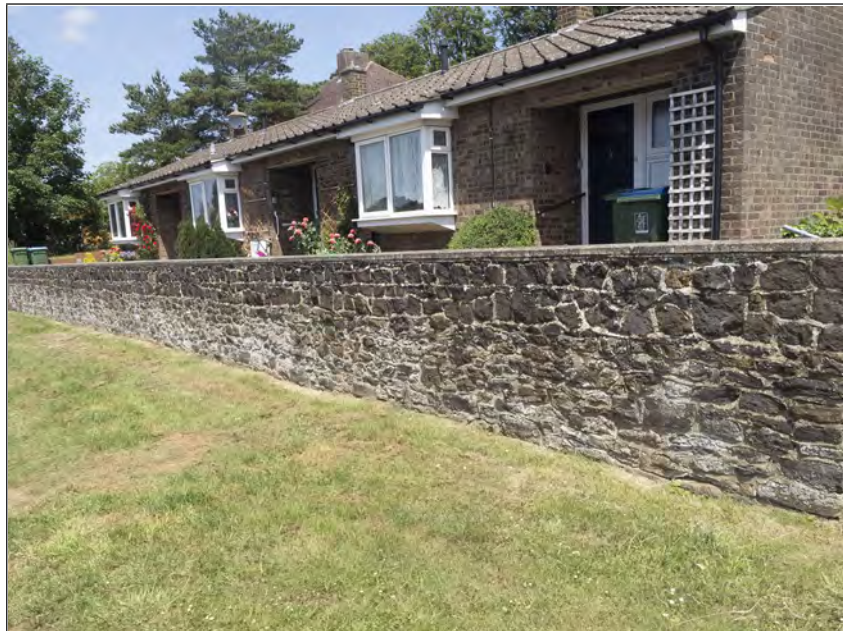
**Condition** ☒ Good ☐ Reasonable ☐ Poor ☐ At Risk ☐ Not seen close

**Notes** Turns the corner onto Pound Hill. Some patches more random than polygonal.

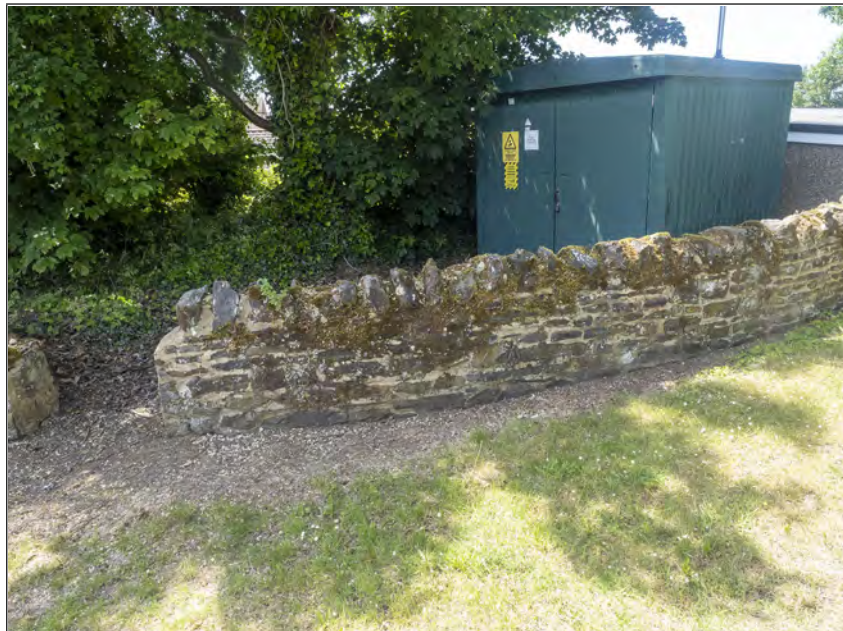
**Condition** ☐ Good ☒ Reasonable ☐ Poor ☐ At Risk ☐ Not seen close

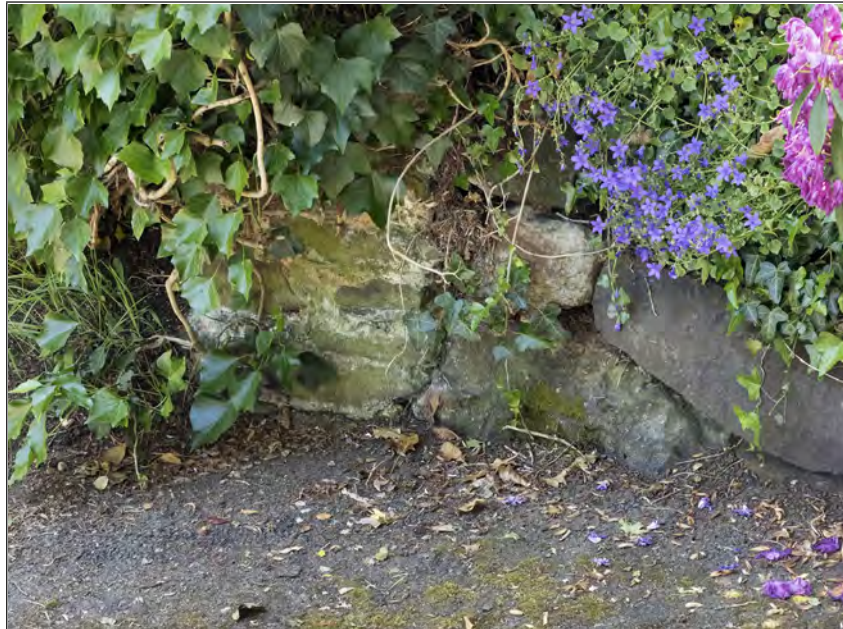
**Condition** ☐ Good ☐ Reasonable ☐ Poor ☐ At Risk ☒ Not seen close

**Notes** Obscured by ivy though seems reasonable.

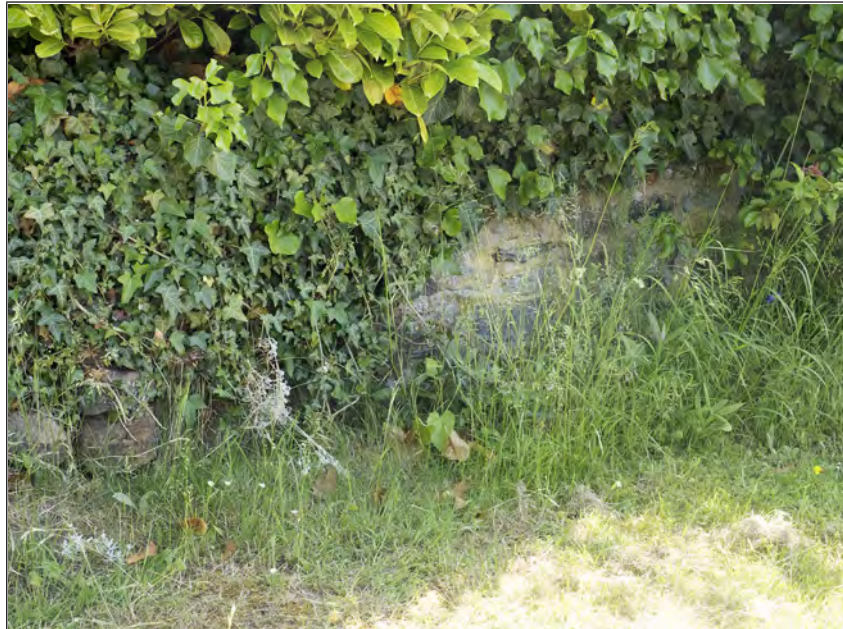
**Condition** ☐ Good ☐ Reasonable ☒ Poor ☐ At Risk ☐ Not seen close

**Notes** Overgrown with ivy + truncated at corner.

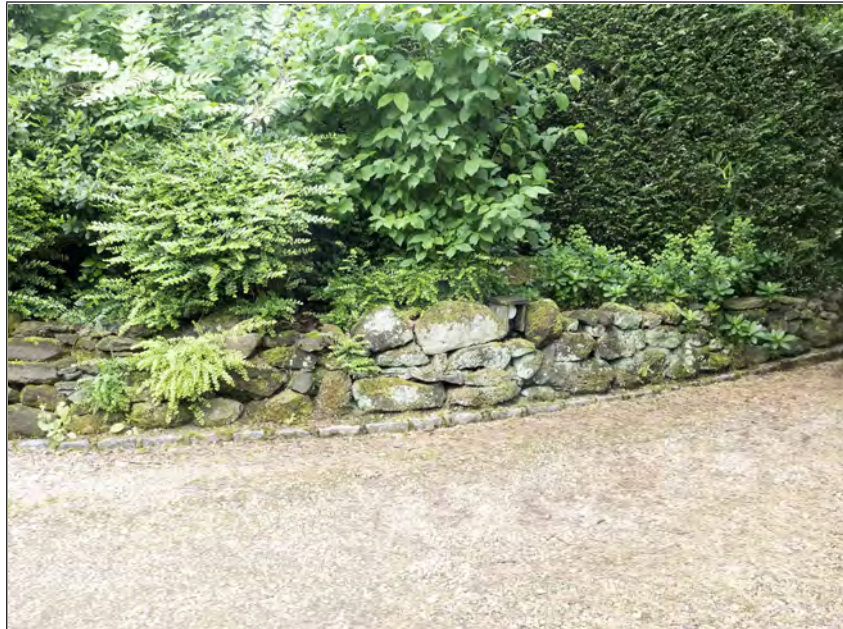
**Condition** ☐ Good ☐ Reasonable ☐ Poor ☐ At Risk ☒ Not seen close

**Notes** Almost totally obscured by ivy but seems reasonable.

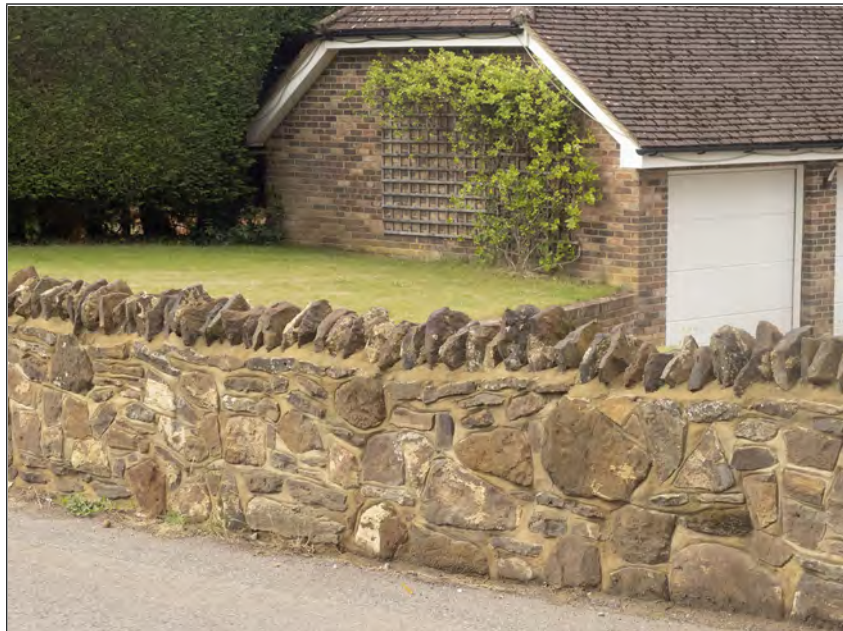
**Condition** ☐ Good ☐ Reasonable ☒ Poor ☐ At Risk ☐ Not seen close

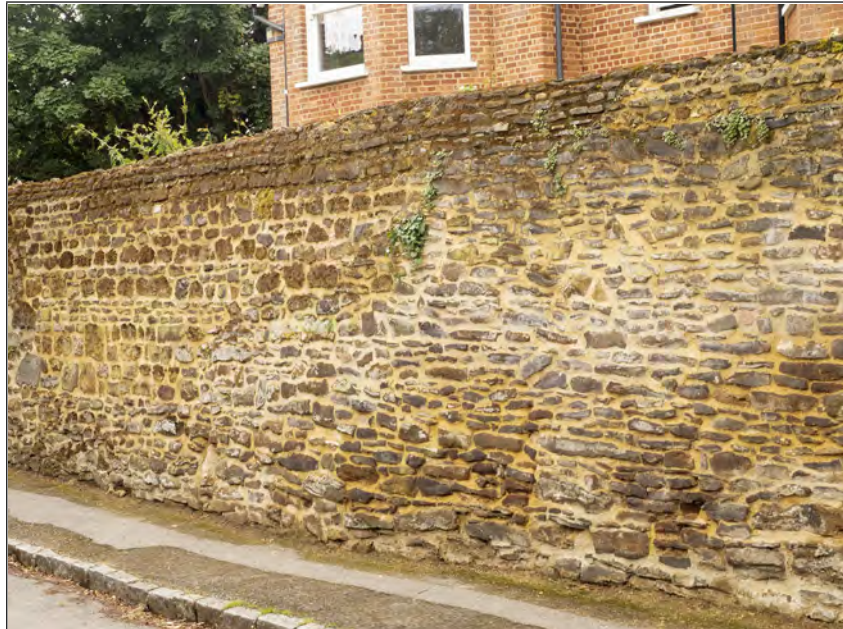
**Condition** ☐ Good ☒ Reasonable ☐ Poor ☐ At Risk ☐ Not seen close

**Notes** Wall has been in part rebuilt uncoursed.

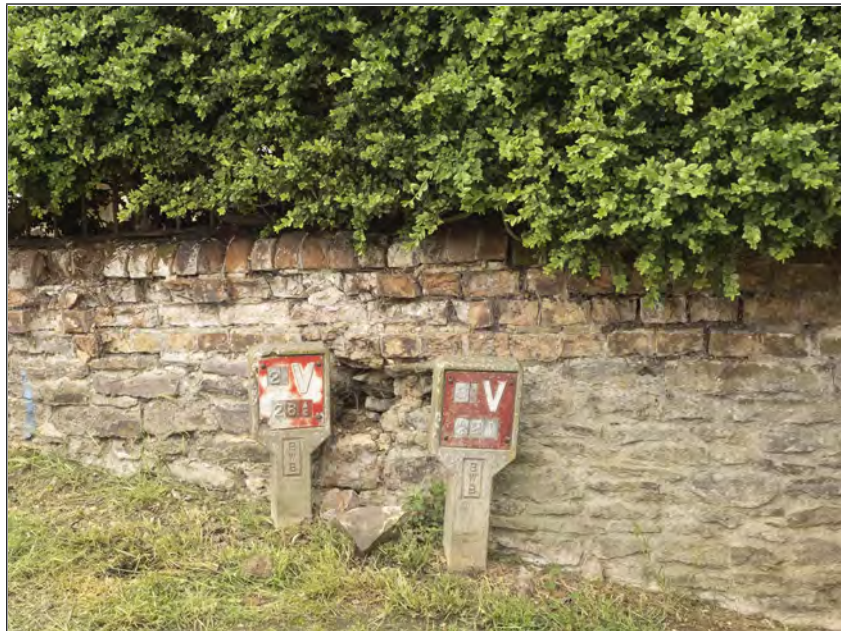
**Condition** ☐ Good ☐ Reasonable ☒ Poor ☐ At Risk ☐ Not seen close

**Notes** Wall is cracked full height and depth on the curved return + leaning progressively out towards road.

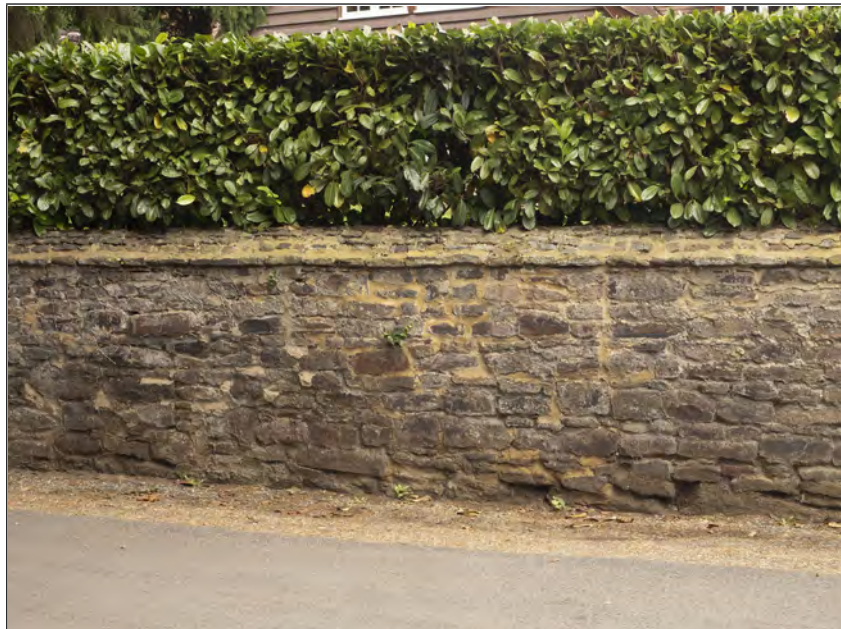
**Condition** ☐ Good ☒ Reasonable ☐ Poor ☐ At Risk ☐ Not seen close

**Notes** Contiguous with wall of 2 Pound Hill, interrupted by new opening formed to allow access to new house, with eastern end of wall rebuild.

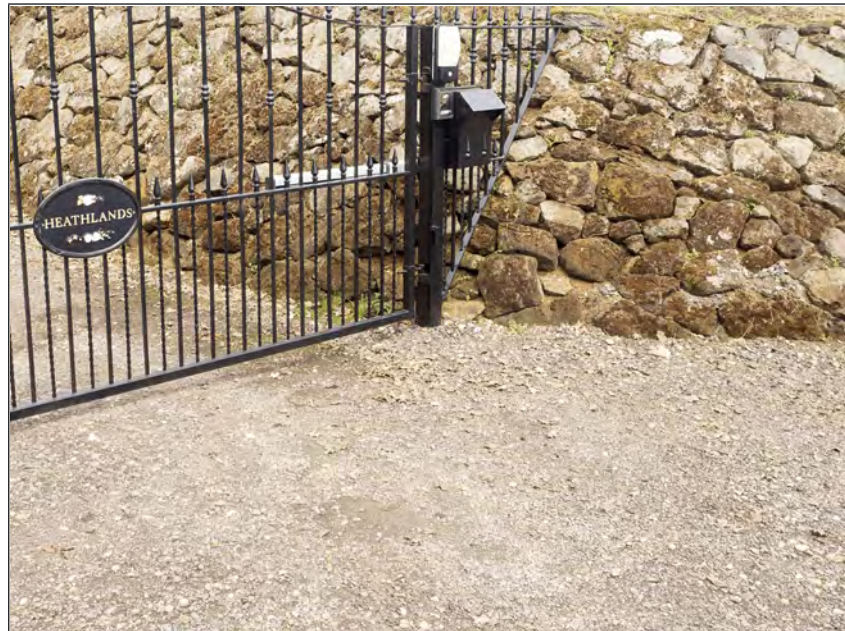
**Condition** ☐ Good ☒ Reasonable ☐ Poor ☐ At Risk ☐ Not seen close

**Notes** Battered walls retaining earth banks to entrance and drive.

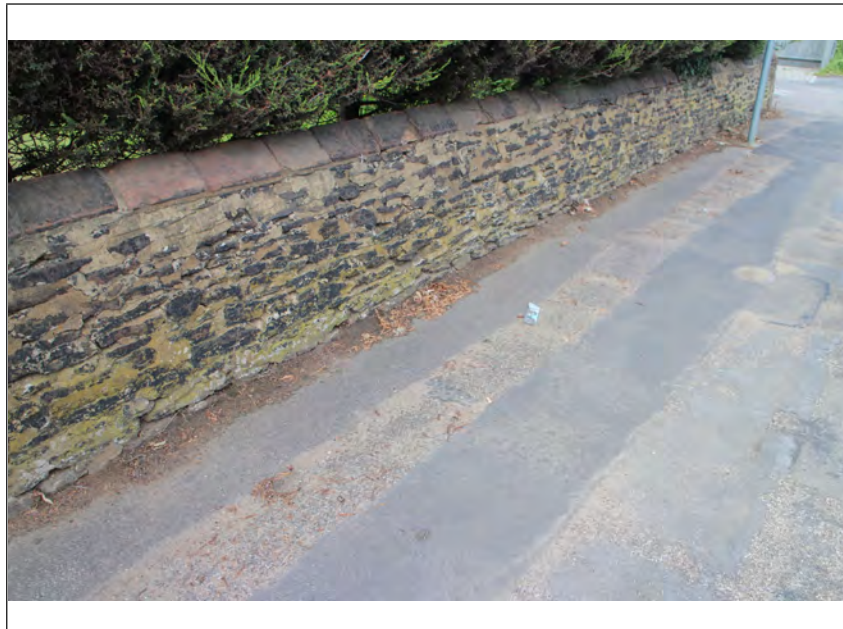
**Condition** ☐ Good ☒ Reasonable ☐ Poor ☐ At Risk ☐ Not seen close

**Notes** Brick or tile coping. ....

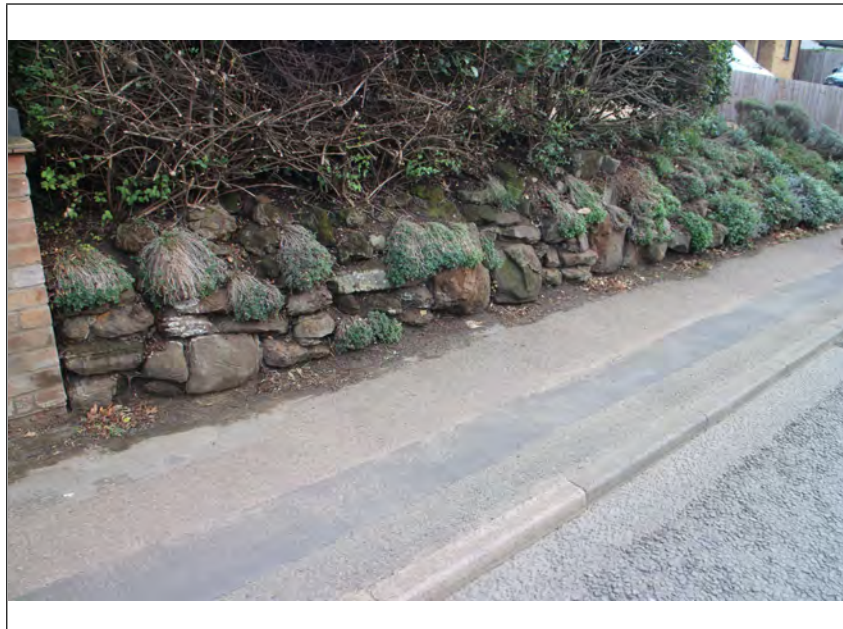
**Condition** ☐ Good ☒ Reasonable ☐ Poor ☐ At Risk ☐ Not seen close

**Notes** Battered wall to front boundary embankment.

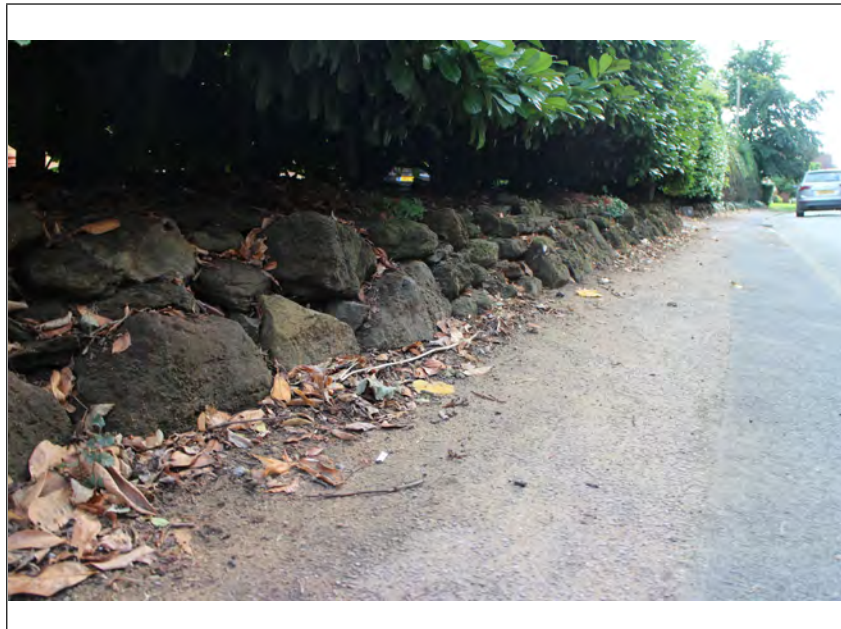
**Condition** ☐ Good ☒ Reasonable ☐ Poor ☐ At Risk ☐ Not seen close

**Notes** Low retaining wall to hedge-topped embankment. Continues as an edging across front of 68.

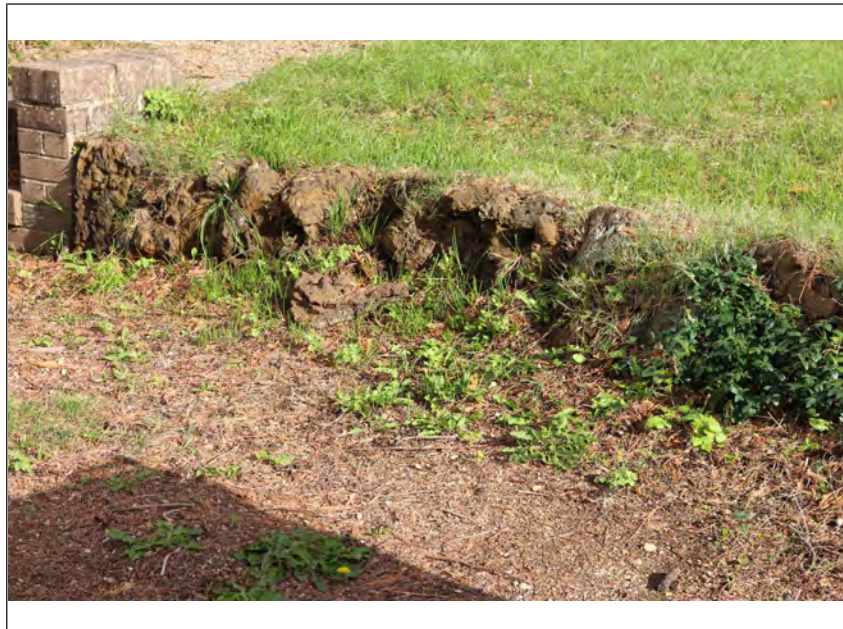
**Condition** ☐ Good ☐ Reasonable ☒ Poor ☐ At Risk ☐ Not seen close

**Notes** Lost coping stones, etc.

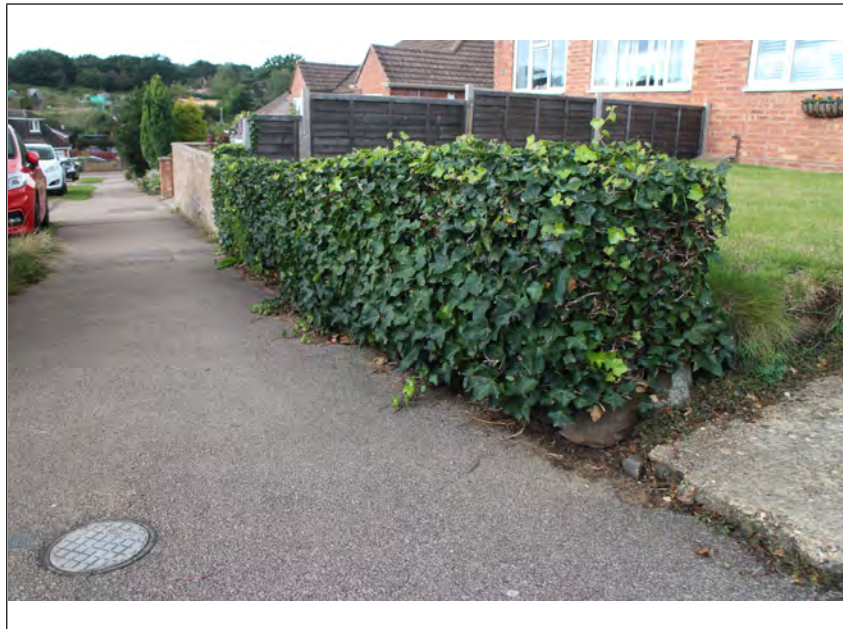
**Condition** ☐ Good ☐ Reasonable ☒ Poor ☐ At Risk ☐ Not seen close

**Notes** Wall heavily obscured by ivy.

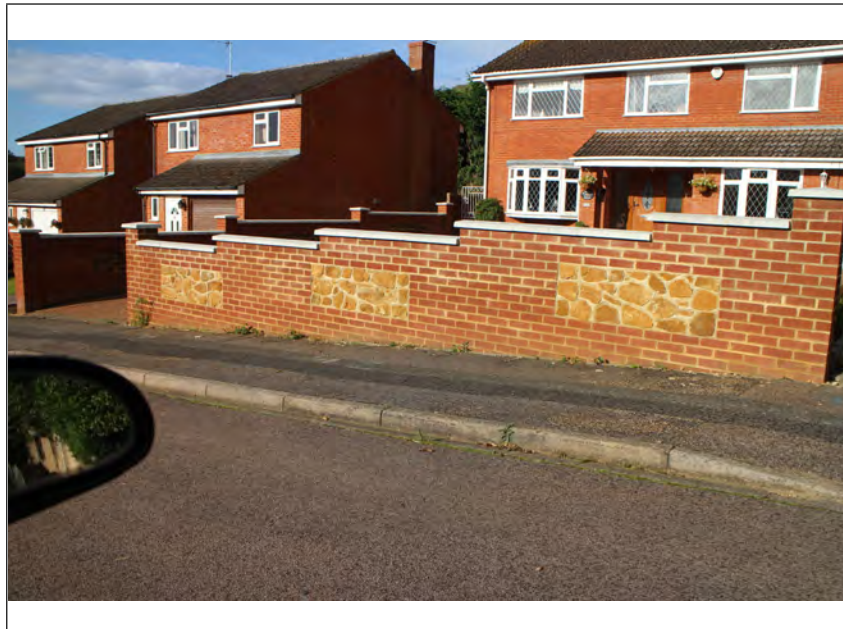
**Condition** ☒ Good ☐ Reasonable ☐ Poor ☐ At Risk ☐ Not seen close

**Notes** 2021 - new walls with rubble insert

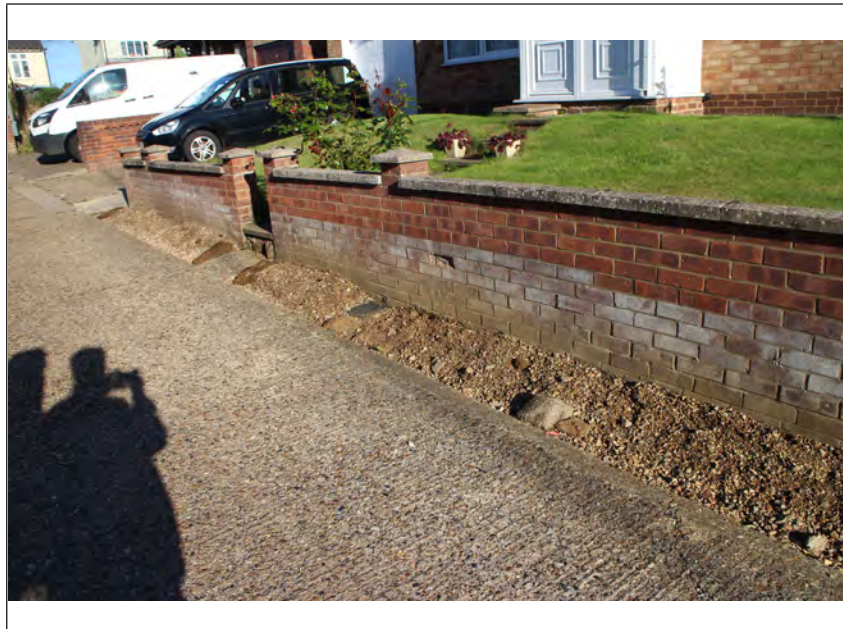
**Condition** ☐ Good ☒ Reasonable ☐ Poor ☐ At Risk ☐ Not seen close

**Notes** 2021 - modern brick wall with random rubble in front

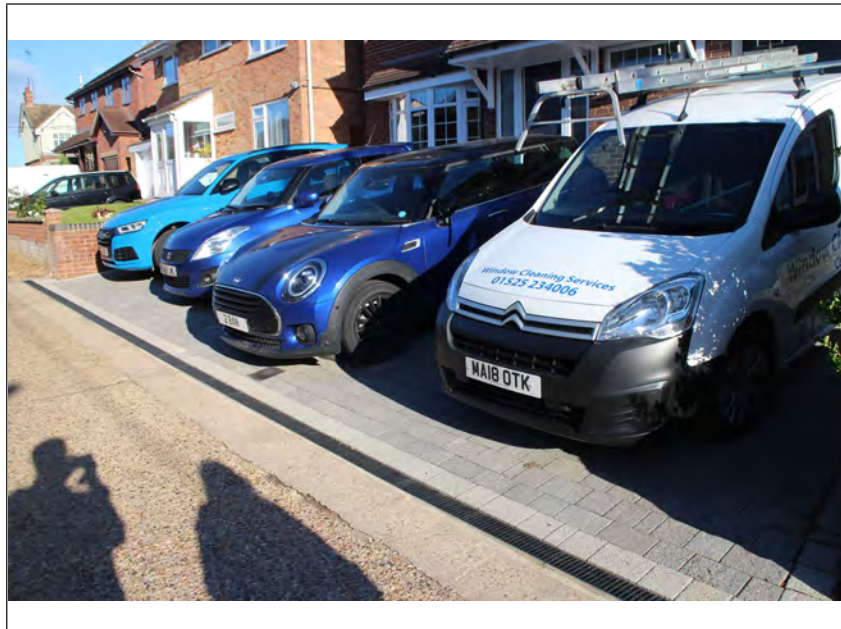
**Notes** 2021 - wall removed and replaced with new parking area

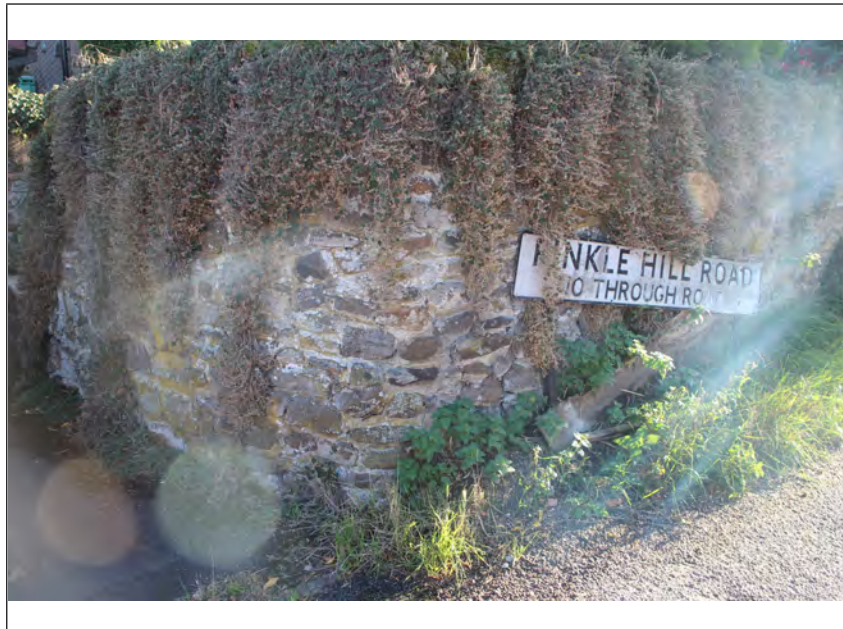
**Condition** ☐ Good ☒ Reasonable ☐ Poor ☐ At Risk ☐ Not seen close

**Notes** Retaining wall to front of house (largely obscured by ivy).

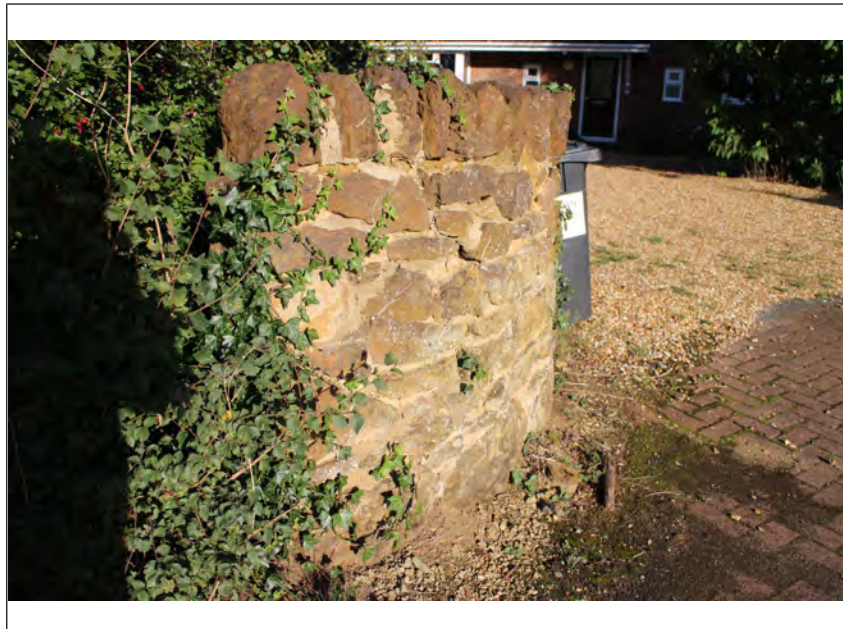
**Condition** ☐ Good ☒ Reasonable ☐ Poor ☐ At Risk ☐ Not seen close

**Notes** Mainly covered in ivy.

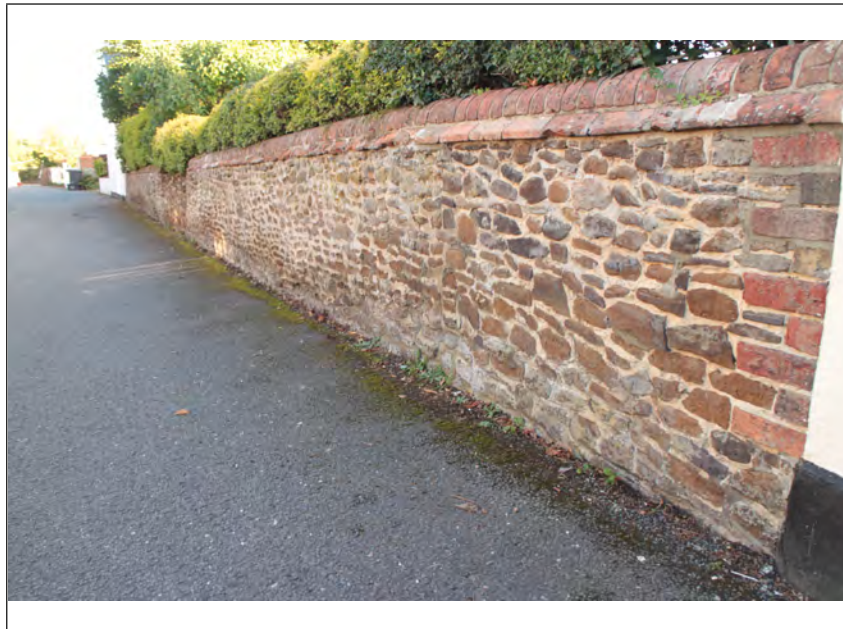
**Condition** ☐ Good ☒ Reasonable ☐ Poor ☐ At Risk ☐ Not seen close

**Notes** Wall to rear of property. Repairs in polygonal stonework.

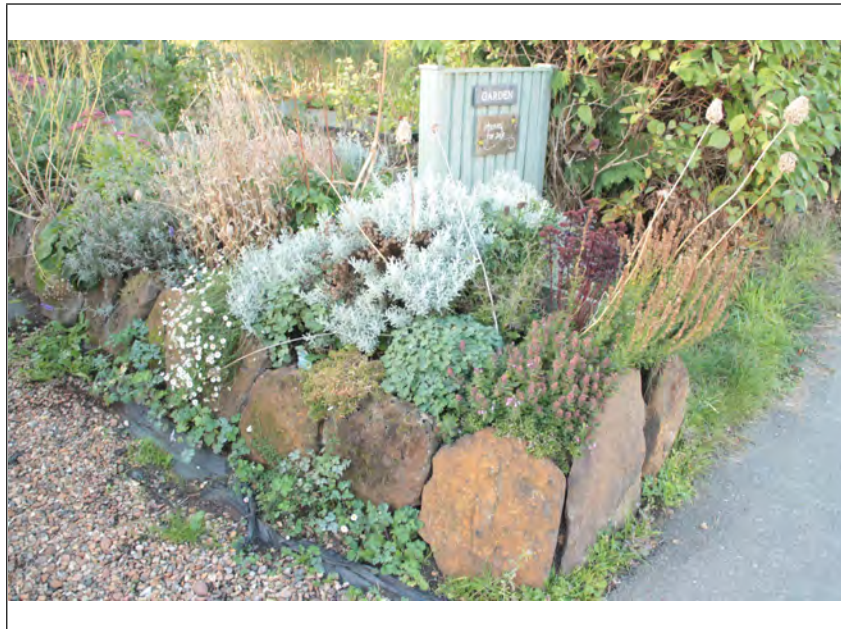
**Notes** Single course of stones. Almost classes as an edging.  
2021 - homeowner relaid as edging

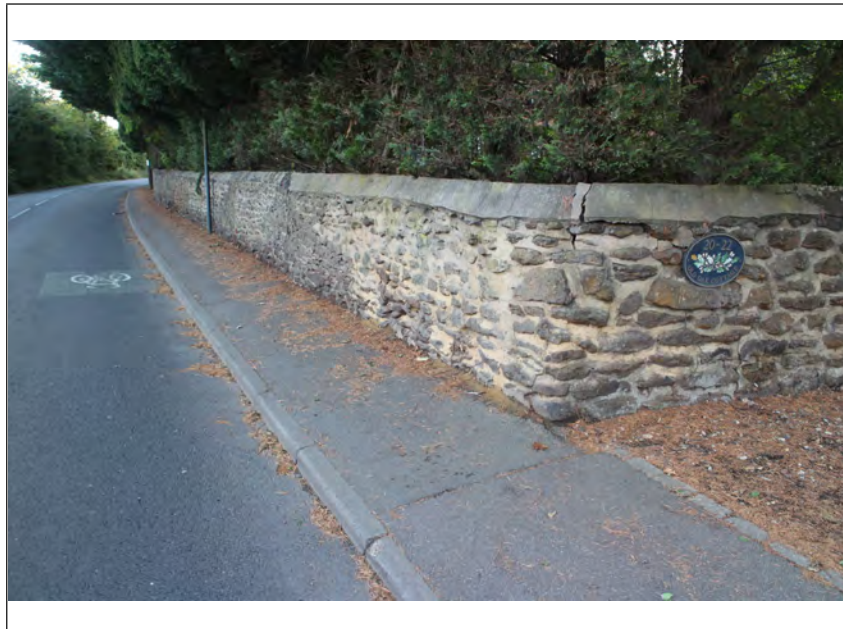
**Condition** ☐ Good ☒ Reasonable ☐ Poor ☐ At Risk ☐ Not seen close

**Notes** Sections repairs in polygonal rubble.

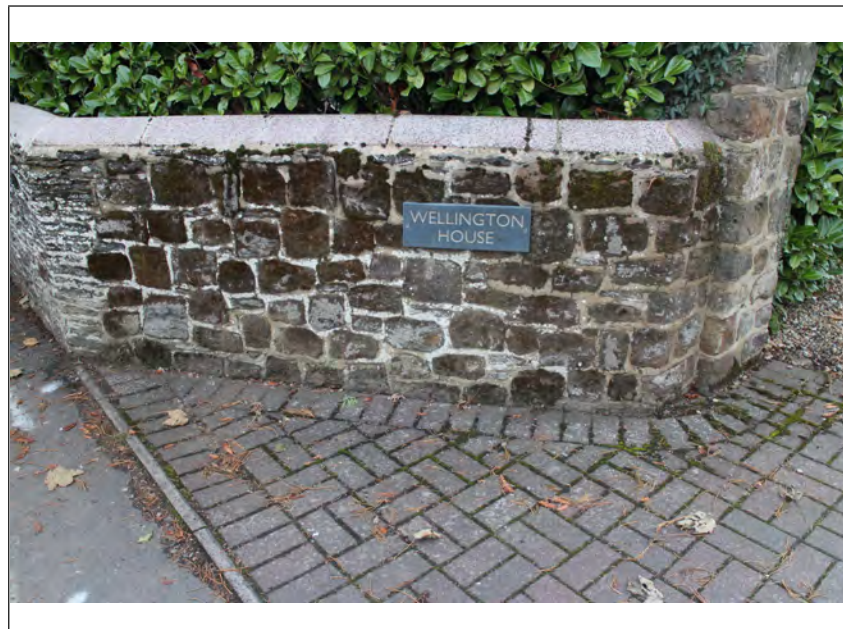
**Condition** ☐ Good ☒ Reasonable ☐ Poor ☐ At Risk ☐ Not seen close

**Notes** Sections repaired in polygonal rubble.

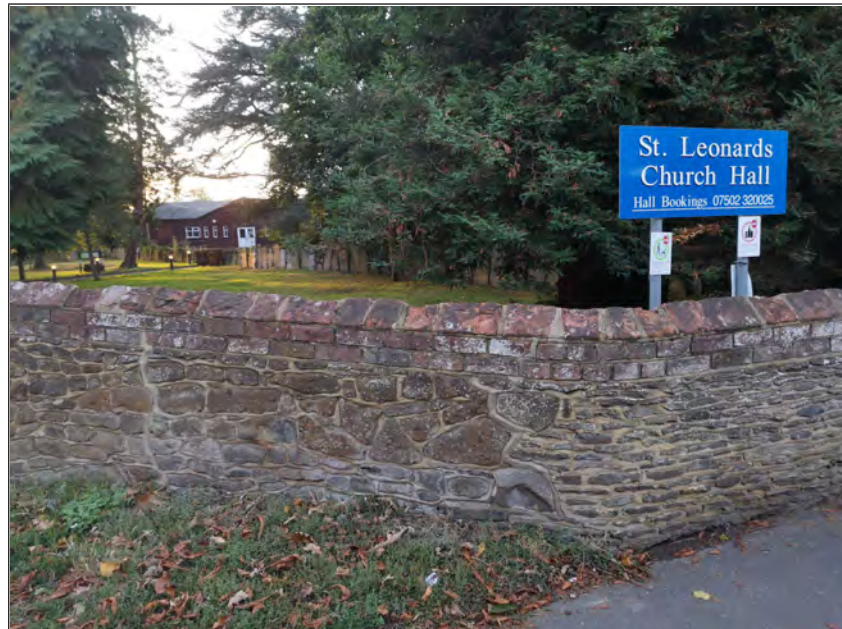
**Condition** ☐ Good ☒ Reasonable ☐ Poor ☐ At Risk ☐ Not seen close

**Notes** Sections repaired in polygonal rubble.

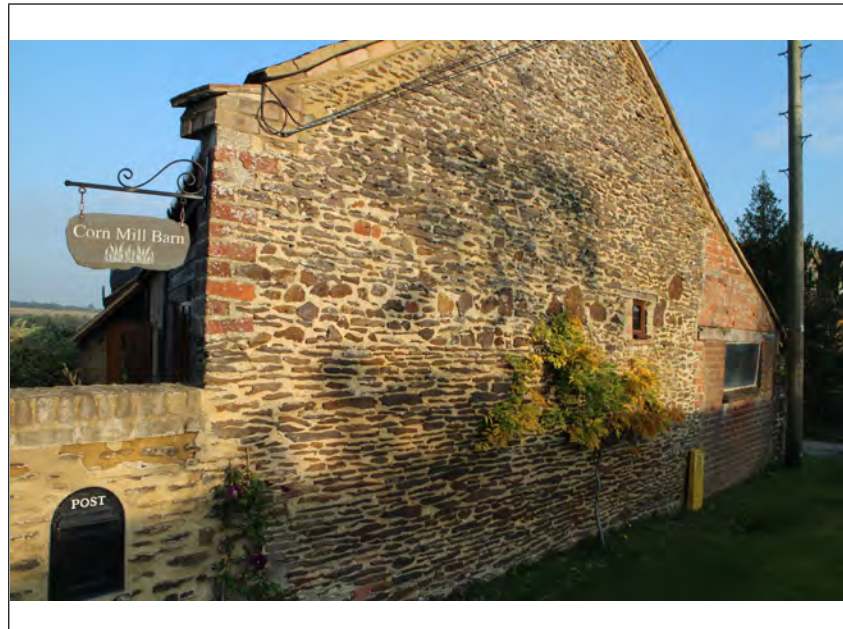
**Condition** ☐ Good ☐ Reasonable ☒ Poor ☐ At Risk ☐ Not seen close

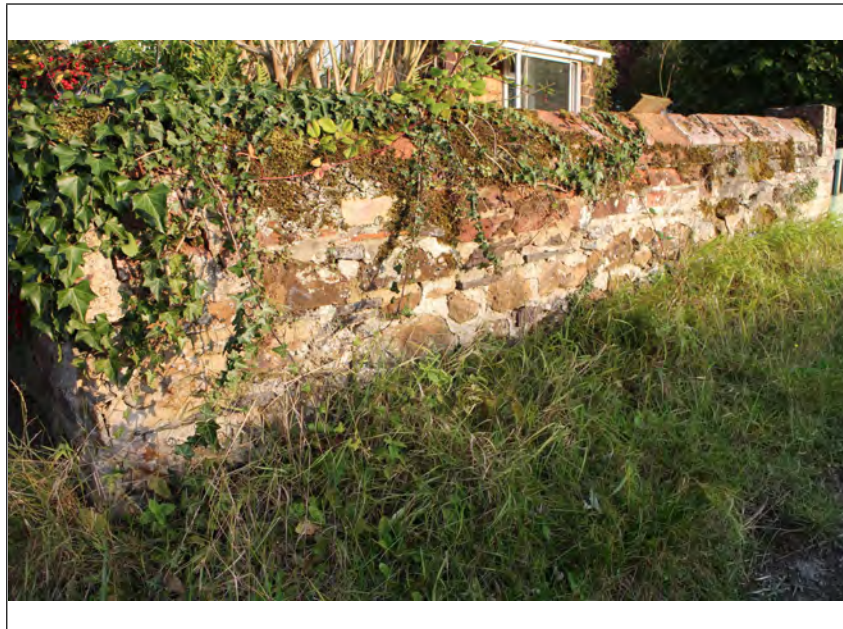
**Condition** ☐ Good ☒ Reasonable ☐ Poor ☐ At Risk ☐ Not seen close

**Notes** Verging on poor.

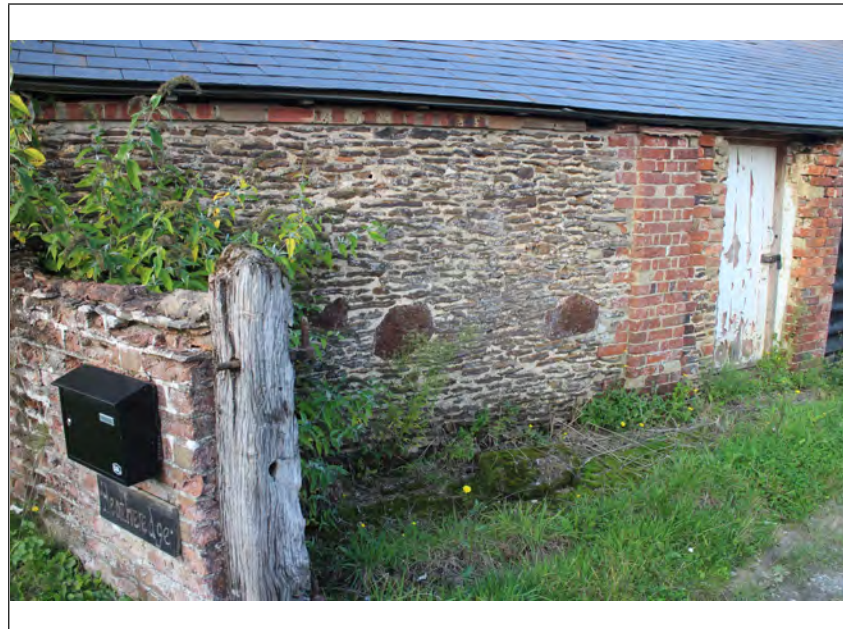
**Condition** ☐ Good ☐ Reasonable ☐ Poor ☒ At Risk ☐ Not seen close

**Notes** Parlous state. Potential project.  
2021 - most of the farm buildings have recently been converted to housing

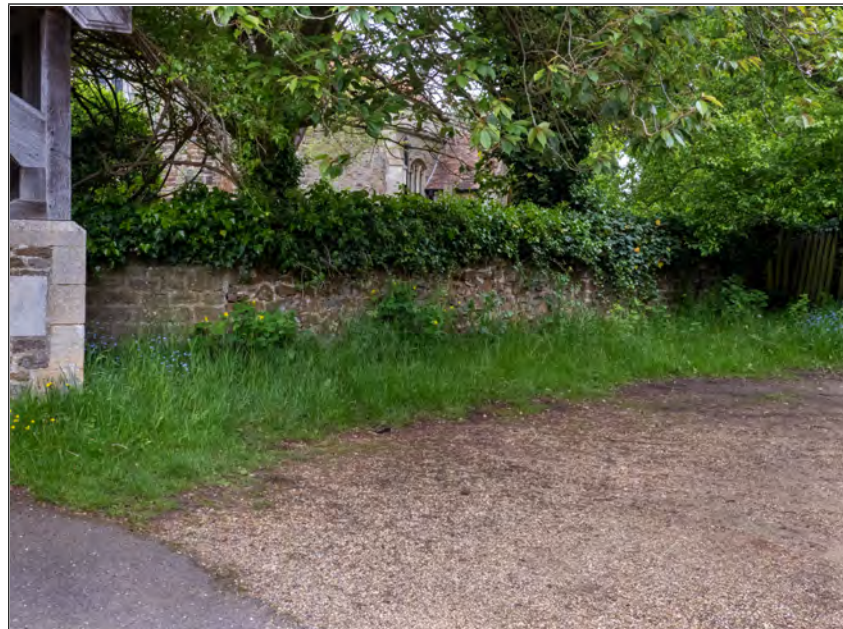
**Condition** ☐ Good ☒ Reasonable ☐ Poor ☐ At Risk ☐ Not seen close

**Notes** Cloaked in ivy (benign) + contiguous with wing wall to Lychgate

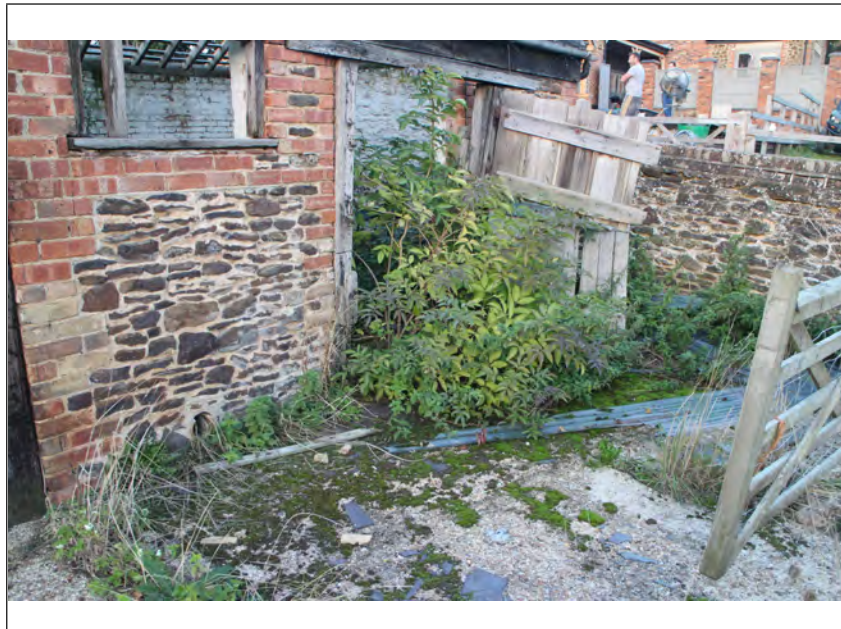
**Notes** Semi-derelict.

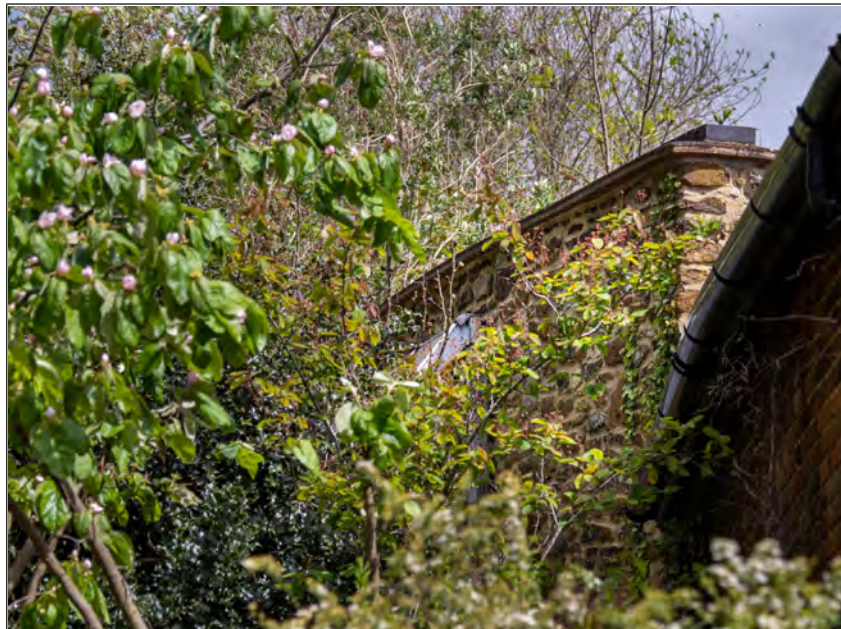
**Condition** ☐ Good ☐ Reasonable ☒ Poor ☐ At Risk ☐ Not seen close

**Notes** Wall between garden of now separated Court House and abandoned Warren Farm.

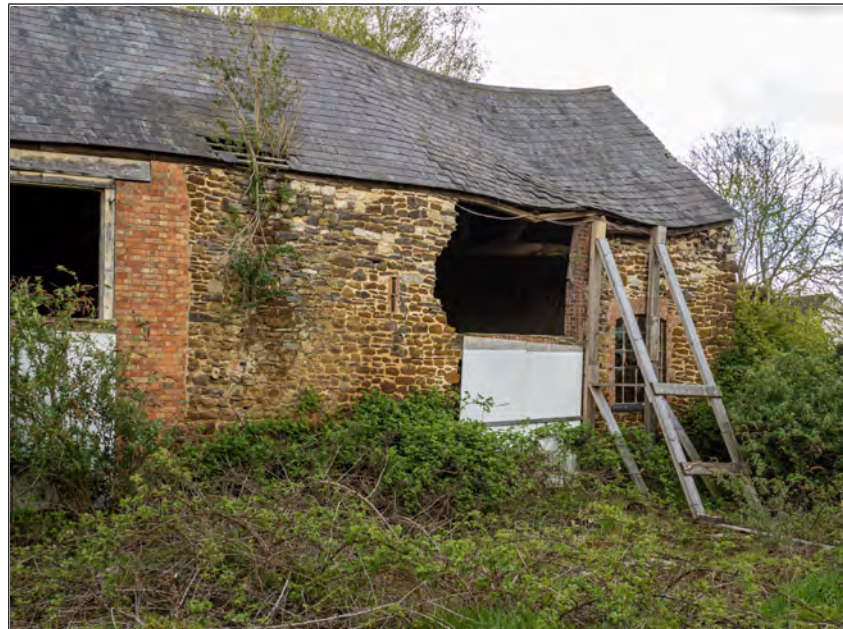
**Condition** ☐ Good ☐ Reasonable ☐ Poor ☒ At Risk ☐ Not seen close

**Notes** Barn, part of abandoned Warren Farm. Very poor and deteriorating with some stonework collapsed.

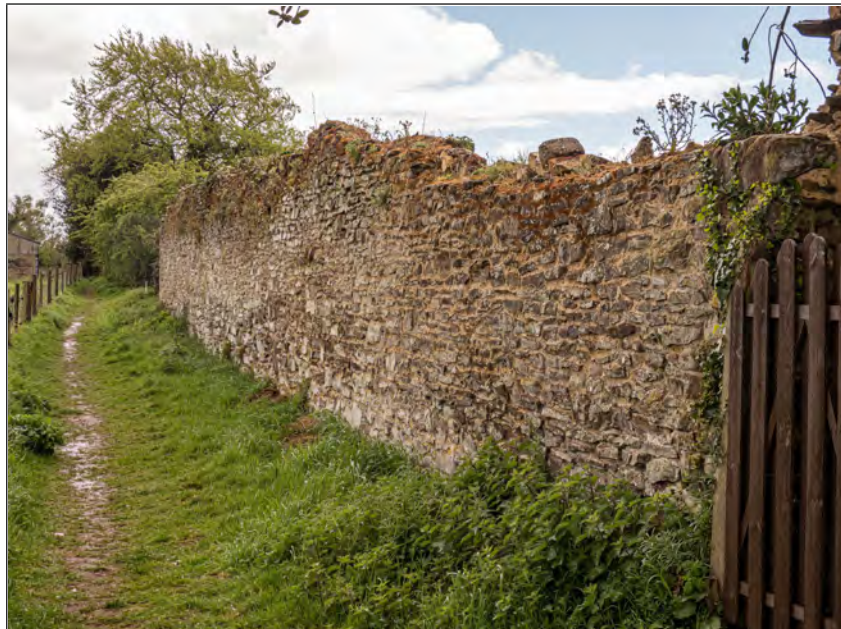
**Condition** ☐ Good ☐ Reasonable ☒ Poor ☐ At Risk ☐ Not seen close

**Notes** Substantial wall to top of field. Contiguous with wall to east (LBR-012).

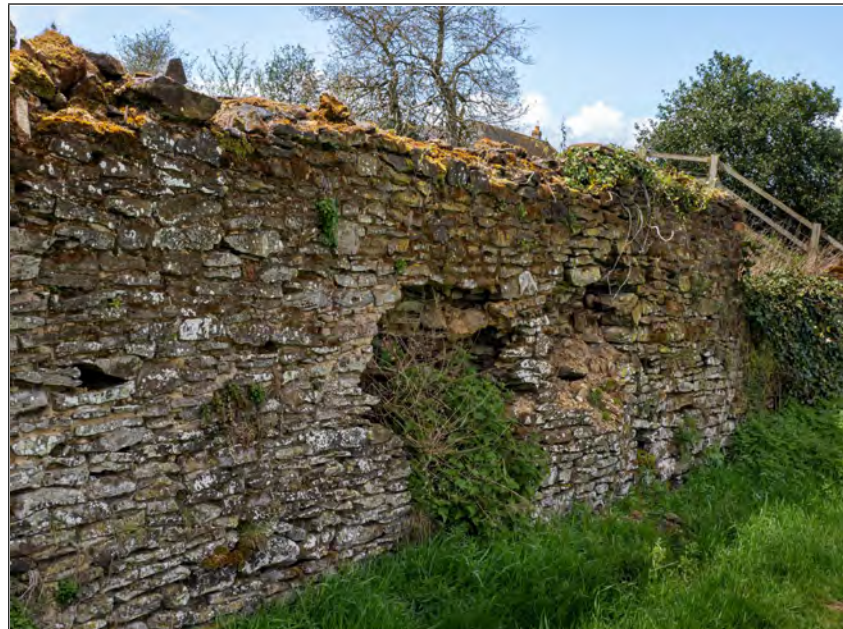
**Condition** ☐ Good ☐ Reasonable ☒ Poor ☐ At Risk ☐ Not seen close

**Notes** Substantial wall to top of field. Contiguous with wall to west (LBR-011). Appears to have been part of a building, though nothing shown on old maps. Returns along eastern boundary (White Maples).

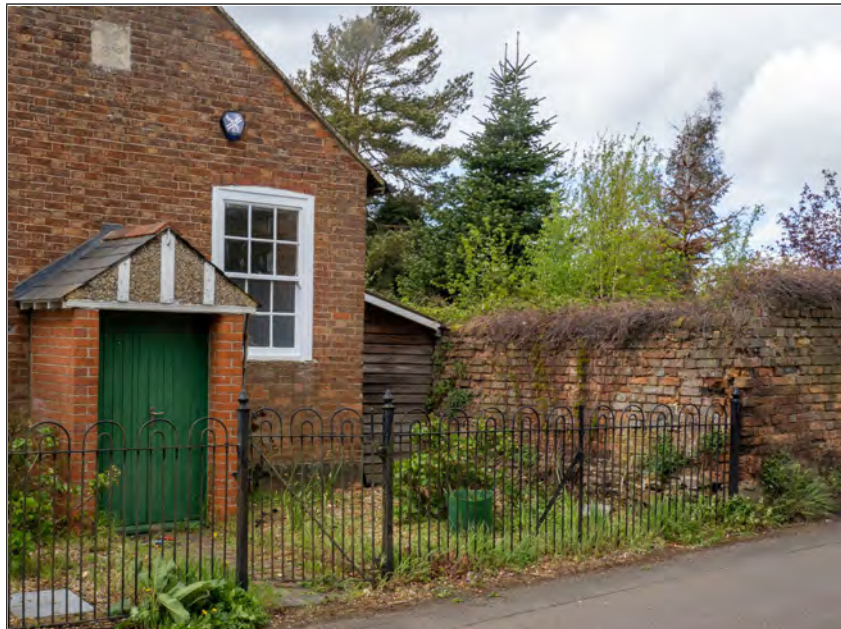
**Condition** ☐ Good ☐ Reasonable ☒ Poor ☐ At Risk ☐ Not seen close

**Notes** Adjacent former chapel to rear of Rothbury (on Great Brickhill Lane).

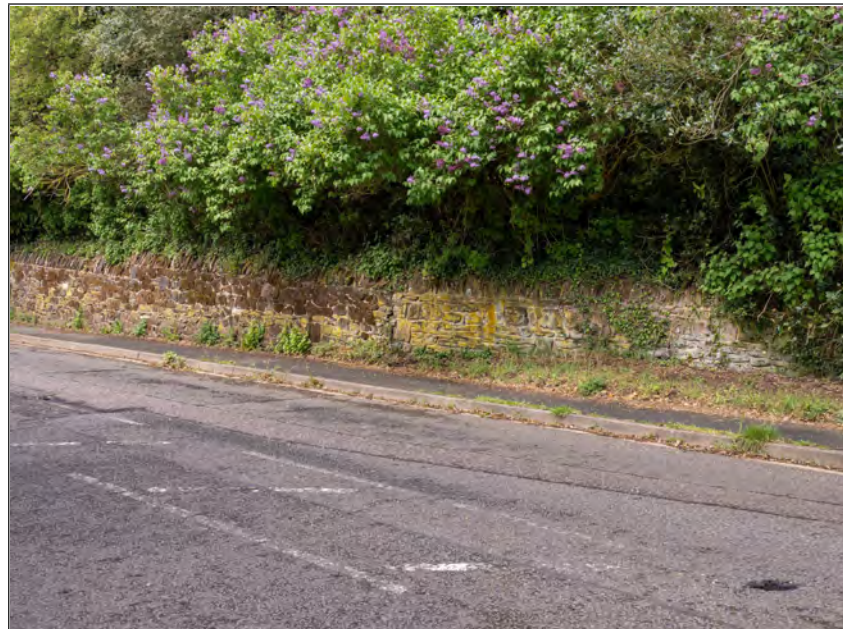
**Condition** ☐ Good ☒ Reasonable ☐ Poor ☐ At Risk ☐ Not seen close

**Notes** On south side of churchyard (Watling Street). Contiguous with wall to Church (LBR -025). Eastern end in older random rubble brought to courses; suggests greater part of wall has been rebuilt.

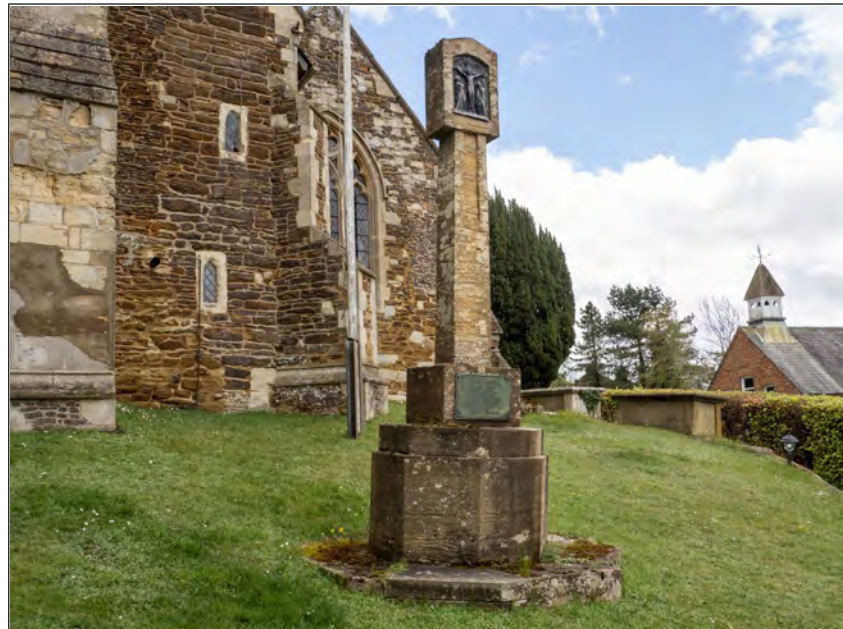
**Condition** ☐ Good ☒ Reasonable ☐ Poor ☐ At Risk ☐ Not seen close

**Notes** Although looks like sandstone (bedding planes on shaft are distinctive), it's possible that the memorial is an imported iron-rich limestone, e.g. Cotswold stone.

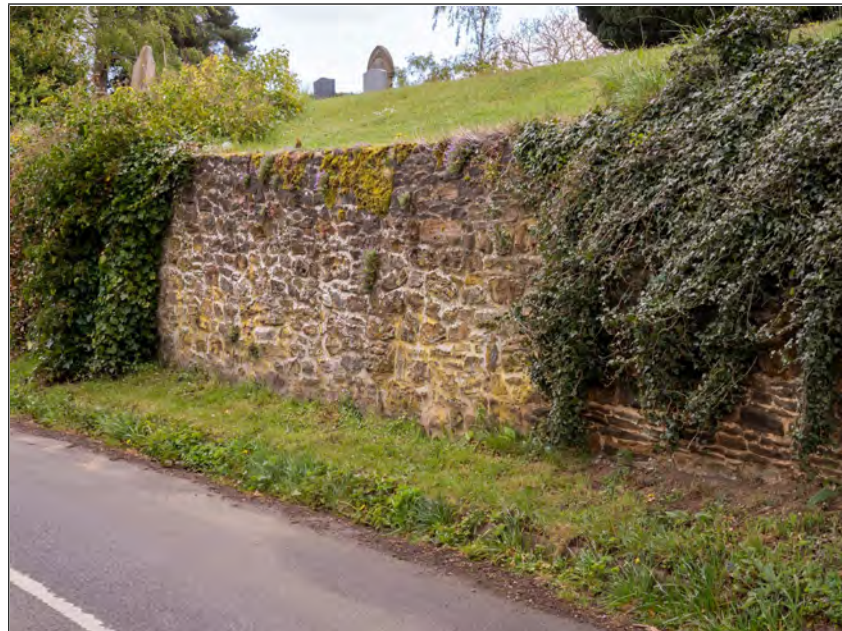
**Condition** ☐ Good ☒ Reasonable ☐ Poor ☐ At Risk ☐ Not seen close

**Notes** On west side of churchyard (Woburn Road). Repaired polygonal rubble.

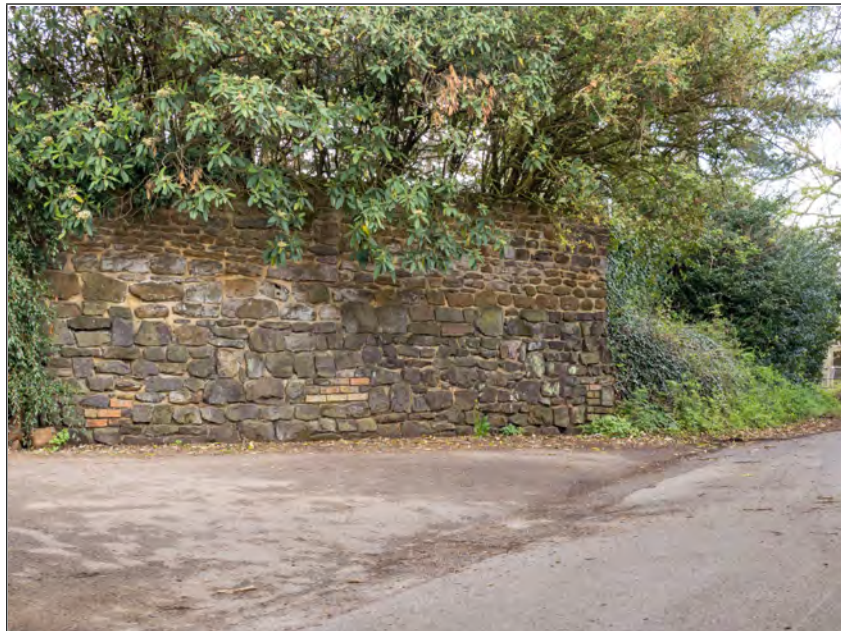
**Condition** ☐ Good ☒ Reasonable ☐ Poor ☐ At Risk ☐ Not seen close

**Notes** Driveway wall. Repairs in polygonal rubble.30/01/201630/01/2016
