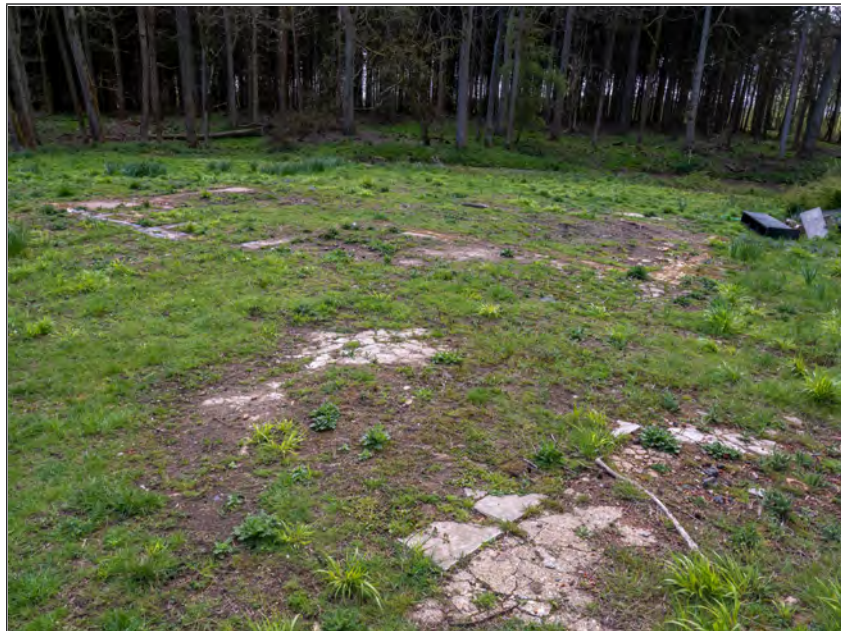
**Condition** ☐ Good ☐ Reasonable ☐ Poor ☒ At Risk ☐ Not seen close

**Notes** Thought to be remains of Buttermilk Farmhouse. Overgrown ruin in very poor condition. Potential Project.

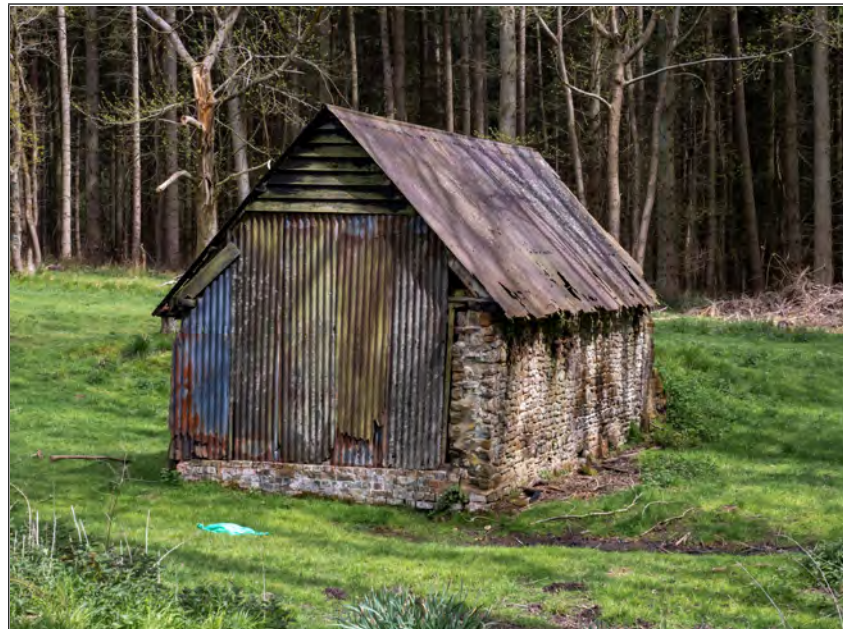
**Condition** ☐ Good ☐ Reasonable ☐ Poor ☒ At Risk ☐ Not seen close

**Notes** Cart shed or animal shelter. Roofed in corrugated iron (wall heads protected) though ruinous. Potential Project.

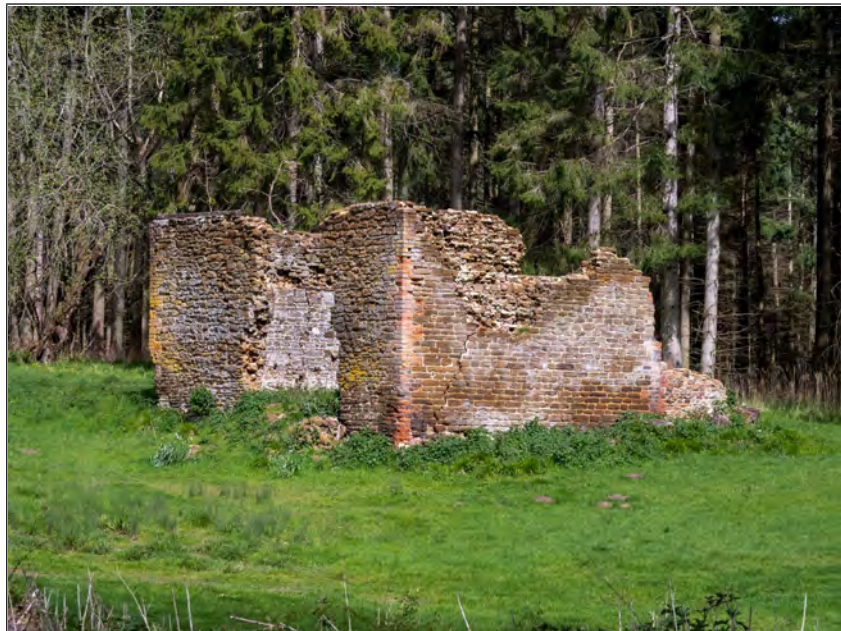
**Condition** ☐ Good ☐ Reasonable ☐ Poor ☒ At Risk ☐ Not seen close

**Notes** Cow house or stable. Actually a mix of squared and random rubble. Parlous state and near collapse. Potential Project.

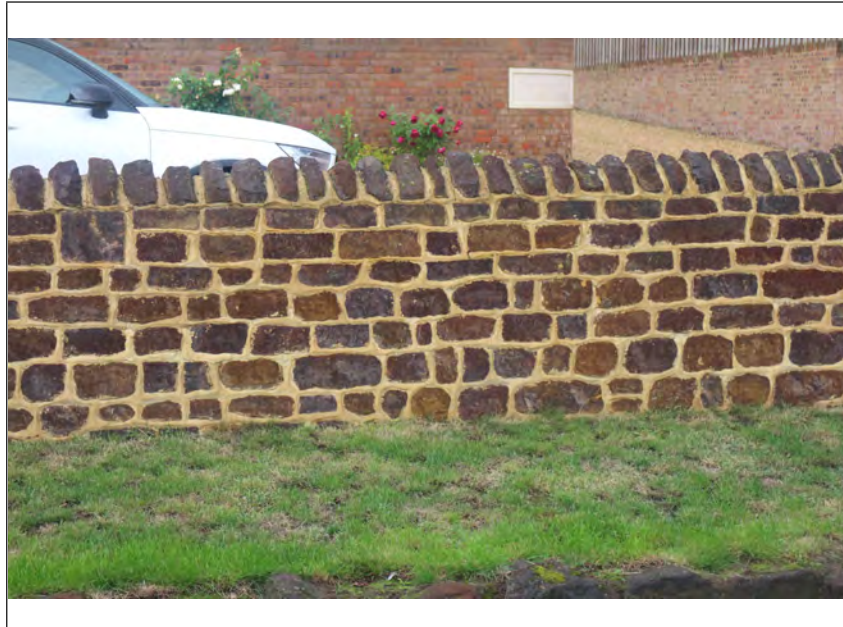
**Condition** ☒ Good ☐ Reasonable ☐ Poor ☐ At Risk ☐ Not seen close

**Notes** Recent build. More cement mortar than visible sandstone.

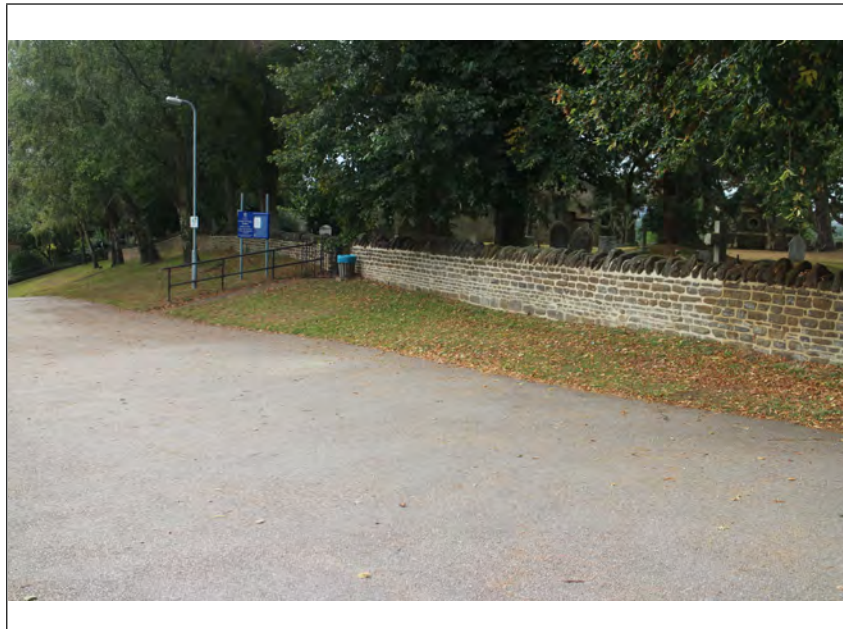
**Condition** ☐ Good ☒ Reasonable ☐ Poor ☐ At Risk ☐ Not seen close

**Notes** Long wall, part covered in ivy. Condition variable. Potential project.

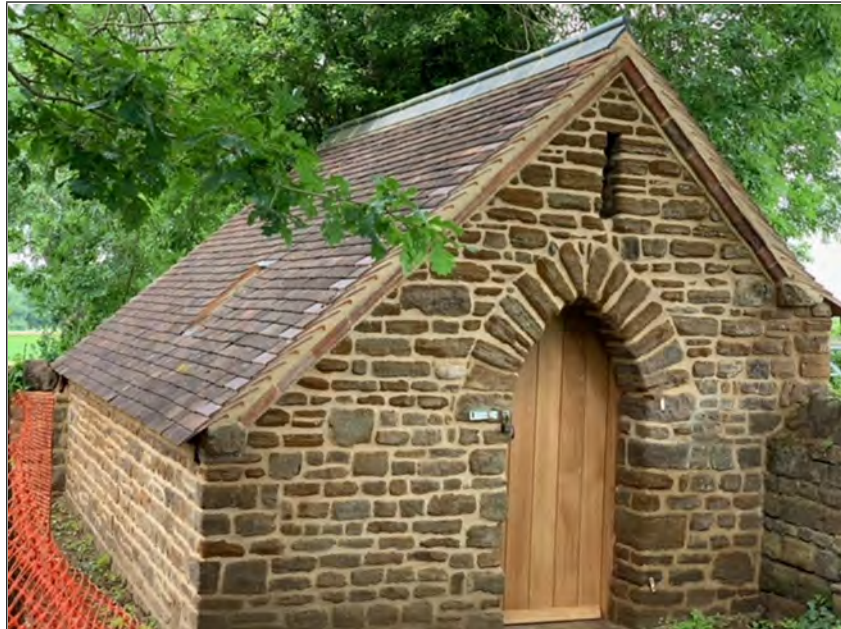
**Condition** ☐ Good ☐ Reasonable ☐ Poor ☒ At Risk ☐ Not seen close

**Notes** Part of listing of church (curtilage structure). Possible project.

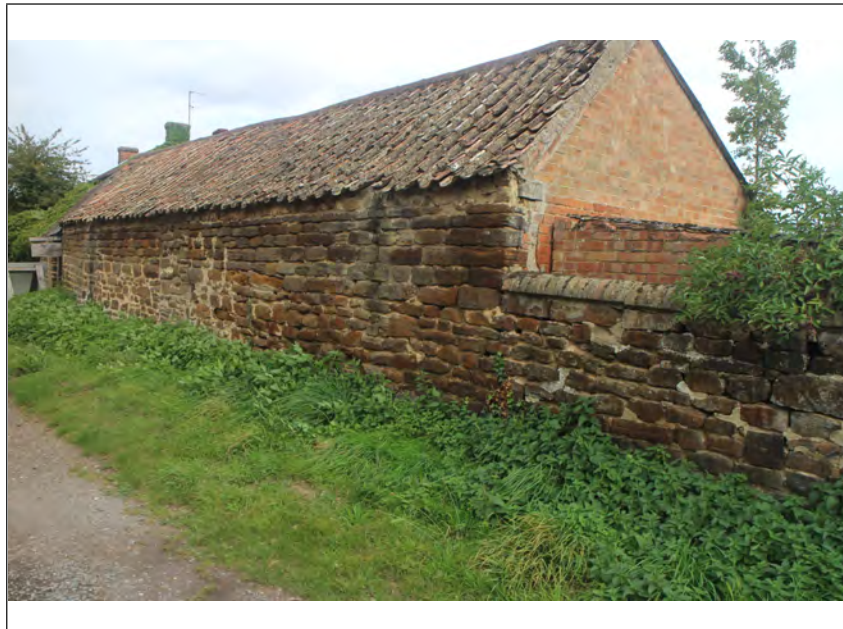
**Condition** ☐ Good ☒ Reasonable ☐ Poor ☐ At Risk ☐ Not seen close

**Notes** Part of run of barns appears to have been recently re-roofed. Includes attached walls to north and south.

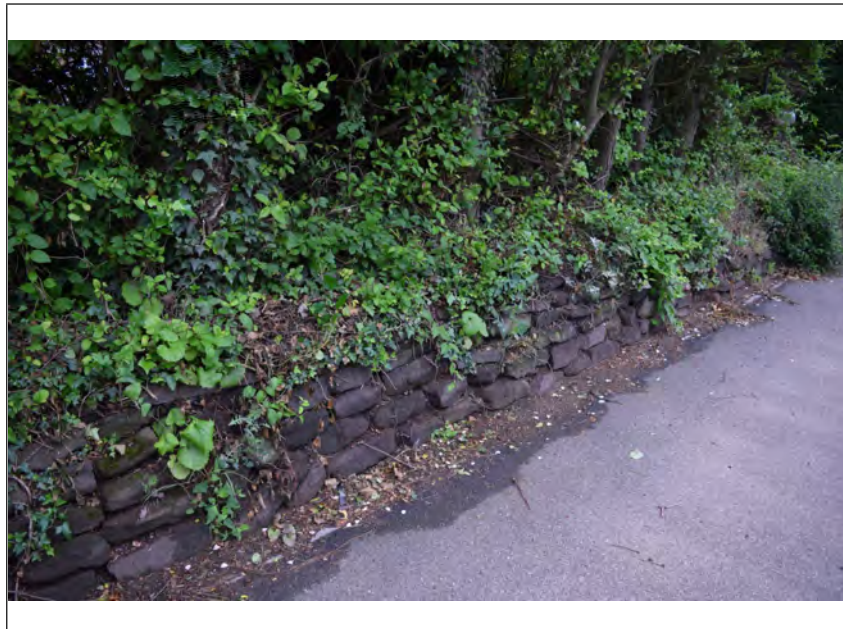
**Condition** ☐ Good ☒ Reasonable ☐ Poor ☐ At Risk ☐ Not seen close

**Notes** Wall covered in ivy. Appears reasonable.

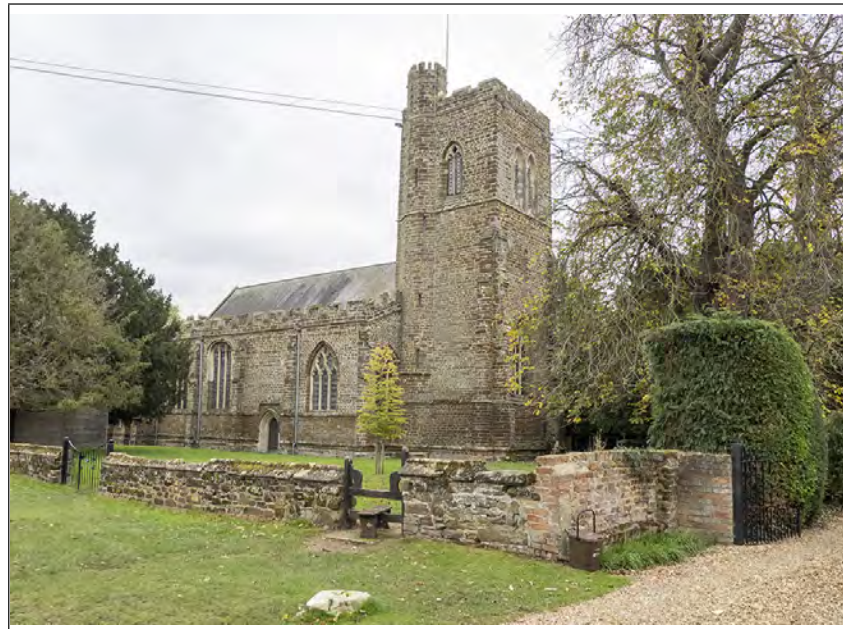
**Condition** ☐ Good ☒ Reasonable ☐ Poor ☐ At Risk ☐ Not seen close

**Notes** Some parts of wall verging on poor.

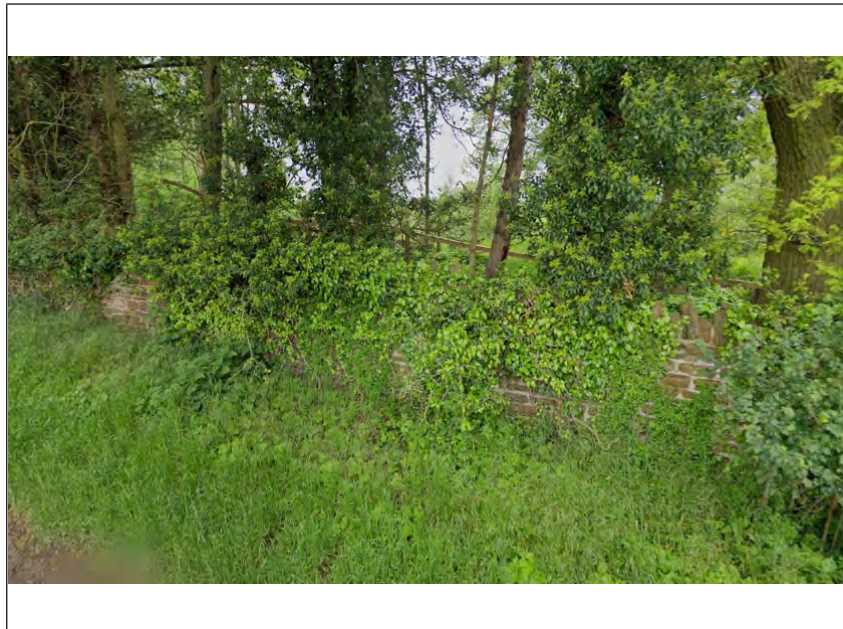
**Condition** ☐ Good ☐ Reasonable ☐ Poor ☒ At Risk ☐ Not seen close

**Notes** On edge of Old Warden Conservation Area + on junction between Ickwell and Old Warden Parks; probably part of the former. Very poor condition and in the main hidden by ivy.

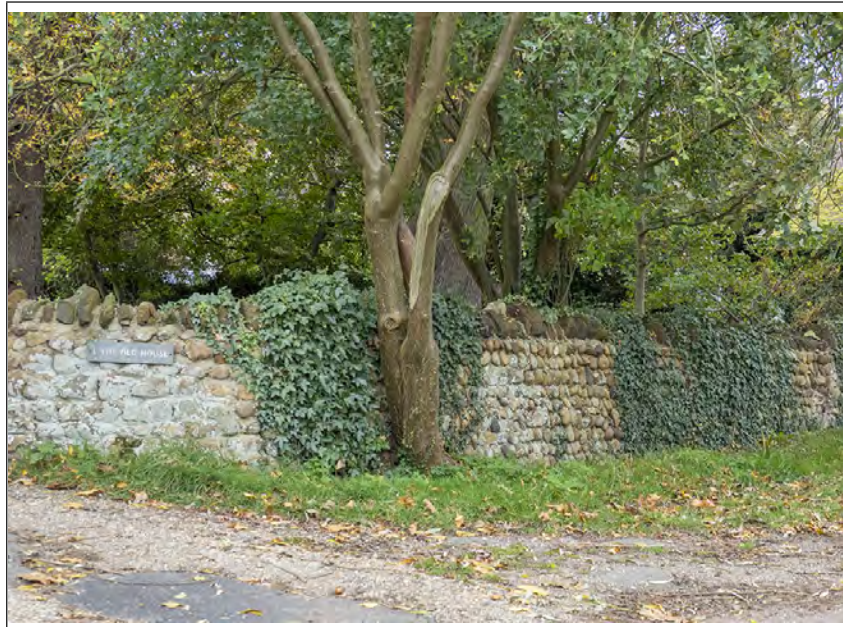
**Condition** ☐ Good ☐ Reasonable ☒ Poor ☐ At Risk ☐ Not seen close

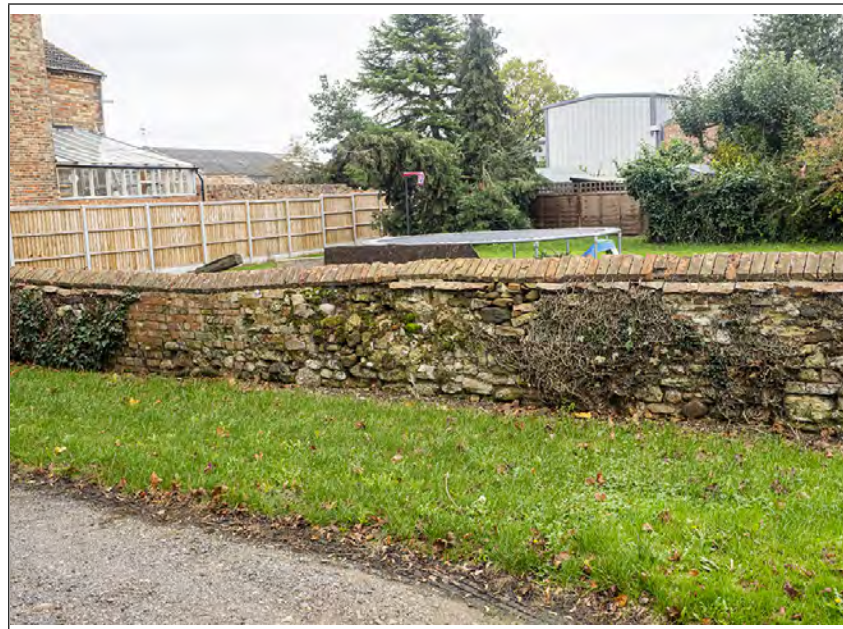
**Condition** ☐ Good ☐ Reasonable ☒ Poor ☐ At Risk ☐ Not seen close

**Notes** Brick piers+ some coping. On corner with Hitchin road so may be related to 27 Hitchin Road (unclear).

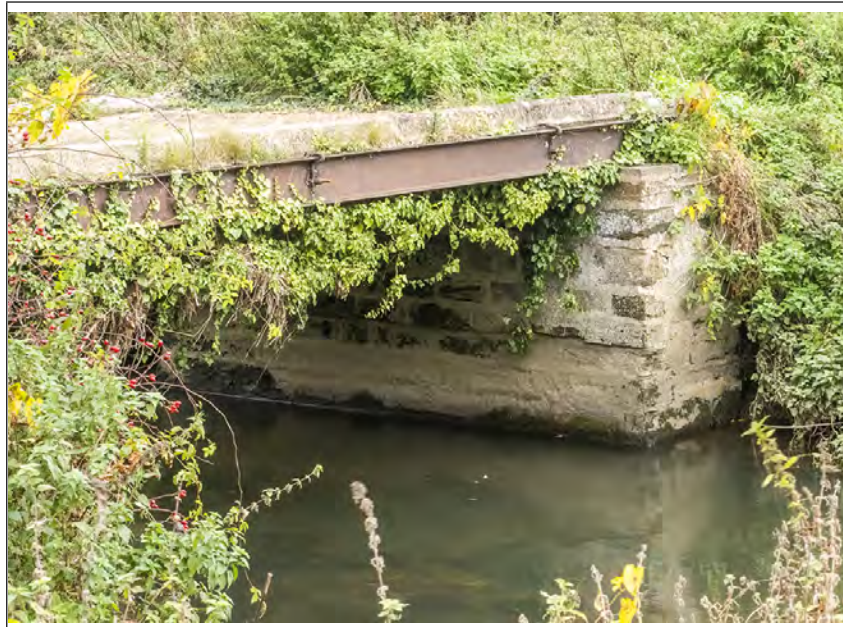
**Notes** Abutments of River Ivel Navigation bridge (or lock) now supporting metal bridge deck without parapets.

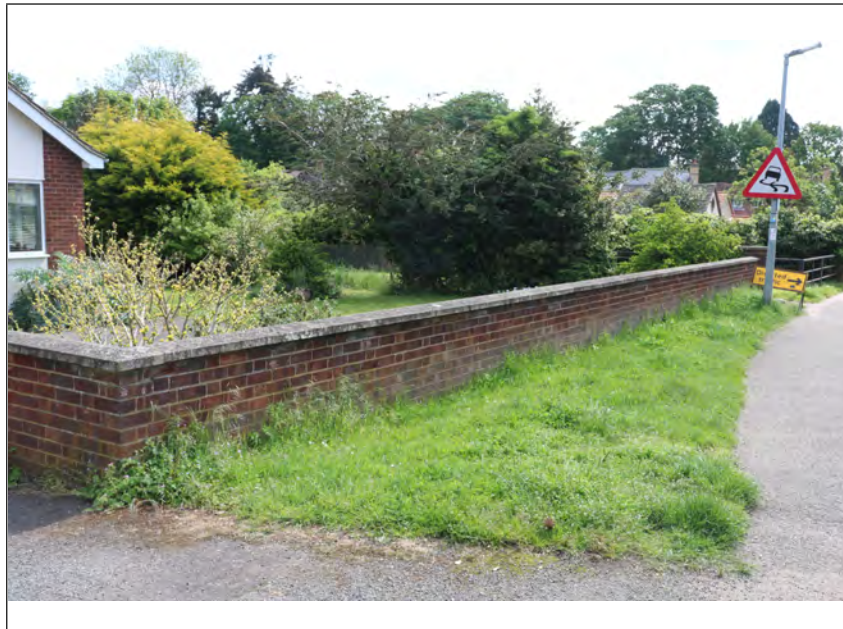
**Condition** ☐ Good ☐ Reasonable ☒ Poor ☐ At Risk ☐ Not seen close

**Notes** Some sandstone mixed in with brick and a variety of other materials in a hotchpotch of a wall.

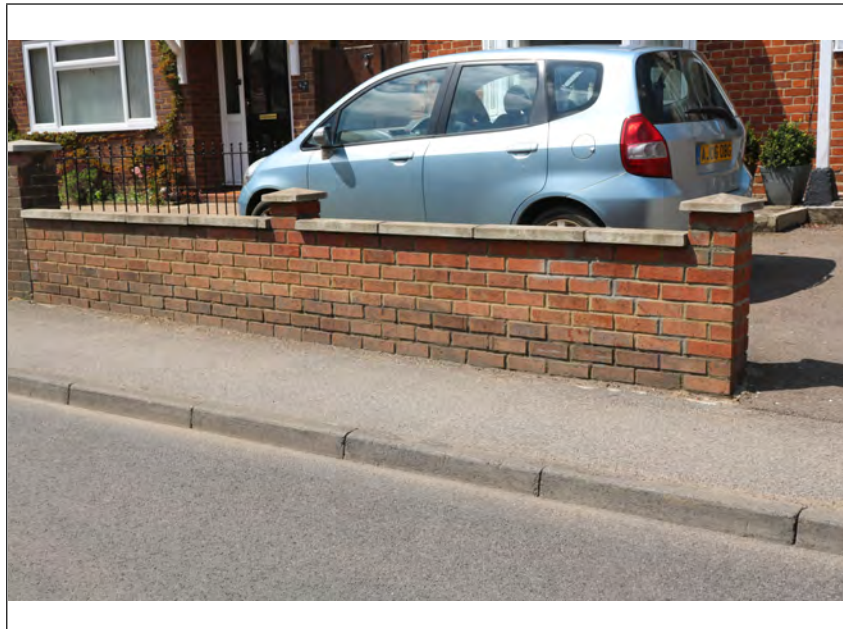
**Notes** Wall replace by brick. Extent of walling reduced since 2001 survey due to hard surfacing of front garden to provide car parking.

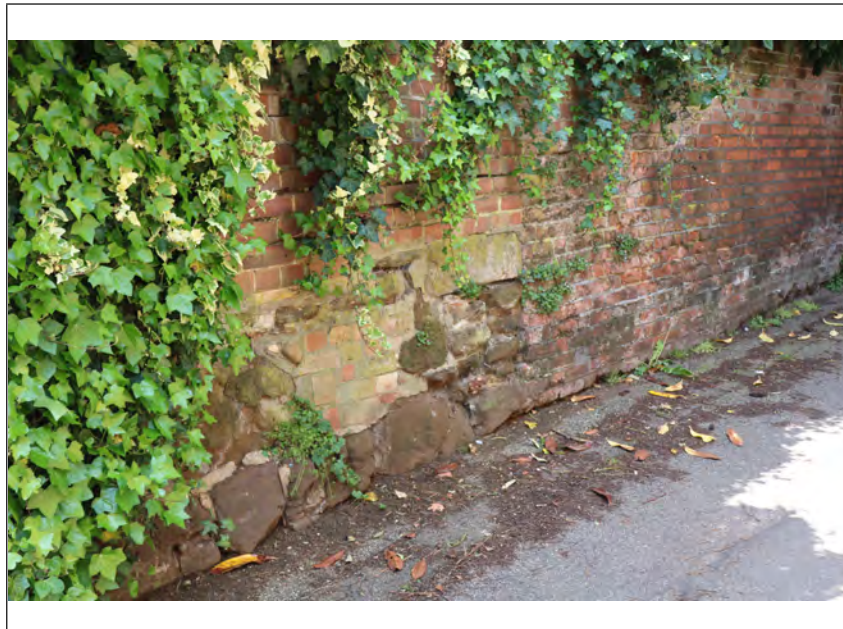
**Condition** ☐ Good ☐ Reasonable ☒ Poor ☐ At Risk ☐ Not seen close

**Notes** Runs alongside garden. Lower courses of wall only in sandstone; remainder in brick.

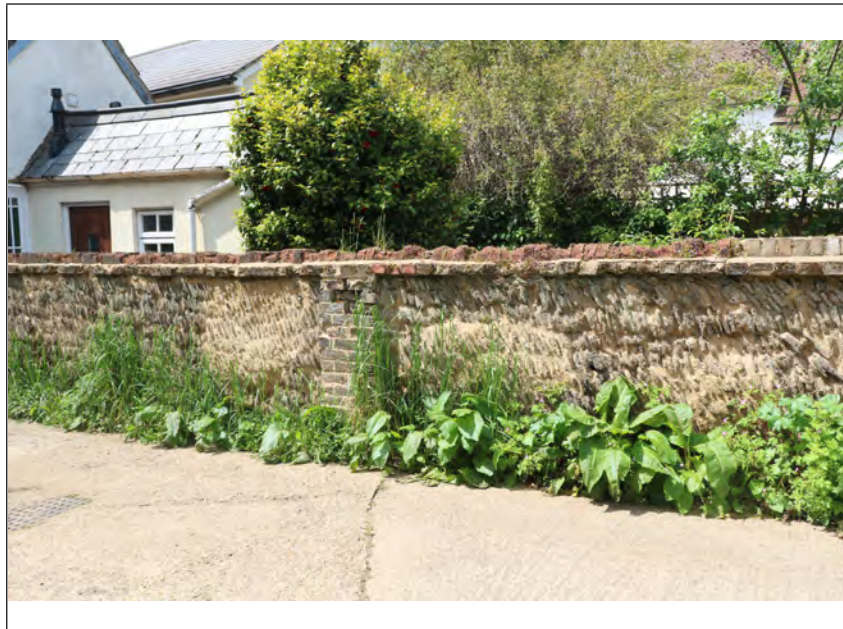
**Condition** ☐ Good ☐ Reasonable ☐ Poor ☒ At Risk ☐ Not seen close

**Notes** Potential project. Loss of stone means that wall is at risk from collapse if not maintained.

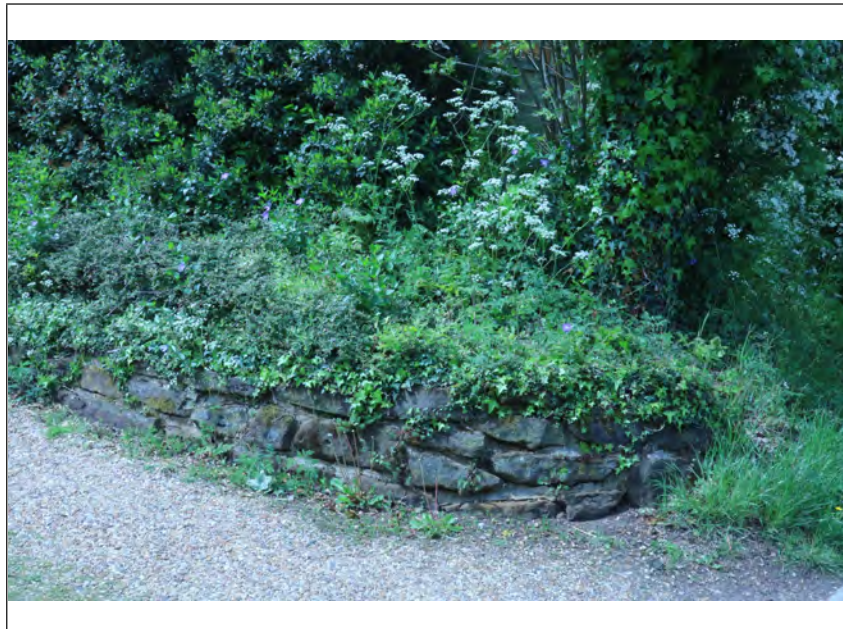
**Condition** ☐ Good ☒ Reasonable ☐ Poor ☐ At Risk ☐ Not seen close

**Notes** Retaining walls to banks at entrance to drive. Part obscured by vegetation.

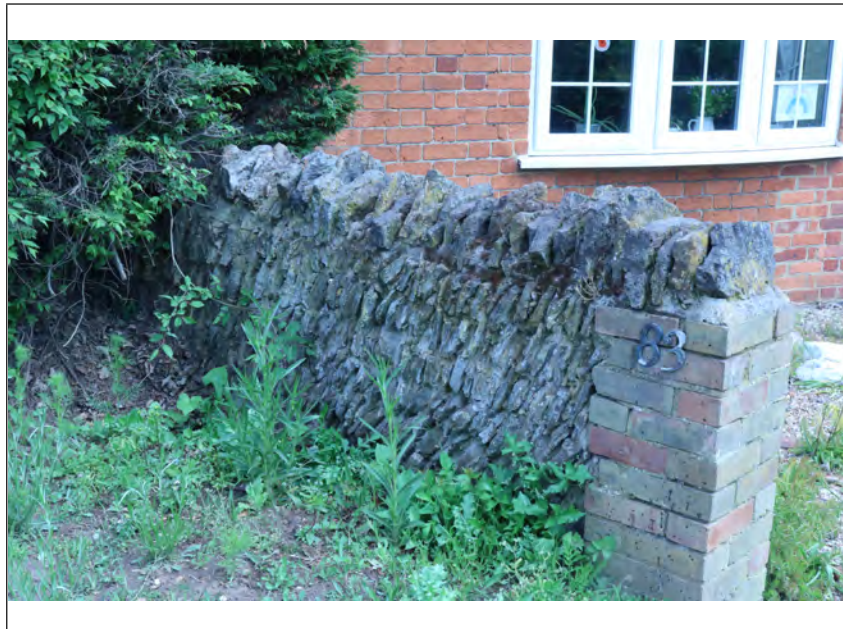
**Condition** ☐ Good ☒ Reasonable ☐ Poor ☐ At Risk ☐ Not seen close

**Notes** Truncated at southern end (vulnerable). Although isolated, an example of the rare herringbone (diagonal) walling which is unique to Potton and Sutton.

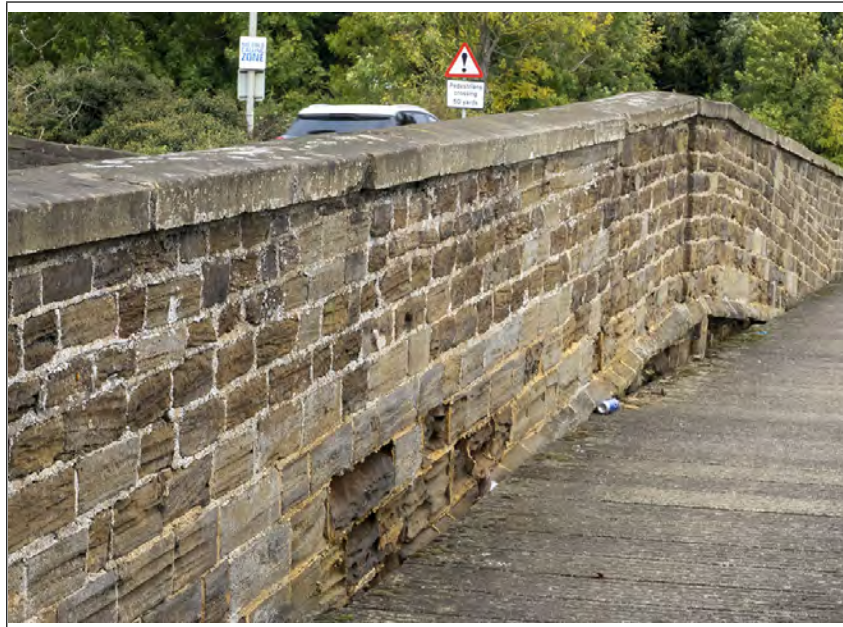
**Condition** ☐ Good ☐ Reasonable ☒ Poor ☐ At Risk ☐ Not seen close

**Notes** Includes parapet of side bridge to west (north side of A603, now garden wall to Ivel Cottage).

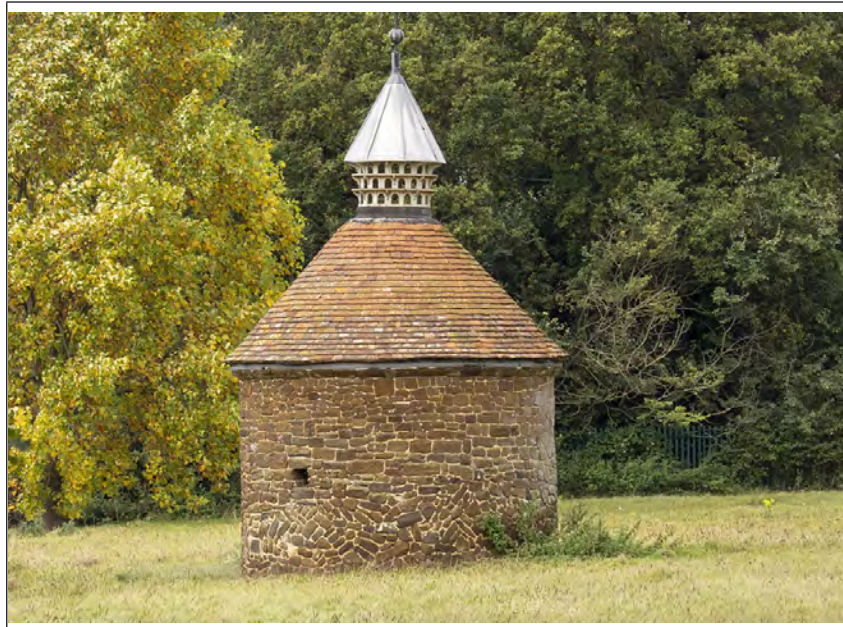
**Notes** Squared stonework is rough with some parts near base being of haphazardly laid random rubble.

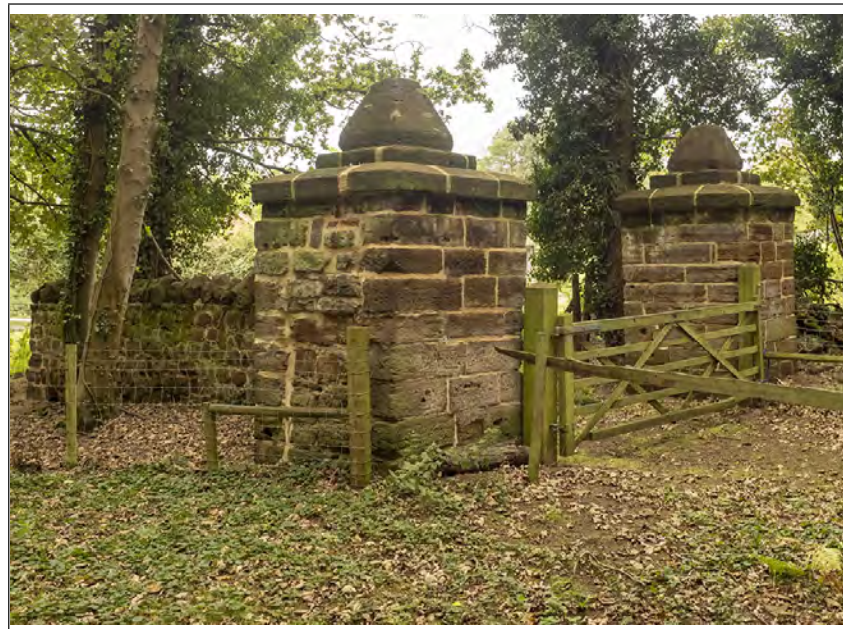
**Condition** ☐ Good ☐ Reasonable ☐ Poor ☒ At Risk ☐ Not seen close

**Notes** 2.8 km long fragmentary wall around RSPB site. Missing in some places, complete in others. Mix of walling types including squared rubble to gateposts though predominantly random brought to courses, though some polygonal also. Wall surrounds a listed building hence is part of designation. 20/01/2016. Potential project

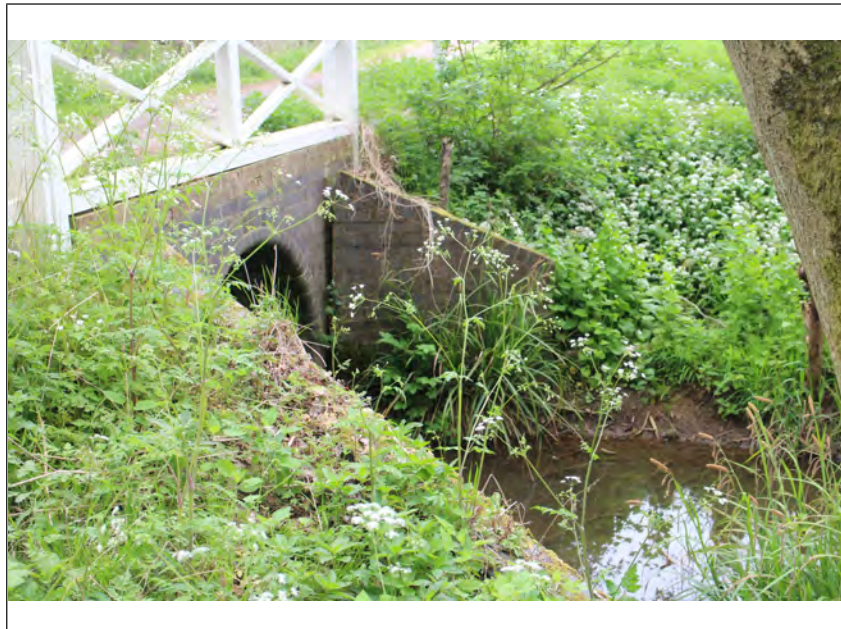
**Condition** ☐ Good ☐ Reasonable ☒ Poor ☐ At Risk ☐ Not seen close

**Notes** Abutments to 1820s standard level Navigation Bridge (iron deck in place). Carries track over stream. Legally, part of listing (within curtilage) of Gastlings Farmhouse 2022 - looks like been rebuilt in brick

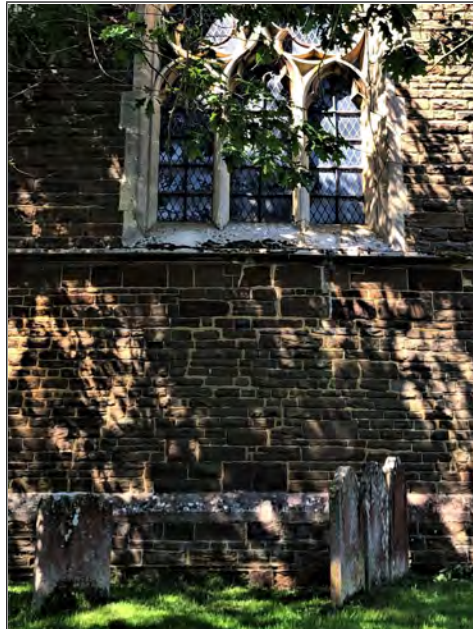
**Condition** ☐ Good ☒ Reasonable ☐ Poor ☐ At Risk ☐ Not seen close

**Notes** Some areas verging on poor condition. Potential project.

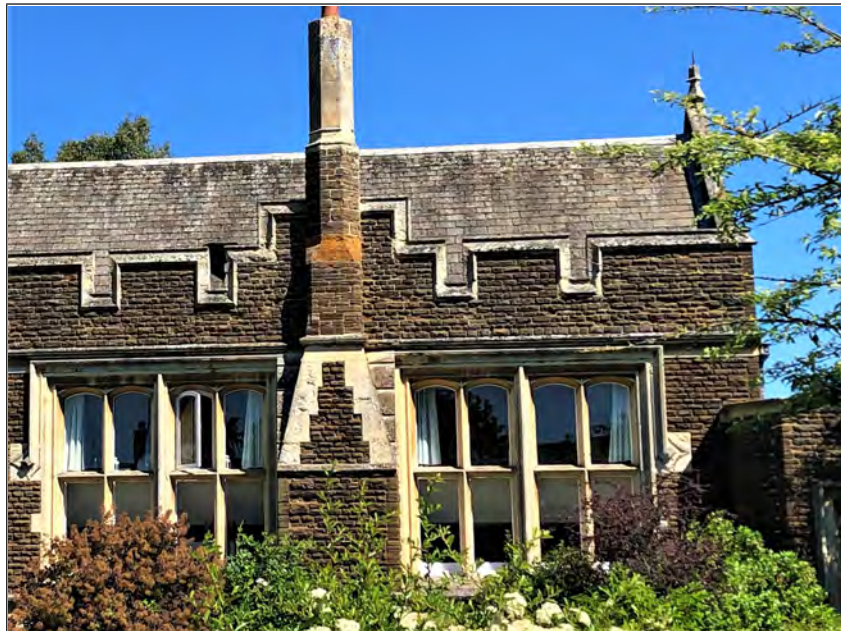
**Notes** Different construction from adjacent wall to The School House, suggesting a different build.

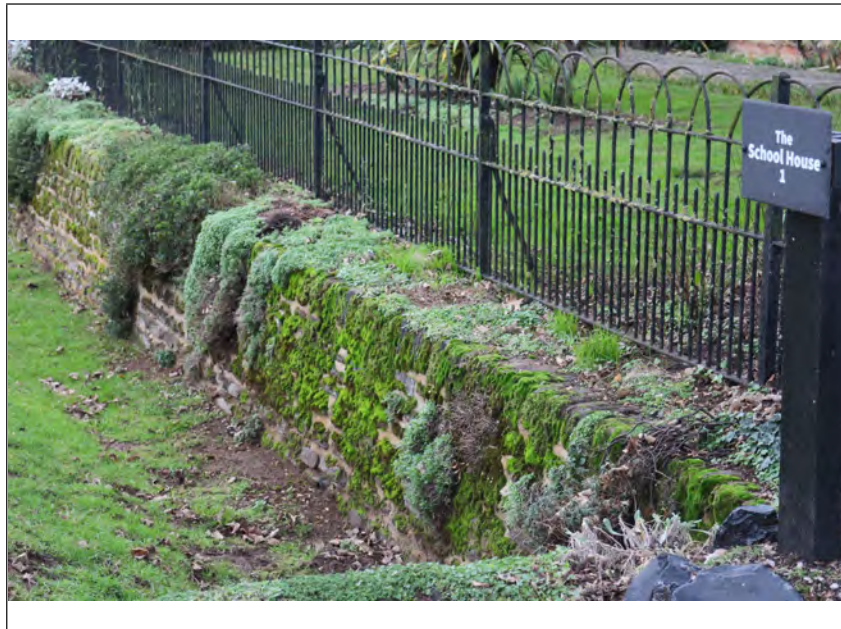
**Notes** Difficult to tell if stones are fully squared due to smeared mortar to face of wall.  
Different construction from adjacent wall to former School, suggesting a different build.

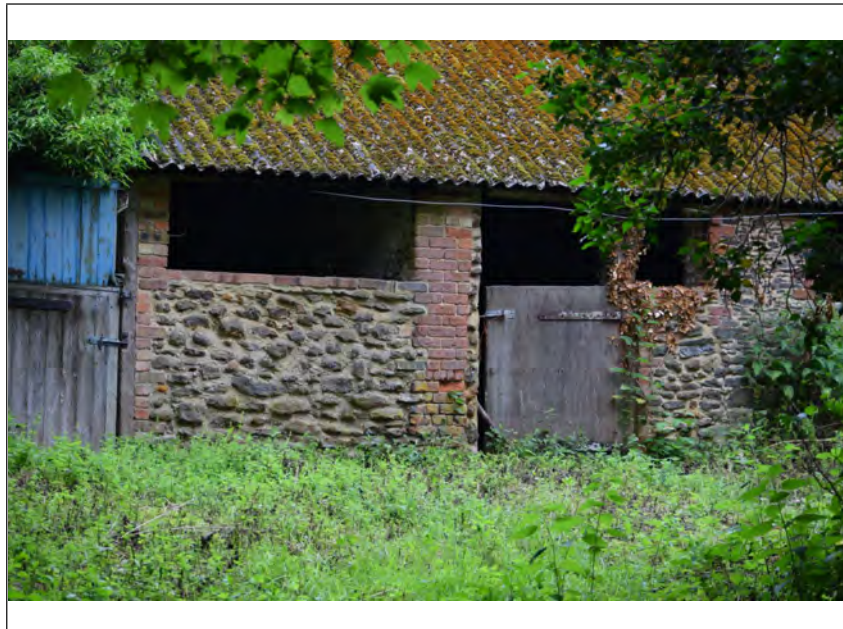
**Condition** ☐ Good ☒ Reasonable ☐ Poor ☐ At Risk ☐ Not seen close

**Notes** Farm building (open) though not sure which farm it is part of. Unused but reasonable condition. Panels of stonework between brick piers. Difficult to tell of walling is uncoursed or polygonal.

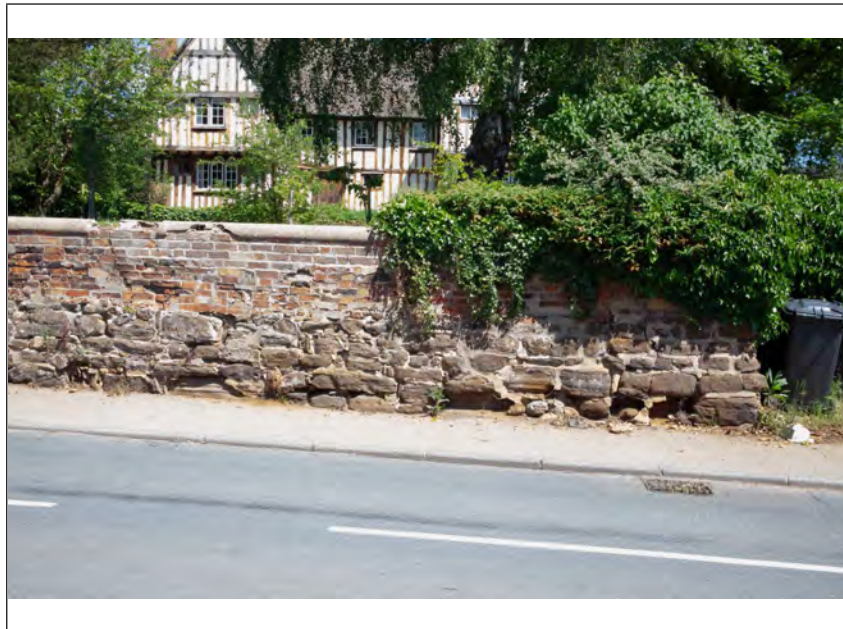
**Condition** ☐ Good ☒ Reasonable ☐ Poor ☐ At Risk ☐ Not seen close

**Notes** Much of the wall is brick. Limestone capping. Potential project

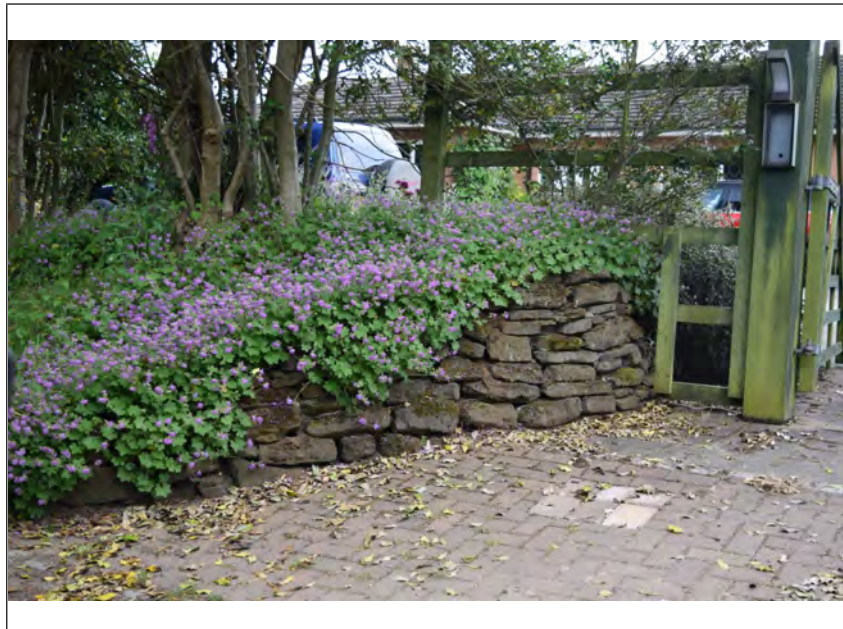
**Condition** ☐ Good ☐ Reasonable ☒ Poor ☐ At Risk ☐ Not seen close

**Notes** Patches of uncoursed rubble. On west and east sides of churchyard. Potential project.

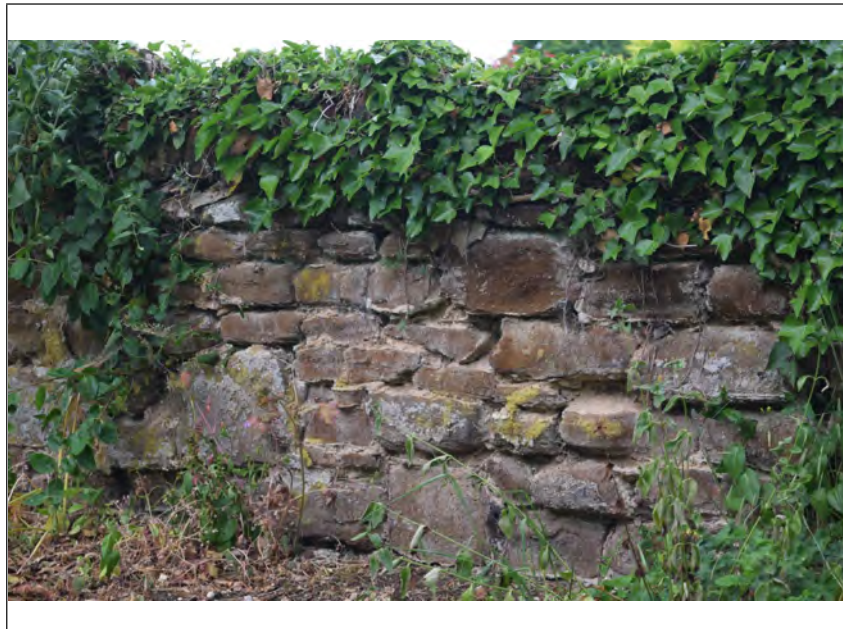
**Condition** ☐ Good ☒ Reasonable ☐ Poor ☐ At Risk ☐ Not seen close

**Notes** Obscured by ivy. Suspect condition under is in places poor. Contiguous with wall of Keeley House.

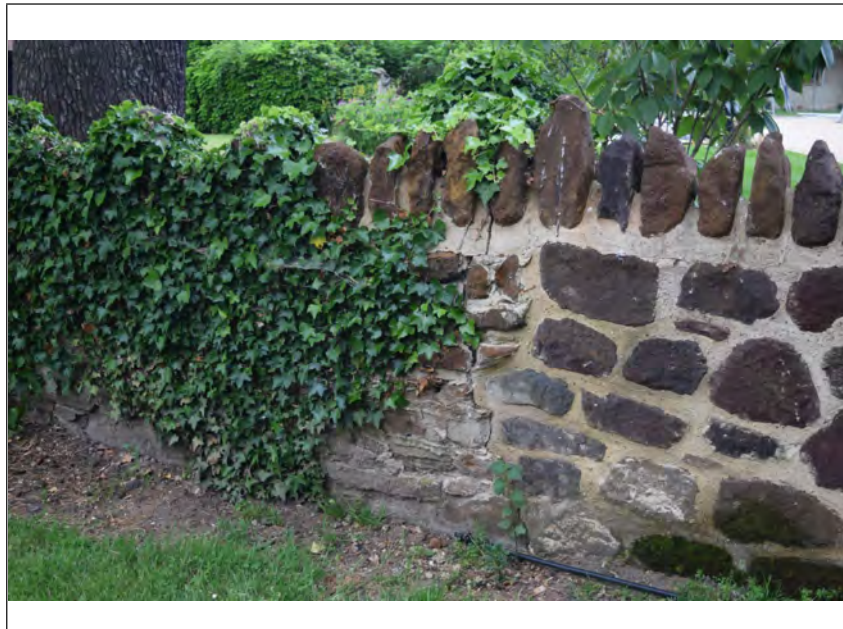
**Condition** ☐ Good ☒ Reasonable ☐ Poor ☐ At Risk ☐ Not seen close

**Notes** Obscured by ivy. Suspect condition under is in places poor. Contiguous with wall of Carisbrooke.

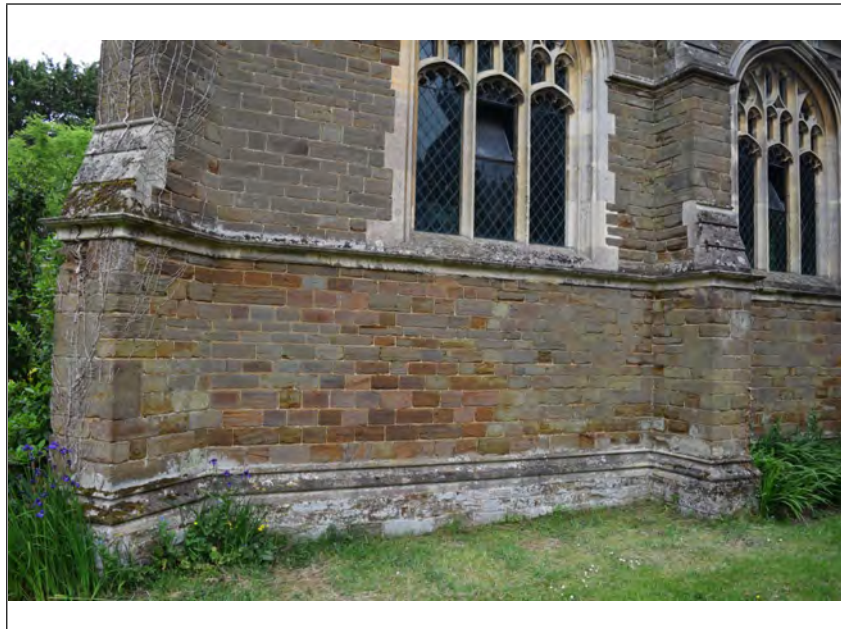
**Condition** ☐ Good ☒ Reasonable ☐ Poor ☐ At Risk ☐ Not seen close

**Notes** Limestone base course + coping. Potential project.

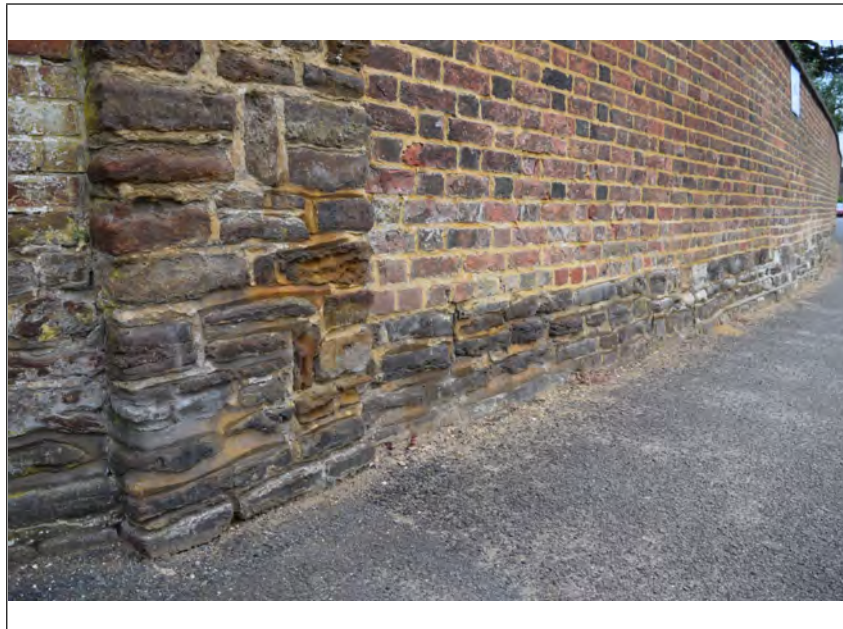
**Condition** ☐ Good ☐ Reasonable ☒ Poor ☐ At Risk ☐ Not seen close

**Notes** Base courses (only) of high brick wall.

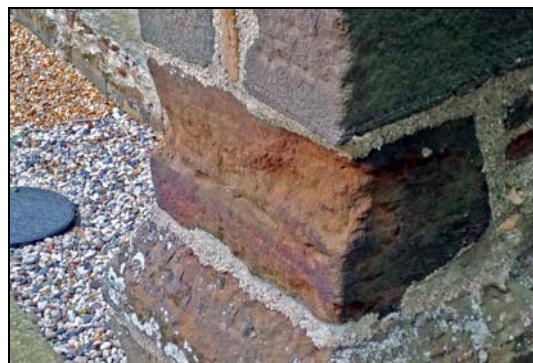
03.05: EROSION OF FRIABLE STONE

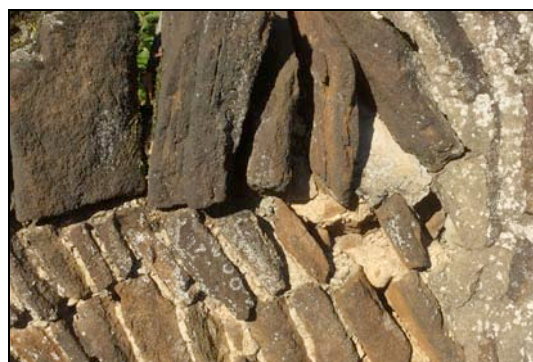
03.07: STONES BEDDED ON EDGE

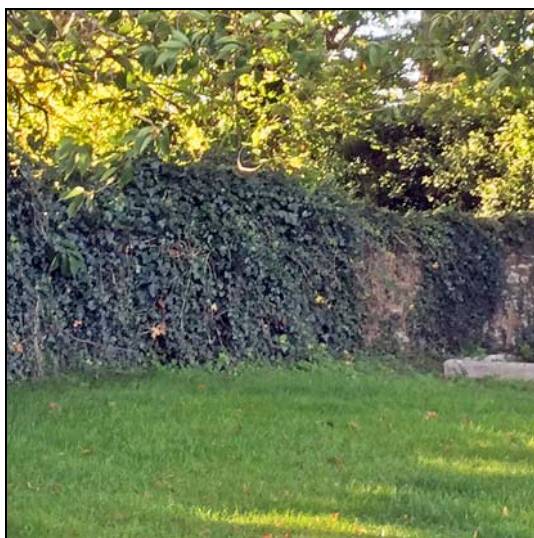
05.01: IVY-COVERED WALL

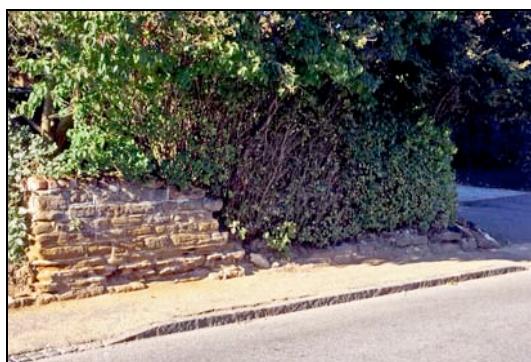
05.04: TOPPLED SANDSTONE WALL IN CLOPHILL HIGH STREET (ON RIGHT)

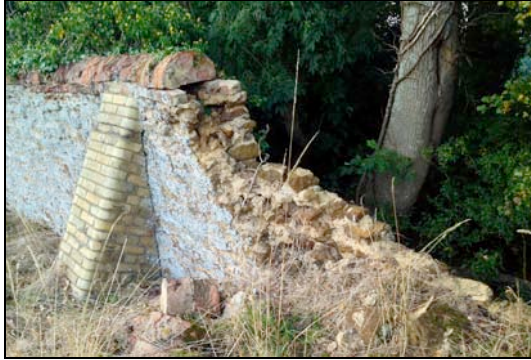
for stones to loosen and eventually become dislodged, leaving voids that make walls vulnerable to progressive collapse, as can be seen in the diagonally-laid wall alongside 6 Market Street in Potton and — an extreme example — much of the 2.8 km sandstone wall to the east, south and west of Sandy Warren (Lodge).

*05.05: TOTAL COLLAPSE OF WALL*

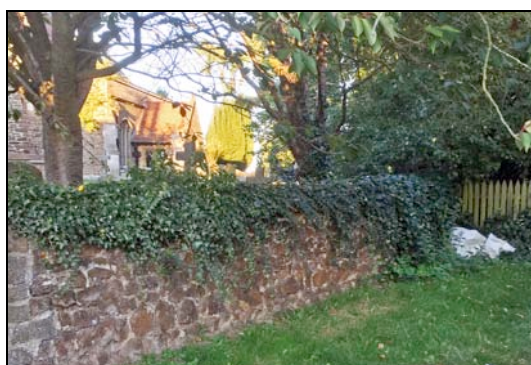
05.12: BENIGN, MANAGED VEGETATION

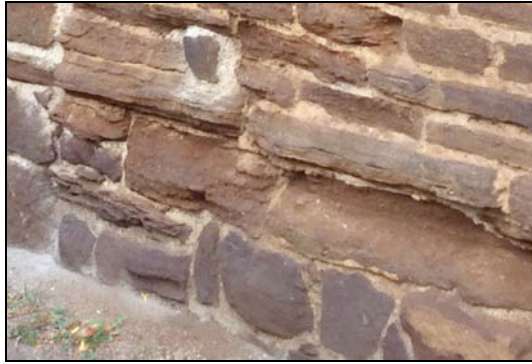
- 05.4.3 However, there is a significant problem with the accelerated decay of sandstone at low level alongside roads and pavements due to contamination by de-icing salts (sodium chloride), the impact of which is intensified by hard, impervious surfaces like asphalt adjacent. This is especially the case in Clophill where the bases of some walls on the High Street (57–59) are so deeply eroded as to risk eventual collapse. Similarly — though to a lesser extent — the long retaining wall running back from the High Street on the east side of Mill Lane (the boundary of Clophill House). It is instructive to compare these walls with the barn at Water End, where a grass verge controls contamination and splash-back, and the stone is in excellent condition.

05.13: SALT EROSION BESIDE ROAD

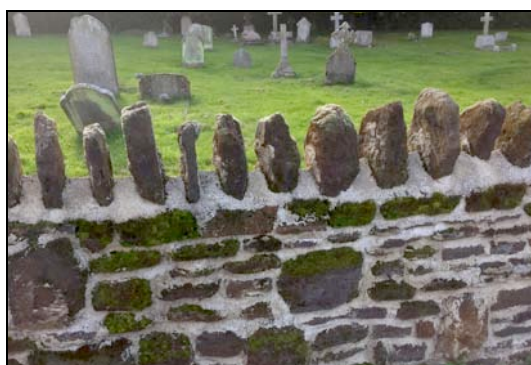
05.20: STRETCHED COPING STONES EXPOSING VULNERABLE MORTAR

- Reinstating missing or failed coping stones, and lifting and re-bedding those which are loose or poorly placed. Also repairs to other types of coping, e.g. brick or dressed stone.

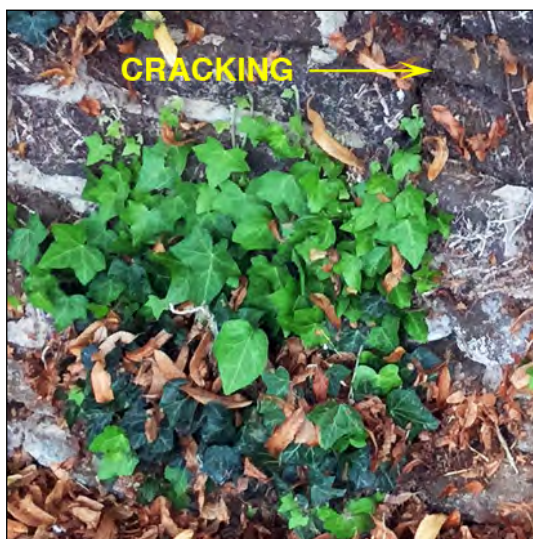
C.01: IVY PENETRATING JOINTS

- Removal of invasive vegetation that is causing damage to stonework, e.g. woody roots which are penetrating joints, and vegetation that needs to be cleared to carry out repairs.

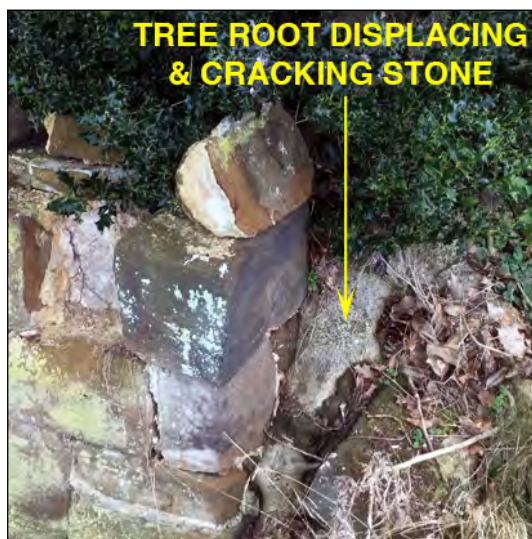
C.02: HOLLY TREE DAMAGING WALL

Attention should also be paid to self-sown trees and other shrubs which may encroach on the stonework and cause displacement or collapse.

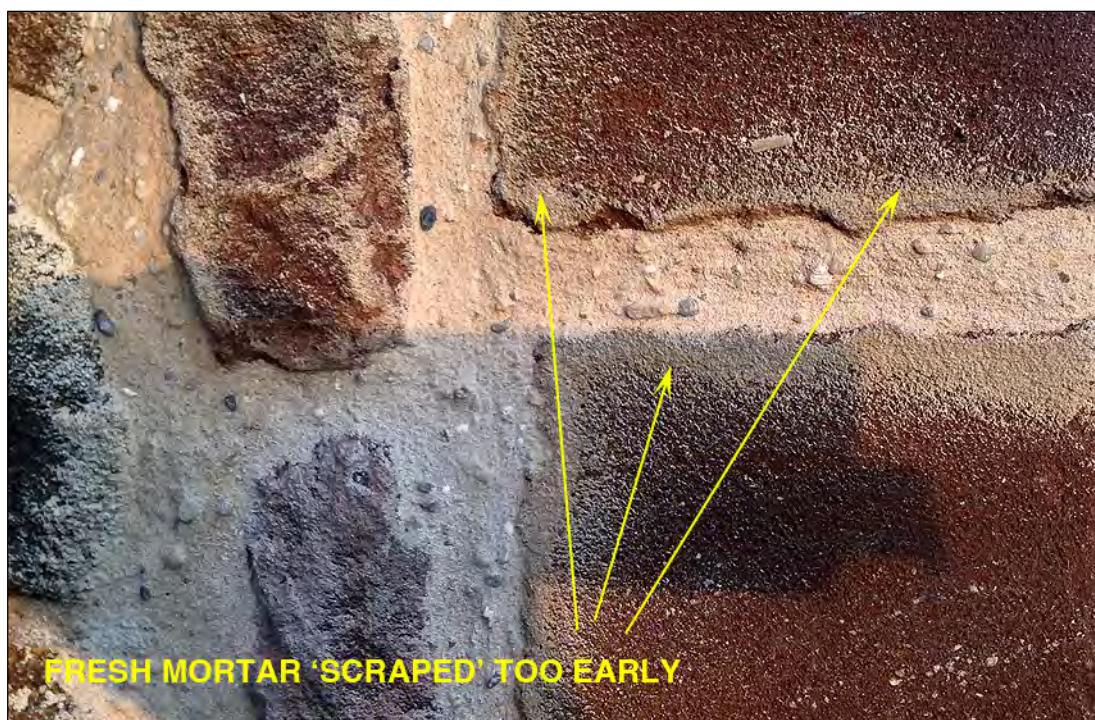
C.06: PERMANENT DISCOLOURATION OF STONEWORK DUE TO ATTEMPT TO REMOVE SURPLUS MORTAR WHILE PLACING (I.E. WHEN FRESH)

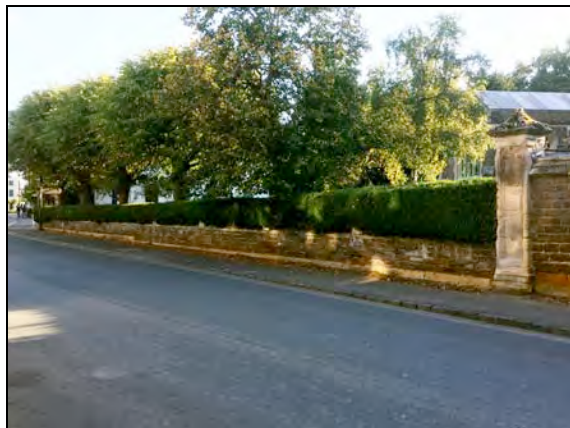
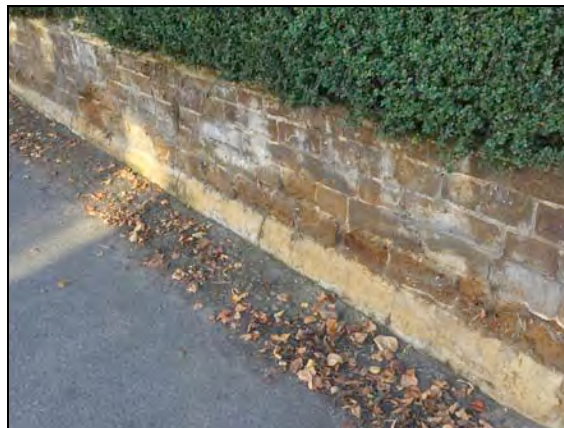
GRID REF: SP948332

Sporadic salt erosion to lower two courses + failing and damaging cement pointing.
