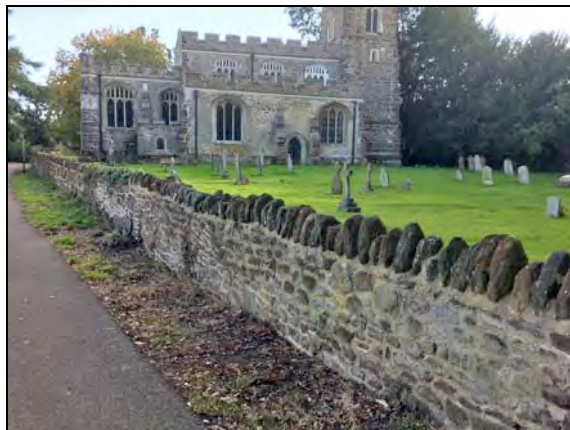
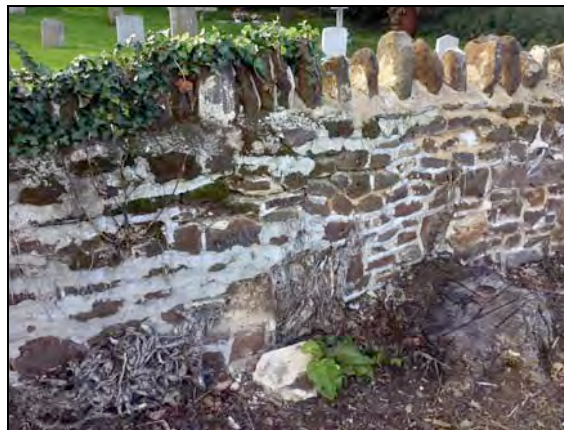
Grid Ref: TL007324

Open joints and failure of cement pointing. Penetrating ivy. 1.0–2.0 square meter of partial collapse, and missing stones including to coping. Recently reset coping stones too far apart.

Repointing, removal of ivy, piecing-in missing stones, reinstatement of runs of missing coping, resetting of existing coping incorporating new stones and some rebuilding.

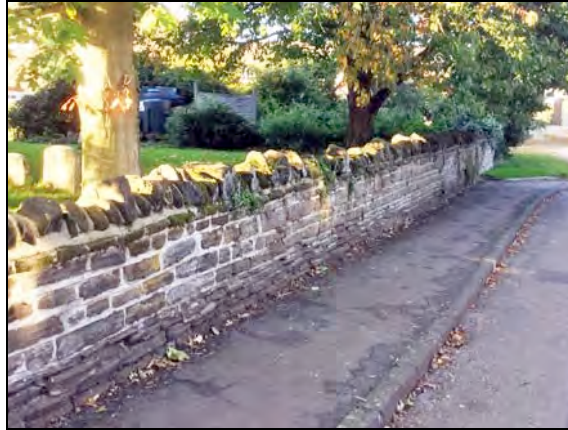
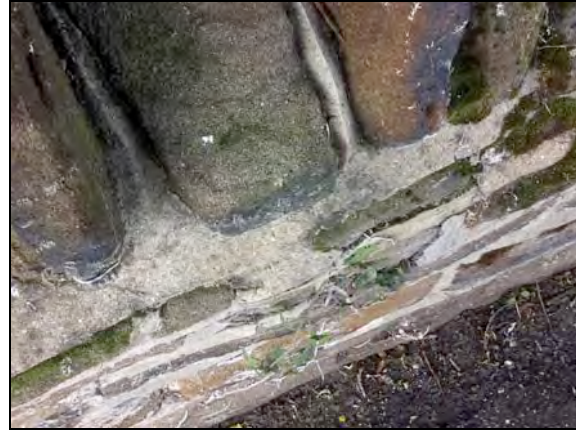
Grid Ref: TL011353

Failed cement pointing and instances of salt erosion at low level (impervious asphalt pavement immediately alongside). Loose copings and some invasive ivy.

Renew failed and failing pointing and some piecing-in of stonework, along with resetting of copings stones and control of vegetation.

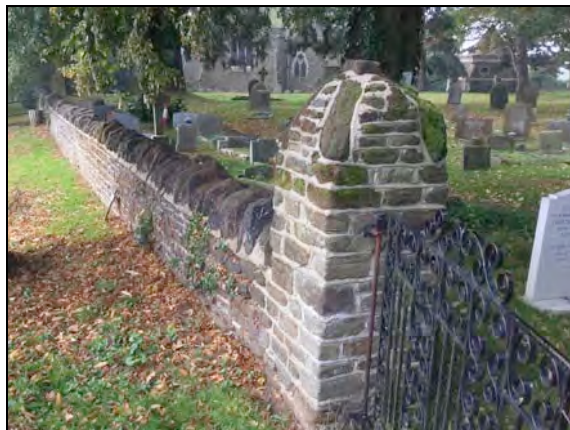
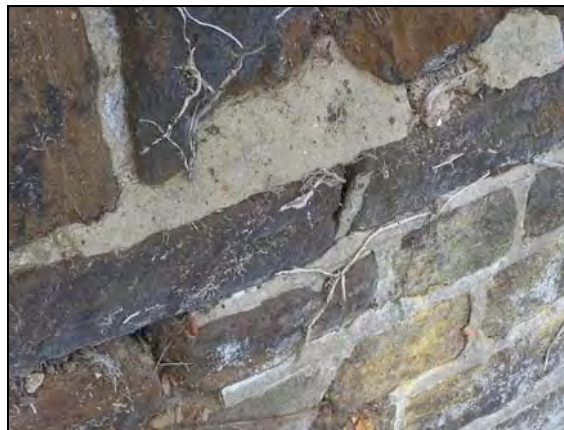
Grid Ref: TL058380

Extensive failure of cement pointing and bedding plus vertical cracking to northern corner with evidence of 'rust jacking' to bed joints either side of north gate. Some penetrating ivy.

Some reduction in ground levels towards northern end, repointing, treatment (removal) of corroding iron, crack repair (stitching) and targeted control of ivy.

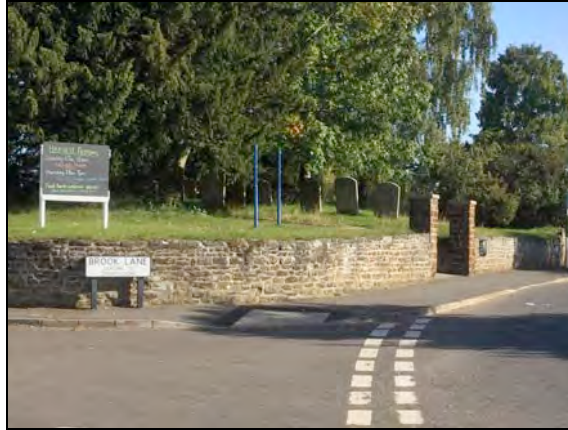
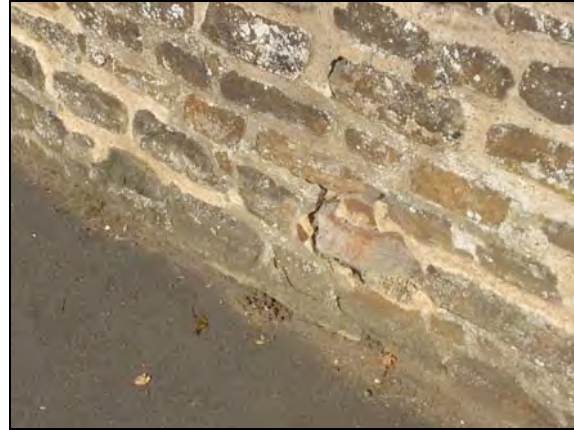
Grid Ref: TL059358

Some loose mortar (including feathered and hence failing lime mortar) with some cracking due to hard cement mortar pointing un able to accommodate thermal expansion. Some salt erosion of stones at low level.

Partial renewal of cement and failed pointing to walls fronting High Street and Brook Lane, along with crack repair, limited piecing-in of eroded stones, and possibly need for localised stabilisation.

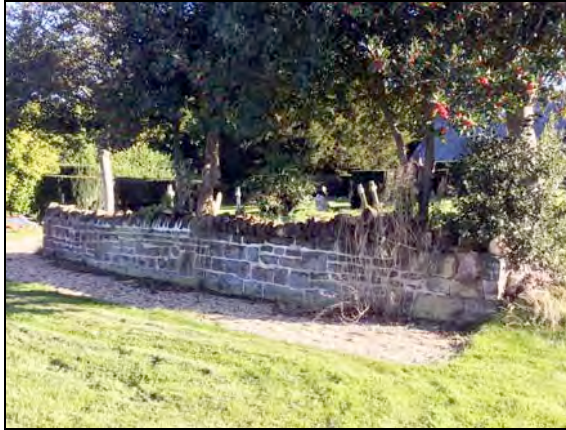
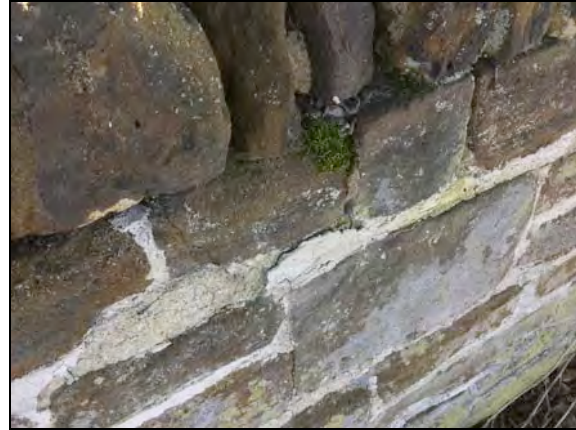
Grid Ref: TL081412

Extensive failure of lime pointing and bedding to north-facing wall. Some washed out joints to east-facing wall. A small number of individual stones eroded or fractured.

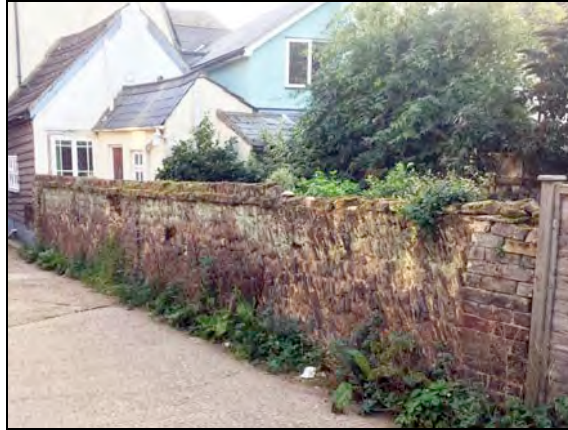
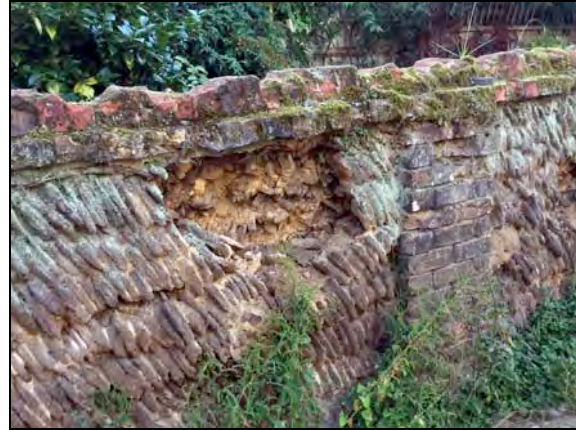
Approximately 22 m long x 1.0 m high wall alongside yard to rear of property. Panels of diagonally laid walling between brick piers with brick-on-edge on sailing course coping.

Missing (hollow) areas of walling threaten stability + decayed or missing brick coping.

Stabilisation: piecing-in or rebuilding fallen (hollow) areas, repairs to coping, repointing, etc.
