The Greensand Country Landscape Partnership

SECRETS OF THE SANDS

SANDSTONE STRUCTURES AUDIT

November 2015

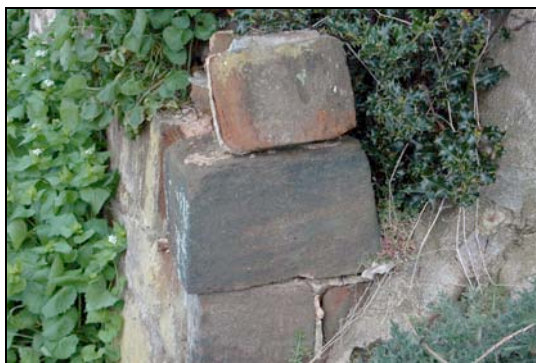
03.04: HARD, DURABLE STONE

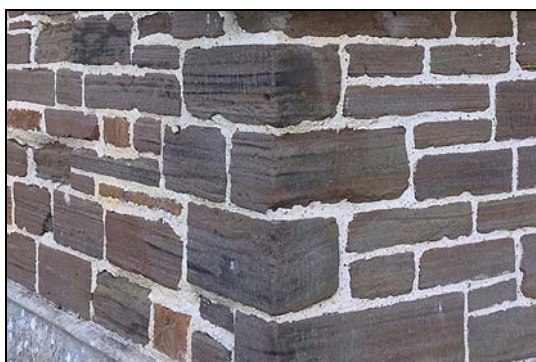
03.06: HORIZONTAL BEDDING PLANES

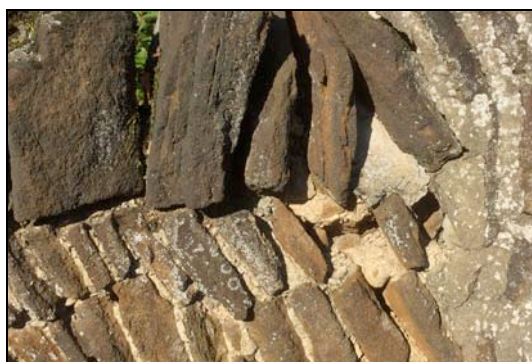
03.07: STONES BEDDED ON EDGE

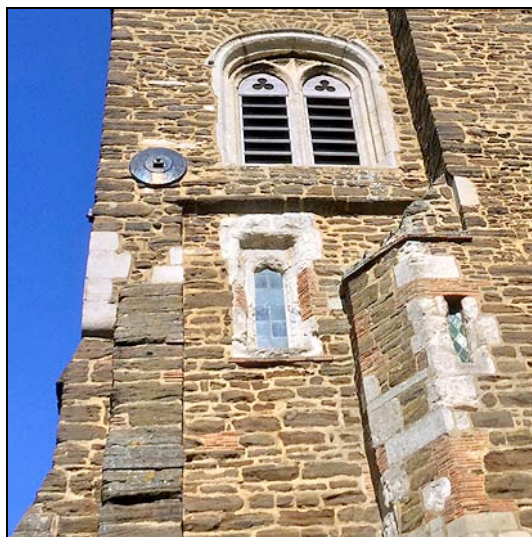
03.14: LIMESTONE DRESSINGS & TILE STITCHING TO SANDSTONE TOWER
